Retrofit satellite radio (SDAR)

AZ82.60-P-0006QA MODEL 209.4## 1# with CODE (494) USA version with CODE (806) Model year 2006 with CODE (810) Sound system with CODE (359) TELE AID emergency call system MODEL 209.4## 1# with CODE (494) USA version with CODE (807) Model year 2007 with CODE (810) Sound system with CODE (359) TELE AID emergency call system

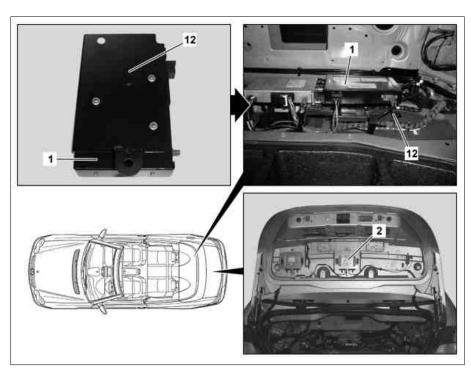
P82.60-5769-06

- 1 SDAR control unit
- 2 SDAR antenna
- 12 SDAR bracket
