Model 218

Center console
 Armrest
 Support plate

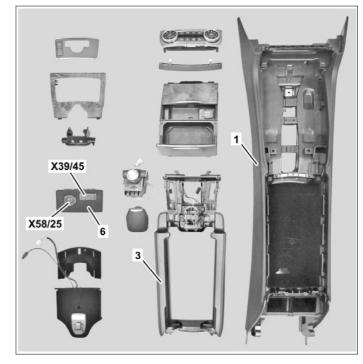
P68.20-4386-12

- 1 Center console
- 2 Bolts
- 3 Armrest
- 4 Bolts
- 5 Electrical connectors
