**MODEL 172, 204, 207, 212, 218, 219, 231**

**Position of propeller shaft without clamp connection**

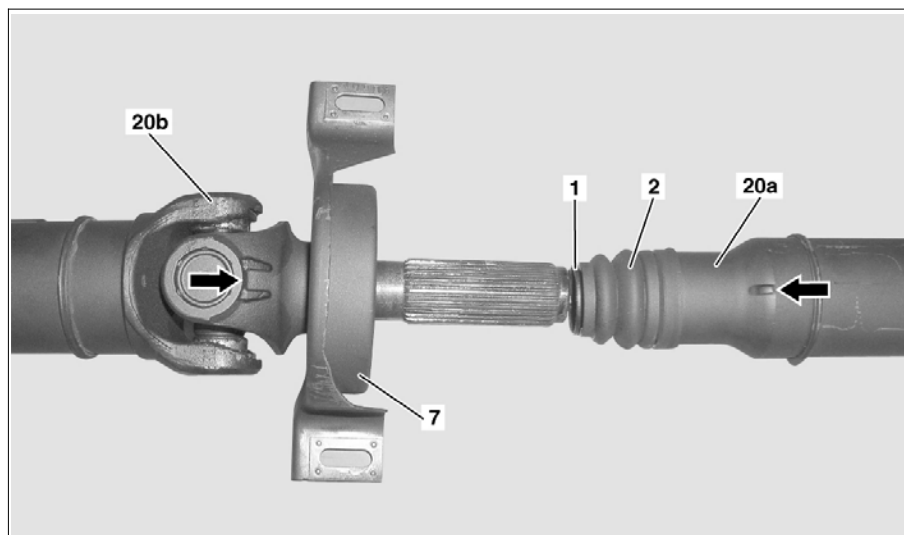
P41.10-2314-05

**i** The humps of the front propeller shaft (20a) must be located between the two humps on the rear propeller shaft (20b) (arrows). Ensure that rubber boot (2) is seated properly.

- 1 Check front propeller shaft (20a), rear propeller shaft (20b), thrust plate (1), rubber boot (2) and propeller shaft center support bearing (7) for wear and damage.

- 2 Grease splined profile of rear propeller shaft (20b) using long-life grease.

- 3 Connect front propeller shaft (20a) and rear propeller shaft (20b).
