P68.10-3283-09

Shown on vehicle as of 1.06.06 with code (494) USA version

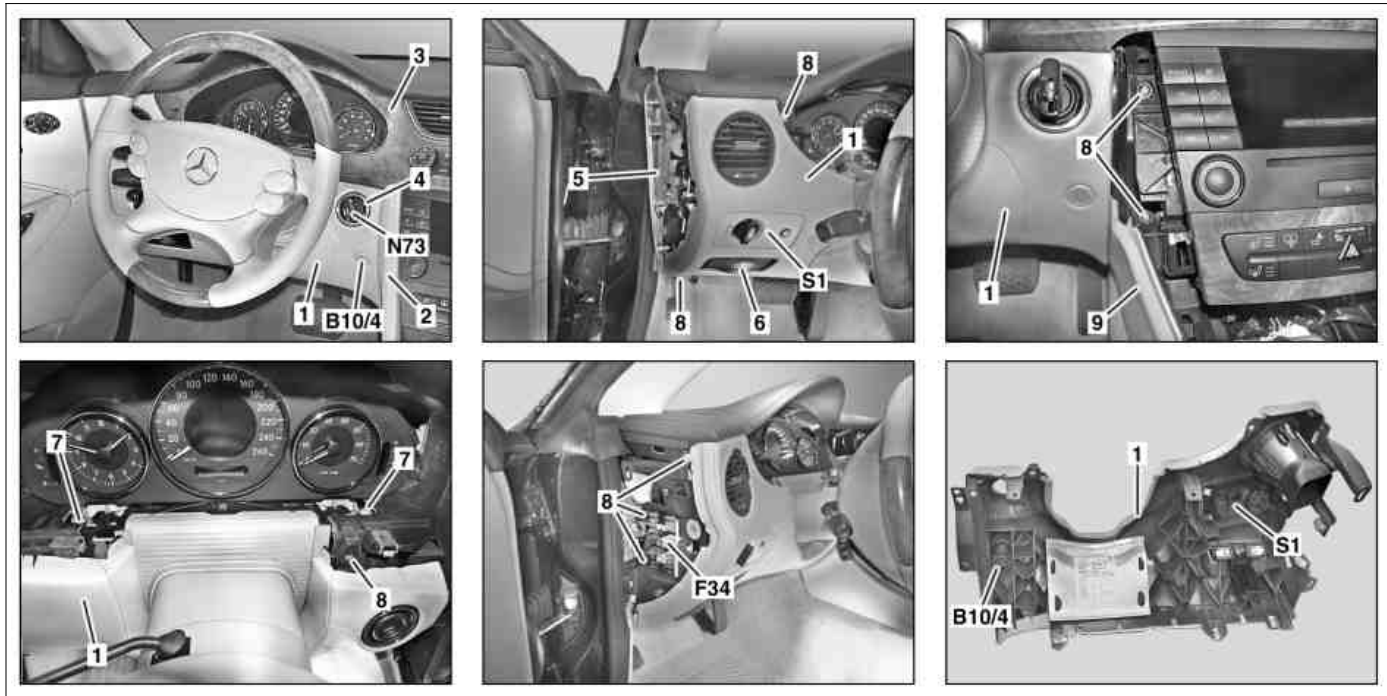
| 1 Driver-side instrument panel bottom section | 5 Left cover | B10/4 In-car temperature sensor |
| 2 Trim at the center console | 6 Release handle | F34 Interior fuse box |
| 3 Trim strip | 7 Bolt | N73 EIS [EZS] control unit |
| 4 Trim ring | 8 Bolts | S1 Rotary light switch |
| | 9 Center console, front | |

See Operator's Manual
2	Remove left cover below instrument panel		AR68.10-P-1500TX
3	Remove center console paneling (2)		AR68.20-P-5169TX
4	Remove trim strip (3) from instrument panel		AR68.10-P-1180TX
5	Unscrew round cover (4) with slotted nut wrench and press EIS control unit (N73) toward front out of driver-side instrument panel bottom section (1)

Installation: Ensure that EIS control unit (N73) is positioned correctly
6	Unclip left cover (5) from instrument panel with mounting wedge

8	⚠ Danger! ⓘ Risk of fire and explosion caused by machining/treating magnesium components Remove bolts (7) Information on machining/treating magnesium components	Keep away from ignition sources and open flames.	AS60.00-Z-0006-01R AH60.00-P-0023-01R
9	⚠ Danger! ⓘ Risk of fire and explosion caused by machining/treating magnesium components Unscrew bolts (8) with battery-powered screwdriver Information on machining/treating magnesium components	Keep away from ignition sources and open flames.	AS60.00-Z-0006-01R AH60.00-P-0023-01R
10	Disconnect electrical connectors (10) at driver kneebag squib (R12/25)	ⓘ Vehicles as of 1.06.06 with code (494) USA version	
11	Remove bolts (11)	ⓘ Vehicles as of 1.06.06 with code (494) USA version Nm	*BA91.60-P-1005-01G
12	Unhook driver-side instrument panel bottom section (1) from front center console (9) and pull toward rear until electrical connectors are accessible

13	ⓘ Disconnect electrical connectors from rotary light switch (S1) and inside air temperature sensor (B10/4) Notes on avoiding damage to electronic components due to electrostatic discharge		AH54.00-P-0001-01A
14	Remove interior fuse box (F34) from driver-side instrument panel bottom section (1)	ⓘ The electrical lines remain installed on the interior fuse box (F34)	
15	Remove driver-side instrument panel bottom section (1)		
16	Install in the reverse order

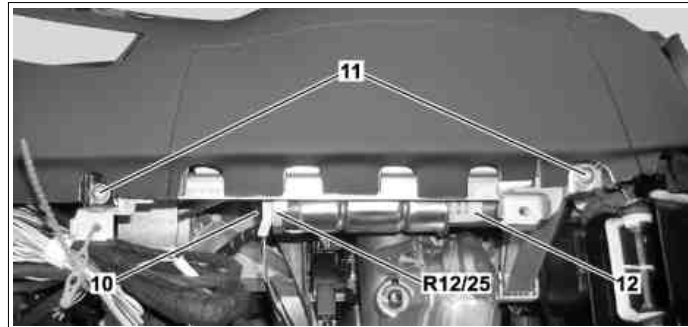
P91.60-3327-10

- 10 Electrical connector
- 11 Bolts
- R12/25 Driver kneebag squib
