Shown on vehicle as of 1.06.06 with code (494) USA version

Remove/install		
1	Move steering wheel upward to limit stop

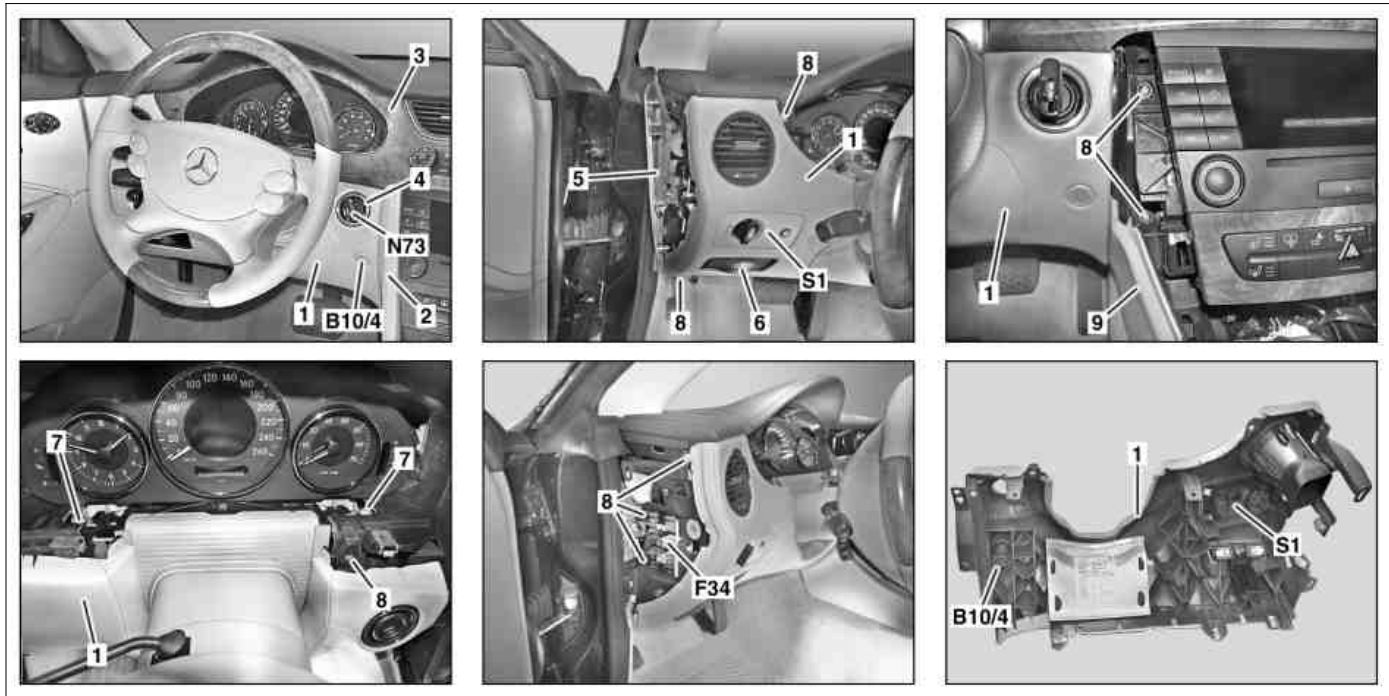
P68.10-3283-09

| 1 Driver-side instrument panel bottom section | 5 Left cover | B10/4 In-car temperature sensor |
| 2 Trim at the center console | 6 Release handle | F34 Interior fuse box |
| 3 Trim strip | 7 Bolt | N73 EIS [EZS] control unit |
| 4 Trim ring | 8 Bolts | S1 Rotary light switch |
| | 9 Center console, front | |

See Operator's Manual
2	Remove left cover below instrument panel		AR68.10-P-1500TX
3	Remove center console paneling (2)		AR68.20-P-5169TX
4	Remove trim strip (3) from instrument panel		AR68.10-P-1180TX
5	Unscrew round cover (4) with slotted nut wrench and press EIS control unit (N73) toward front out of driver-side instrument panel bottom section (1)

Installation: Ensure that EIS control unit (N73) is positioned correctly
6	Unclip left cover (5) from instrument panel with mounting wedge

8	⚠ Danger! ⓘ Risk of fire and explosion caused by machining/treating magnesium components Remove bolts (7) Information on machining/treating magnesium components	Keep away from ignition sources and open flames.	AS60.00-Z-0006-01R AH60.00-P-0023-01R
9	⚠ Danger! ⓘ Risk of fire and explosion caused by machining/treating magnesium components Unscrew bolts (8) with battery-powered screwdriver Information on machining/treating magnesium components	Keep away from ignition sources and open flames.	AS60.00-Z-0006-01R AH60.00-P-0023-01R
10	Disconnect electrical connectors (10) at driver kneebag squib (R12/25)	ⓘ Vehicles as of 1.06.06 with code (494) USA version	
11	Remove bolts (11)	ⓘ Vehicles as of 1.06.06 with code (494) USA version Nm	*BA91.60-P-1005-01G
12	Unhook driver-side instrument panel bottom section (1) from front center console (9) and pull toward rear until electrical connectors are accessible

13	ⓘ Disconnect electrical connectors from rotary light switch (S1) and inside air temperature sensor (B10/4) Notes on avoiding damage to electronic components due to electrostatic discharge		AH54.00-P-0001-01A
14	Remove interior fuse box (F34) from driver-side instrument panel bottom section (1)	ⓘ The electrical lines remain installed on the interior fuse box (F34)	
15	Remove driver-side instrument panel bottom section (1)		
16	Install in the reverse order

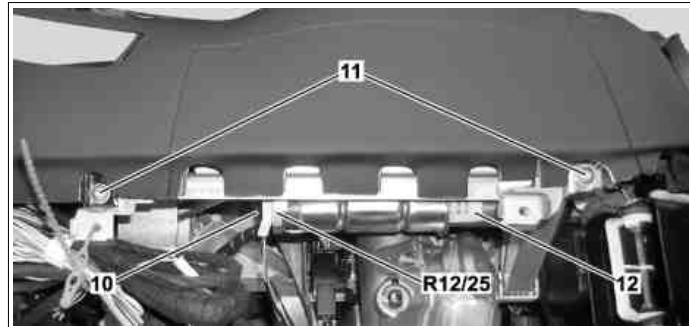
P91.60-3327-10

- 10 Electrical connector
- 11 Bolts
- R12/25 Driver kneebag squib
