**MODEL 207.4**  
as of model year 2014  
without CODE 427 (7-speed automatic transmission)

**MODEL 207.4**  
up to model year 2014

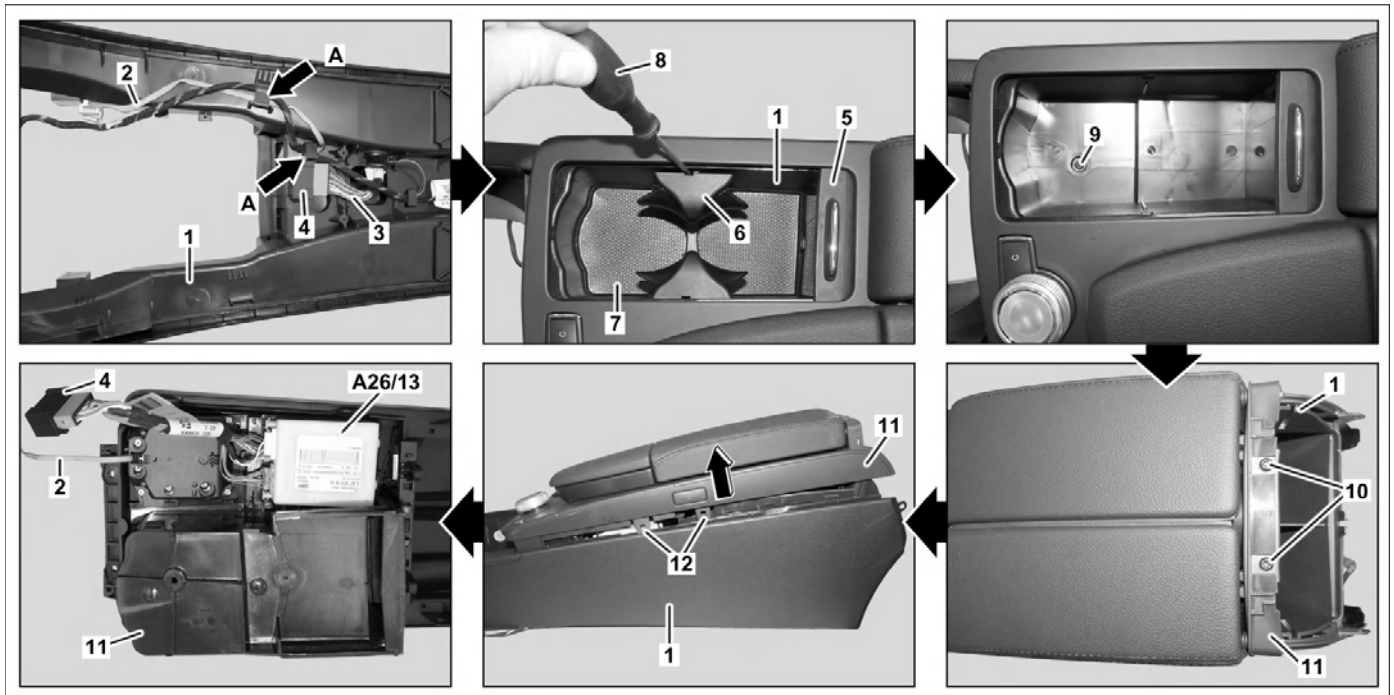
P68.20-4261-09

1	Center console	6	Beverage holder	11	Armrest
2	Electrical wiring harness	7	Insertion element	12	Lugs
3	Electrical wiring harness	8	Screwdriver	A26/13	Interior protection sensor (master) (with CODE (882) Interior monitoring (only with ATA only)
4	Electrical connector	9	Screw		
5	Roller blind	10	Bolts

↖ ↗	Disassemble/assemble		
1	Remove center console (1)		AR68.20-P-2000CW
2	Lay center console (1) down with bottom up	⚠	Lay center console (1) down on clean dry cloth. Otherwise damage may occur.
3	Unclip connector on electrical wiring harness (2) from center console (1) and expose electrical wiring harness (2) on center console (1) (arrows A)		
4	Unclip electrical connector (4) from center console (1)		
5	Lay center console (1) with top up	⚠	Lay center console (1) down on clean dry cloth. Otherwise damage may occur.
6	Slide roller blind (5) toward rear

7	Unclip beverage holder (6) as shown from center console (1) with screwdriver (8) on both sides in area of cutouts for beverage holder (6) and remove upward		
8	Remove insertion element (7)		
9	Unscrew screw/bolt (9)		
10	Remove bolts (10)	<p>⚠ <b>Installation:</b> Carefully tighten bolts (10). Otherwise the center console (1) can be damaged and must be replaced.</p>	
11	Unclip armrest (11) on lugs (12) on left and right side of center console (1), guide out upward and remove	<p>⚠ Carefully unclip armrest (11). Otherwise the lugs (12) can break off.</p> <p>⚠ <b>Installation:</b> Make sure that electrical lines are not pinched. Otherwise the vehicle electrical system may be damaged.</p> <p><b>i</b> Remove all electrical lines on armrest (11) from center console (1). The number of electrical lines depends on the vehicle equipment.</p> <p><b>☑</b> Mounting wedge</p>	*110589035900
12	Unclip interior protection sensor (master) (A2613) from armrest (11) and lay down to side with electrical wiring harness connected	<p>MODEL 207.4 as of model year 2014 with CODE 882 (Interior monitoring (with ATA [EDW] only)) without CODE 427 (7-speed automatic transmission)</p> <p>MODEL 207.4 up to model year 2014 with CODE 882 (Interior monitoring (with ATA [EDW] only))</p>

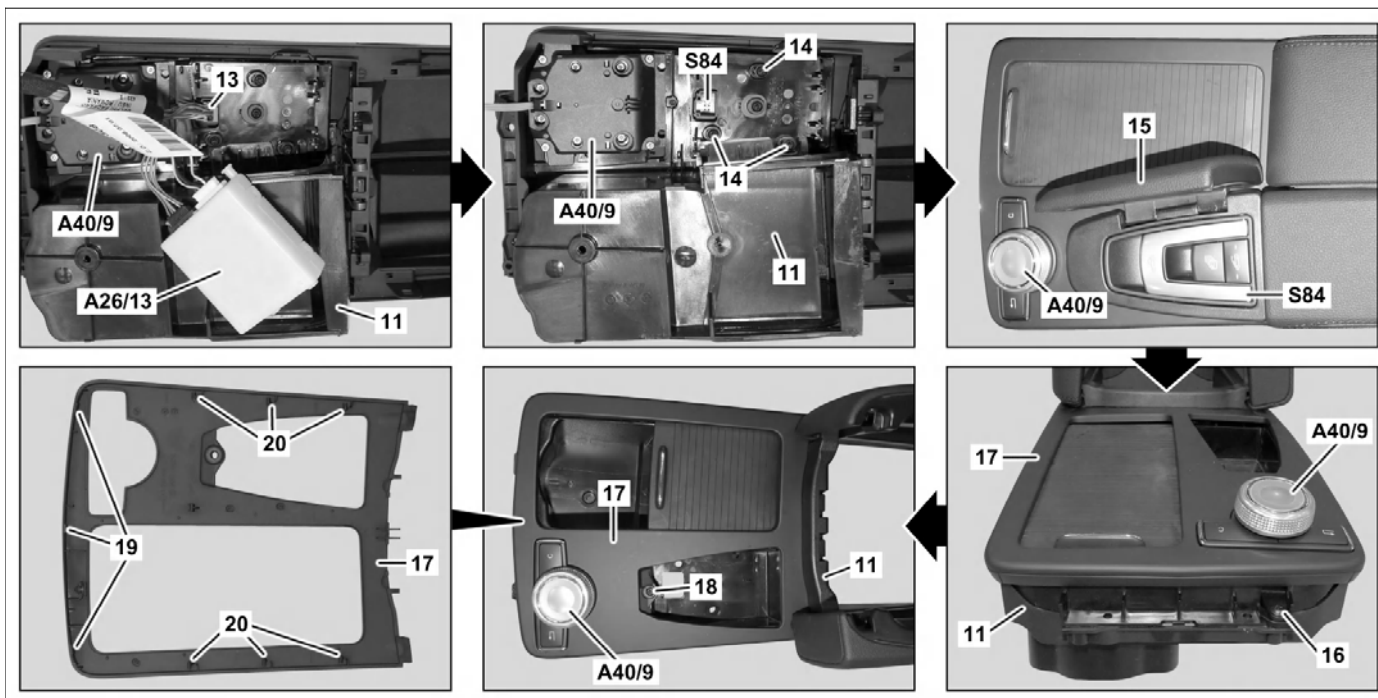
P68.20-4262-09

| 11 | Armrest | 16 | Screw | 20 | Side catch hook |
| 13 | Electrical connector | 17 | Cover | A26/13 | Interior protection sensor (master) (with CODE (882) Interior monitoring (only with ATA only)) |
| 14 | Bolts | 18 | Screw | A40/9 | Audio/COMAND control panel |
| 15 | Support | 19 | Front catch hook | S84 | Soft top control switch |

13	Disconnect electrical connector (13)		
14	Remove screws/bolts (14)		
15	Remove covering (15) with soft top control switch (S84) from armrest (11)		
16	Remove screw/bolt (16)		
17	Unscrew screw/bolt (18)		
18	First unclip front catch hooks (19), then side catch hooks (20) and remove cover (17) from armrest (11) toward front	<p>⚠ Carefully unclip cover (17). Otherwise the cover (17) can be damaged and must be replaced.</p>	
19	Lift audio/COMAND control panel (A40/9), remove with electrical wiring harness (2) toward rear from armrest (11)		
20	Pull roller blind (5) toward front out of armrest (11) and remove		
21	Unclip Media Interface electrical connector (X18/70) and guide toward out through opening in connecting strip (41) or mounting console (39)	<p>MODEL 207.4 as of 3/1/11 up to model year 2014 with CODE 512 (COMAND APS with DVD changer)</p> <p>MODEL 207.4 as of model year 2014 with CODE 512 (COMAND APS with DVD changer) without CODE 427 (7-speed automatic transmission)</p> <p><b>i</b> On vehicles as of model year 2014 the connecting strip (41) will be eliminated. The electrical connector for Media Interface (X18/70) is clipped directly into the housing of the center console (1).</p>

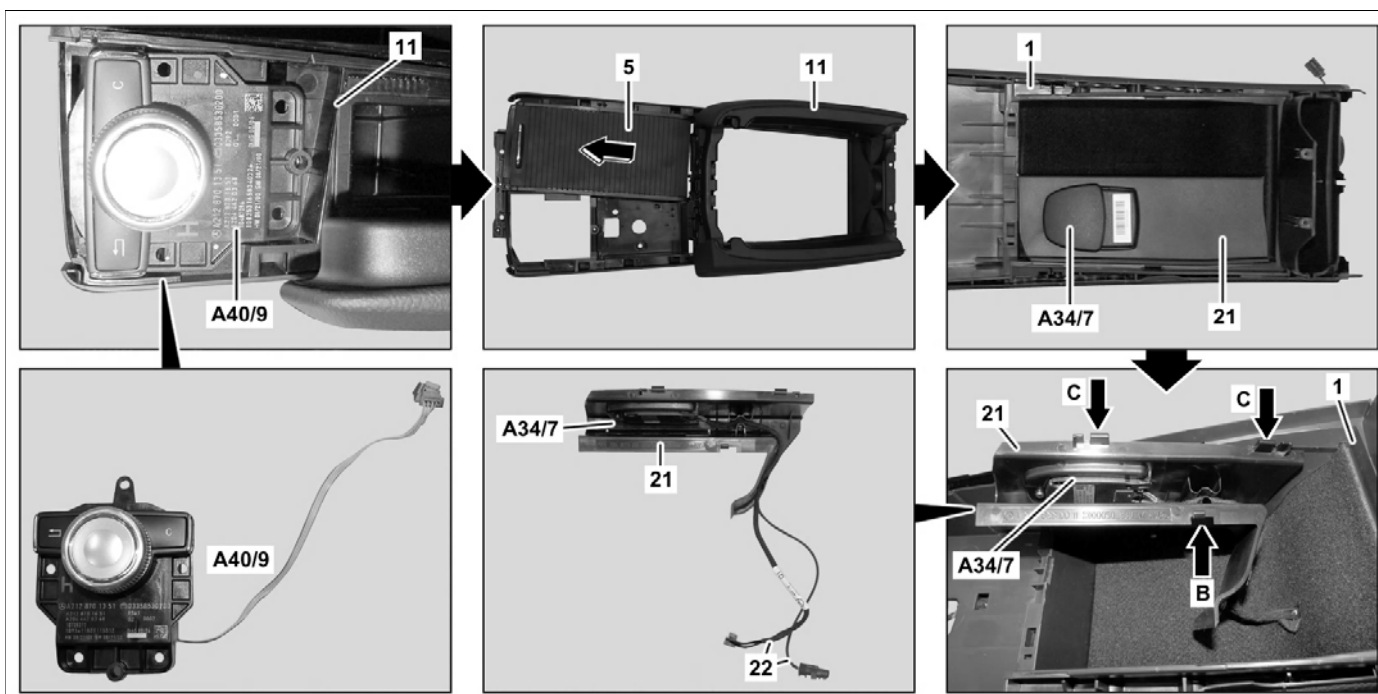
P68.20-4263-09

Shown on vehicle up to 28.02.2011 with code (386) Comfort telephony

| 1 | Center console | 21 | Mounting console (on vehicles up to 28.02.2011 with CODE 386 (Comfort telephony)) | A40/9 | Audio/COMAND control panel |

- 5      *Roller blind*
- 11     *Armrest*
- 22     *Electrical lines (with CODE 386 (Comfort telephony))*
- A34/7 *Bluetooth module (with CODE 386 (Comfort telephony))*

**Shown on vehicle as of 01.03.2011 with code (386) Comfort telephony**

- 1      *Center console*
- 22     *Electrical lines (with CODE 386 (Comfort telephony))*
- 23     *Long wedge*
- 25     *Catch hook*
- 39     *Mounting console (pivotable) (on vehicles as of 01.03.2011 with code (386) Comfort telephony)*
- 40     *Bolt (MODEL 207.4 as of 01.03.11 up to model year 2014 with CODE 386 (Comfort telephony) or CODE 512 (COMAND APS incl. DVD changer) or CODE 518 (Media Interface), MODEL 207.4 as of model year 2014 with CODE 386 (Comfort telephony))*
- A34/7 *Bluetooth module (with CODE 386 (Comfort telephony))*

23.1	Unclip mounting console (21) at bottom (arrow B), pivot toward inside and unclip at top (arrows C)	<p>MODEL 207.4 up to 2/28/11 up to model year 2014 with CODE 386 (Comfort telephony)</p> <p>

23.2	Unclip mounting console (39) with long wedge (23) from center console (1)	<p>MODEL 207.4 as of 3/1/11 up to model year 2014 with CODE 386 (Comfort telephony)</p> <p>MODEL 207.4 as of model year 2014 with CODE 386 (Comfort telephony) without CODE 427 (7-speed automatic transmission)</p> <p>

Carefully unclip mounting console (39). Otherwise the catch hooks (25) can break and the mounting console (39) must be replaced.</p> <p>

26.1	Guide mounting console (21) with Bluetooth module (A347) and electrical lines (22) out of center console (1) and remove	MODEL 207.4 up to 2/28/11 up to model year 2014 with CODE 386 (Comfort telephony)

26.2	Guide mounting console (39) with Bluetooth module (A347) and electrical lines (22) out of center console (1) and remove	<p>MODEL 207.4 as of 3/1/11 up to model year 2014 with CODE 386 (Comfort telephony)</p> <p>MODEL 207.4 as of model year 2014 without CODE 427 (7-speed automatic transmission)</p> <p><b>i</b> Guide electrical lines (22) through opening at bottom into center console (1).</p>	
27	Assemble in the reverse order

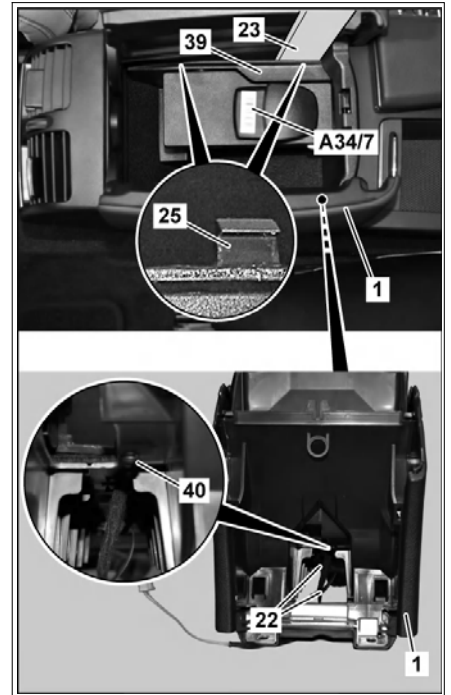
P82.70-7615-03

**Shown on vehicle as of 01.03.2011 up to model year 2014 without CODE 386 (Comfort telephony)**

- 41      *connecting strip (up to model year 2014 without CODE 386 (Comfort telephony))*
- X18/70 *Electrical connector for Media Interface (with CODE 518 (Media Interface))*
- X115    *USB electrical connector (vehicles as of 01.07.11 up to model year 2014 with CODE 512 (COMAND APS incl. DVD changer) or CODE 526 (COMAND (without navigation)) or CODE 528 (COMAND incl. DVD changer) or CODE 527 (COMAND APS with single DVD drive (with navigation)), Vehicles as of 01.06.12 up to model year 2014 with CODE 510 (Audio 20 CD with CD changer) or CODE 523 (Radio MB Audio 20), Vehicles as of model year 2014)*

22	Unscrew bolt (40) at bottom of center console (1) on mounting console mount (39) or connecting strip (41)	<p>MODEL 207.4 as of 3/1/11 up to model year 2014 with CODE 386 (Comfort telephony)</p> <p>MODEL 207.4 as of 3/1/11 up to model year 2014 with CODE 512 (COMAND APS with DVD changer)</p> <p>MODEL 207.4 as of 3/1/11 up to model year 2014 with CODE 518 (Media interface)</p> <p>MODEL 207.4 as of model year 2014 with CODE 386 (Comfort telephony) without CODE 427 (7-speed automatic transmission)</p> <p>MODEL 207.4 as of model year 2014 with CODE 512 (COMAND APS with DVD changer) without CODE 427 (7-speed automatic transmission)</p> <p>

As of model year 2014 the connecting strip (41) will be eliminated.</p>

Long wedge</p>	*115589035900
24	Unclip connecting strip (41) with long wedge (23) from center console (1) and remove	<p>MODEL 207.4 as of 3/1/11 up to model year 2014 with CODE 512 (COMAND APS with DVD changer) without CODE 386 (Comfort telephony)</p> <p>MODEL 207.4 up to 3/1/11 up to model year 2014 with CODE 518 (Media interface) without CODE 386 (Comfort telephony)</p> <p>MODEL 207.4 as of model year 2014 with CODE 512 (COMAND APS with DVD changer) without CODE 386 (Comfort telephony) without CODE 427 (7-speed automatic transmission)</p> <p>MODEL 207.4 as of model year 2014 with CODE 518 (Media interface) without CODE 386 (Comfort telephony) without CODE 427 (7-speed automatic transmission)</p> <p>

Carefully unclip connecting strip (41). Otherwise the catch hooks can break and the connecting strip (41) must be replaced.</p> <p>

The catch hook on the connecting strip (41) is located at the same location as the catch hook (25) of the mounting console (39).</p> <p>

25	Unclip USB electrical connector USB (X115) from connecting strip (41) or housing from center console (1) and remove	<p>MODEL 207.4 as of 6/1/12 up to model year 2014 with CODE 510 (Audio 20 CD with CD changer)</p> <p>MODEL 207.4 as of 6/1/12 up to model year 2014 with CODE 523 (MB Audio 20 radio)</p> <p>MODEL 207.4 as of 7/1/11 up to model year 2014 with CODE 512 (COMAND APS with DVD changer)</p> <p>MODEL 207.4 as of 7/1/11 up to model year 2014 with CODE 526 (COMAND (without navigation))</p> <p>MODEL 207.4 as of 7/1/11 up to model year 2014 with CODE 527 (COMAND APS with single DVD drive (with navigation))</p> <p>MODEL 207.4 as of 7/1/11 up to model year 2014 with CODE 528 (COMAND with DVD changer)</p> <p>MODEL 207.4 as of model year 2014 without CODE 427 (7-speed automatic transmission)</p> <p><b>i</b> On vehicles as of model year 2014 the connecting strip (41) will be eliminated. The USB electrical connector(X115) is directly clipped into the housing of center console (1)</p>
