MODEL 207.4
 as of model year 2014
 without CODE 427 (7-speed automatic transmission)

MODEL 207.4
 up to model year 2014

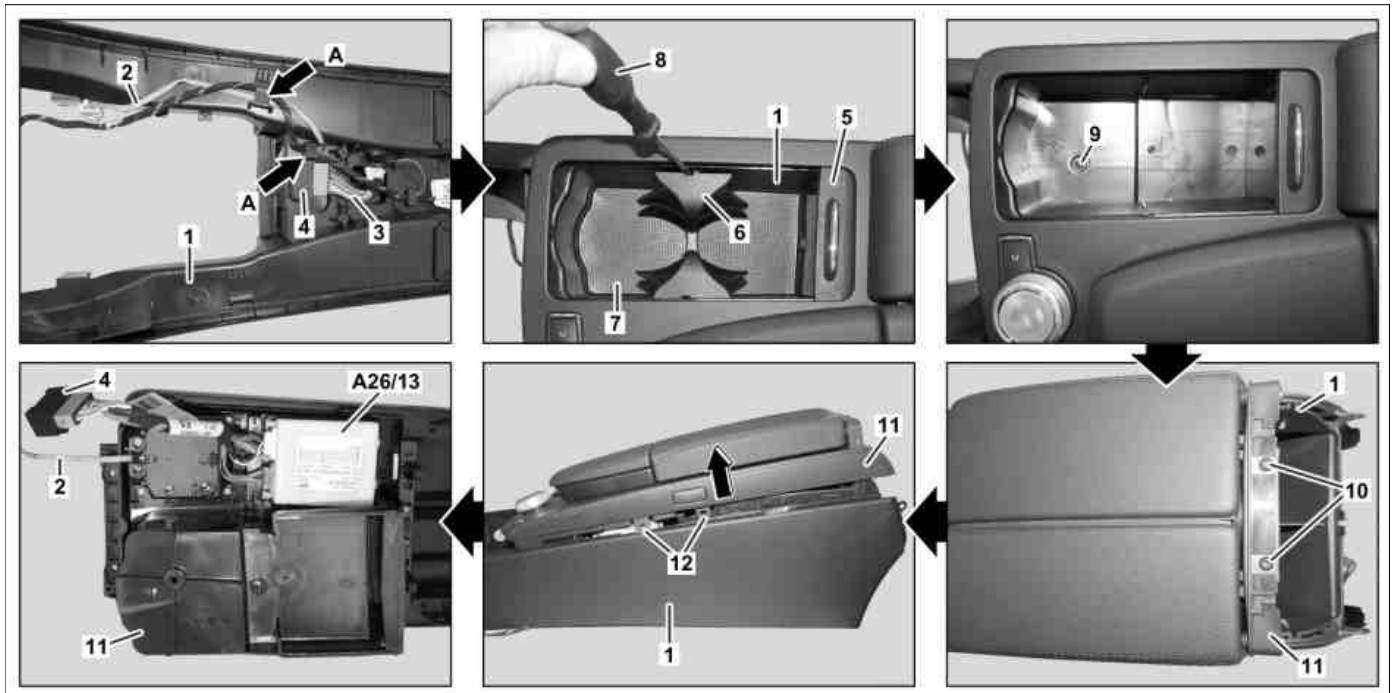
P68.20-4261-09

| 1 | Center console | 6 | Beverage holder | 11 | Armrest |
| 2 | Electrical wiring harness | 7 | Insertion element | 12 | Lugs |
| 3 | Electrical wiring harness | 8 | Screwdriver | A26/13 | Interior protection sensor (master)
| 4 | Electrical connector | 9 | Screw | | |
| 5 | Roller blind | 10 | Bolts | | |

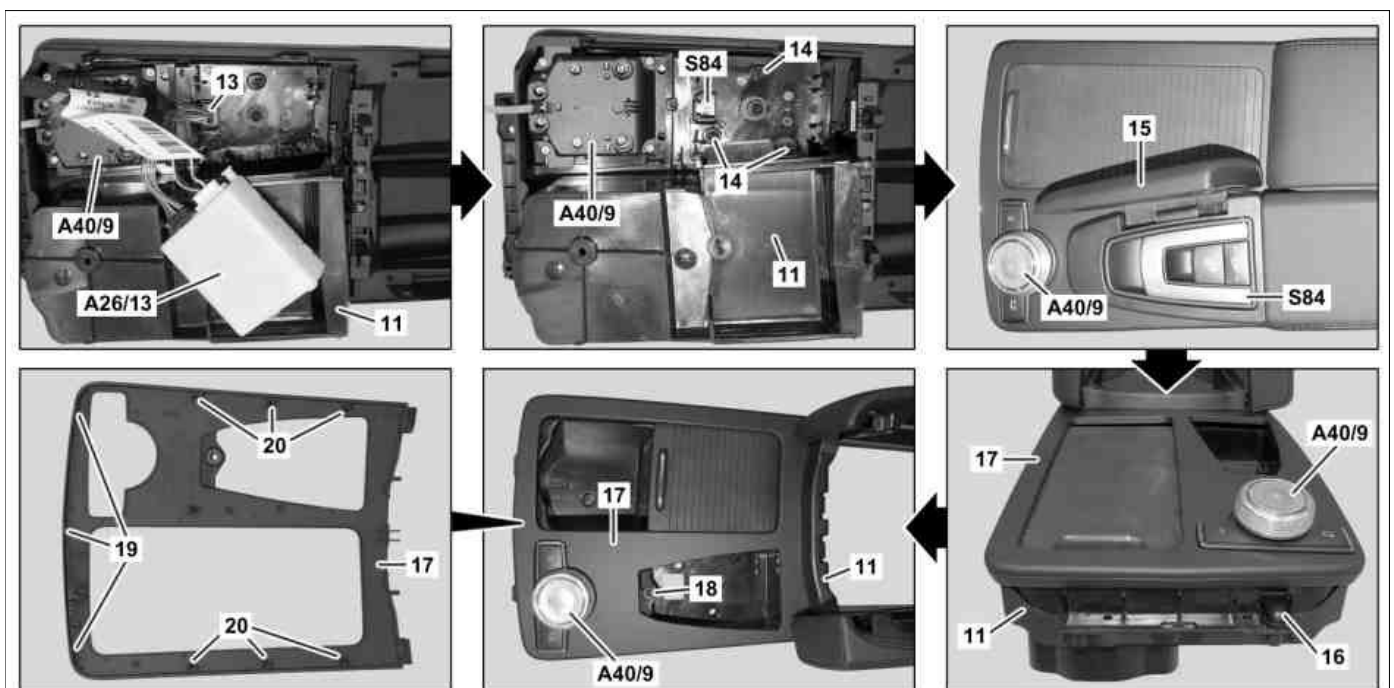
11	Armrest	16	Screw	20	Side catch hook
13	Electrical connector	17	Cover	A26/13	Interior protection sensor (master) (with CODE (882) Interior monitoring (only with ATA only)
14	Bolts	18	Screw	A40/9	Audio/COMAND control panel
15	Support	19	Front catch hook	S84	Soft top control switch

13	Disconnect electrical connector (13)		
14	Remove screws/bolts (14)		
15	Remove covering (15) with soft top control switch (S84) from armrest (11)		
16	Remove screw/bolt (16)		
17	Unscrew screw/bolt (18)		
18	First unclip front catch hooks (19), then side catch hooks (20) and remove cover (17) from armrest (11) toward front

Carefully unclip cover (17). Otherwise the cover (17) can be damaged and must be replaced.	
19	Lift audio/COMAND control panel (A40/9), remove with electrical wiring harness (2) toward rear from armrest (11)		
20	Pull roller blind (5) toward front out of armrest (11) and remove		
21	Unclip Media Interface electrical connector (X18/70) and guide toward out through opening in connecting strip (41) or mounting console (39)	MODEL 207.4 as of 3/1/11 up to model year 2014 with CODE 512 (COMAND APS with DVD changer) MODEL 207.4 as of model year 2014 with CODE 512 (COMAND APS with DVD changer) without CODE 427 (7-speed automatic transmission)

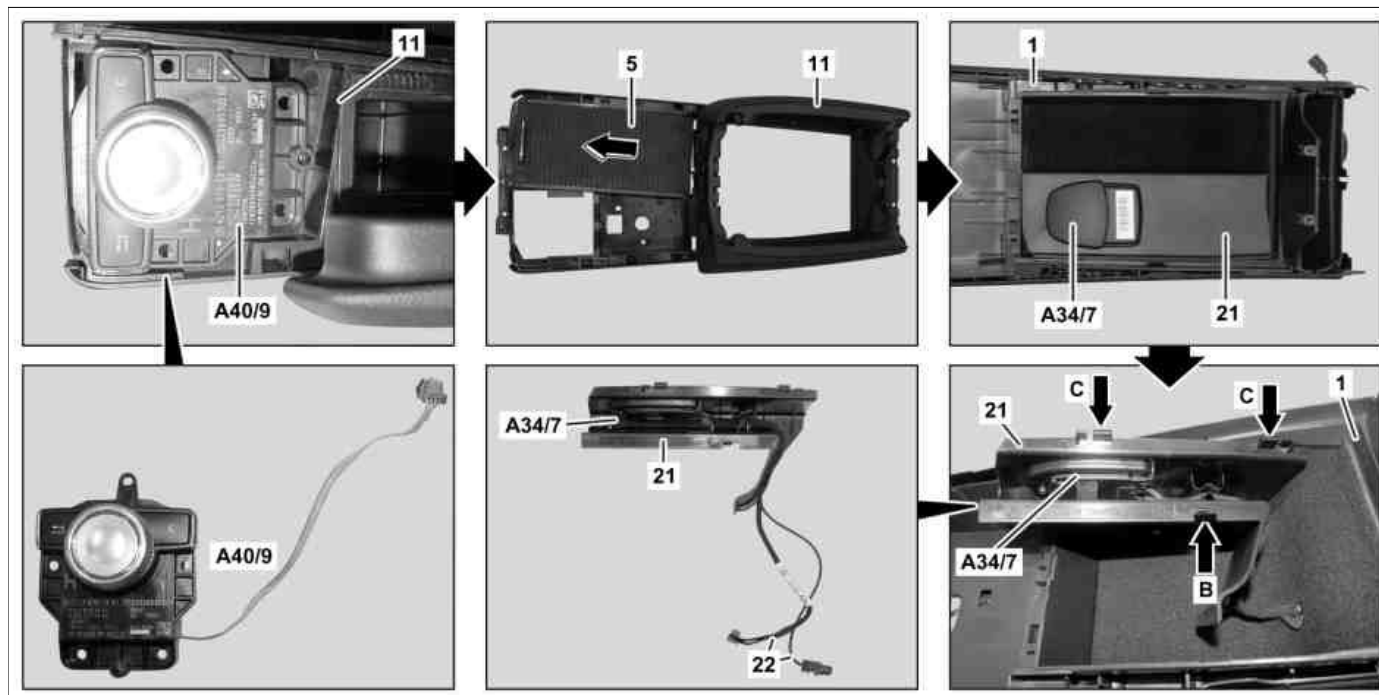
Shown on vehicle up to 28.02.2011 with code (386) Comfort telephony

1	Center console	21	Mounting console (on vehicles up to 28.02.2011 with CODE 386 (Comfort telephony))	A40/9	Audio/COMAND control panel
5	Roller blind	22	Electrical lines (with CODE 386 (Comfort telephony))		
11	Armrest	A34/7	Bluetooth module (with CODE 386 (Comfort telephony))

Shown on vehicle as of 01.03.2011 with code (386) Comfort telephony

- 1 Center console
- 22 Electrical lines (with CODE 386 (Comfort telephony))
- 23 Long wedge
- 25 Catch hook
- 39 Mounting console (pivotable) (on vehicles as of 01.03.2011 with code (386) Comfort telephony)
- 40 Bolt (MODEL 207.4 as of 01.03.11 up to model year 2014 with CODE 386 (Comfort telephony) or CODE 512 (COMAND APS incl. DVD changer) or CODE 518 (Media Interface), MODEL 207.4 as of model year 2014 with CODE 386 (Comfort telephony))
- A34/7 Bluetooth module (with CODE 386 (Comfort telephony))

23.1	Unclip mounting console (21) at bottom (arrow B), pivot toward inside and unclip at top (arrows C)	MODEL 207.4 up to 2/28/11 up to model year 2014 with CODE 386 (Comfort telephony)

23.2	Unclip mounting console (39) with long wedge (23) from center console (1)	MODEL 207.4 as of 3/1/11 up to model year 2014 with CODE 386 (Comfort telephony) MODEL 207.4 as of model year 2014 with CODE 386 (Comfort telephony) without CODE 427 (7-speed automatic transmission)
