Model	204.0 (except 204.077), 204.2 (except 204.277), 204.3 with code 409 (Left/right front multicontour seat)
Model	207, 212, 218 with code 409 (Left/right front multicontour seat)
Model	463.202/236/237 as of model year 2010 up to model year 2013 with code SM7 (Left front multicontour seat) with code SM8 (Front passenger multicontour seat)
Model	463.222/270/271/303/340/341 as of model year 2010 up to model year 2013 with code SM7 (Left front multicontour seat) with code SM8 (Front passenger multicontour seat)
Model	463.242 as of model year 2013 up to model year 2015 with code S52 (Left/right individual seats in rear with seat heater)
Model	463.306/336 as of model year 2010 up to model year 2013 with code SM7 (Left front multicontour seat) with code SM8 (Front passenger multicontour seat)
Model	463.346 as of model year 2010 up to model year 2013 with code SM7 (Left front multicontour seat) with code SM8 (Front passenger multicontour seat) /FACELIFT 2012

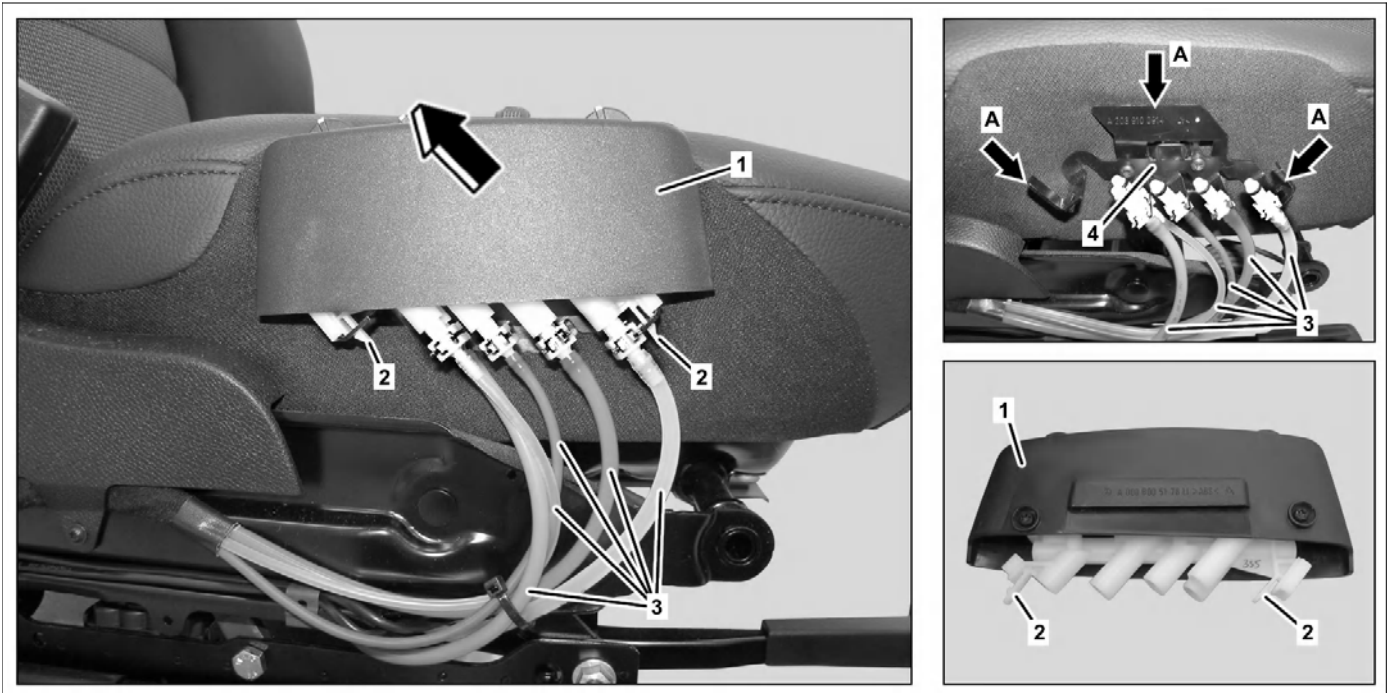
P91.25-2419-09

Shown on model 204, on removed left front seat

| 1 Control valve | 3 Pneumatic lines |
| 2 Catch hook | 4 Bracket |

Remove/install		
1	Push both catch hooks (2) inwards, while at the same time pulling the control valve (1), as shown, upwards at an angle out of the holder (4) and the pneumatic lines (3) and remove	<b>i</b> <b>Installation:</b> Check sealing rings of pneumatic lines (3) for damage, replace if necessary. Ensure that control valve (1) is correctly seated in the guides (arrows A) of the bracket (4).	
2	Install in the reverse order
