Right front seat belt or left front seat belt does not roll up completely

| Topic number | LI91.40-P-053536 |
| Function group | 91.40 - Seat belts, emergency tensioning retractors |
| Validity | Model series 207, 218 in production period from 09.2011 up to and including 01.2012 |

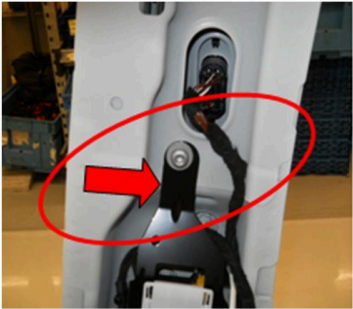
OK connection: Shown on model series 218 right front seat - Figure 2

| Attachments | |
|---|---|
| Picture 2.jpg | <p>OK alignment of reversible emergency tensioning retractor. Shown on right front seat in model series 218.</p> |

Realign the reversible emergency tensioning retractor within the installation tolerance.

- Slacken the mounting bolts on the reversible emergency tensioning retractor.
- Push the reversible emergency tensioning retractor at the upper mounting bolt towards the rear of the vehicle and tighten the mounting bolt.

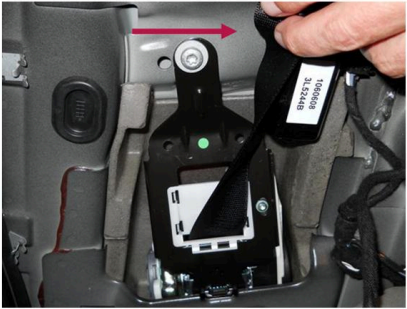
OK connection: Shown on model series 207 left front seat - Figure 3

| Attachments | |
|---|---|
| Picture 3.jpg | <p>OK alignment of reversible emergency tensioning retractor. Shown on left front seat in model series 207.</p> |
