Date: August 16, 2007
Order No.: S-B-68.00/54a
Supersedes: S-B-68.00/54
Group: 68

SUBJECT: *Model 164 / 203 / 209 / 211 / 216 / 219 / 221 / 251*
Model Year - All

One-Time Use of Expansion Rivet with Sealing Function - Protecting Systems from Water

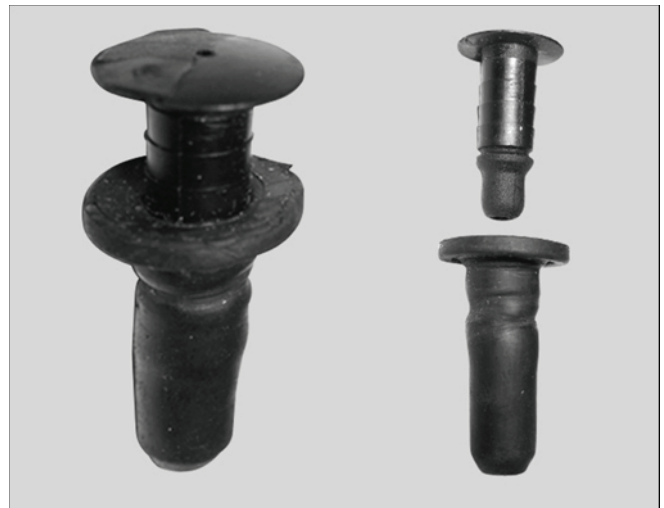
Figure 1

It has been observed that the sealing action of the expansion or body-bound rivet does not work once it is removed.

1. The expansion rivets become deformed after they have been removed (Figure 1).

3. Anytime it is necessary to remove one of these rivets, throw it out and replace it with a new one (Figure 3).

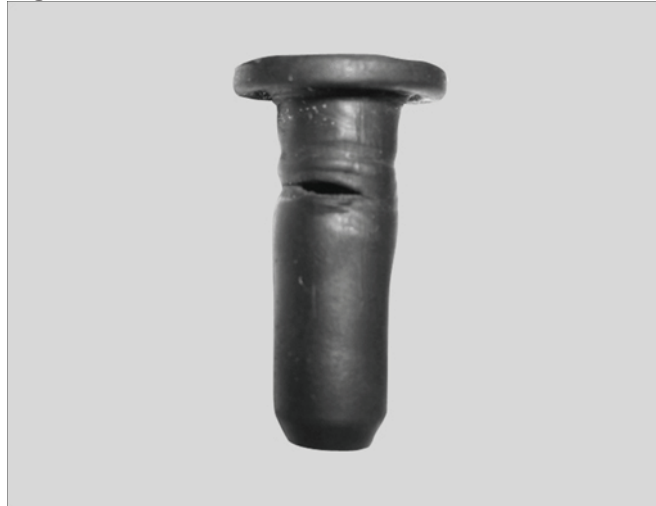
Figure 2

2. They can also become cracked after they are removed (Figure 2).

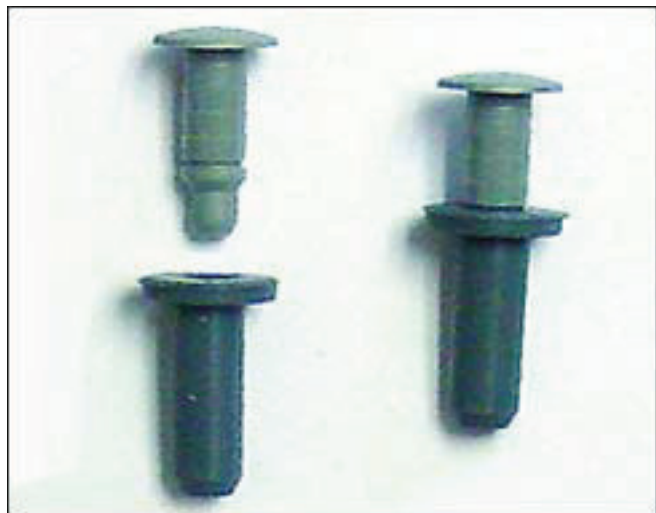
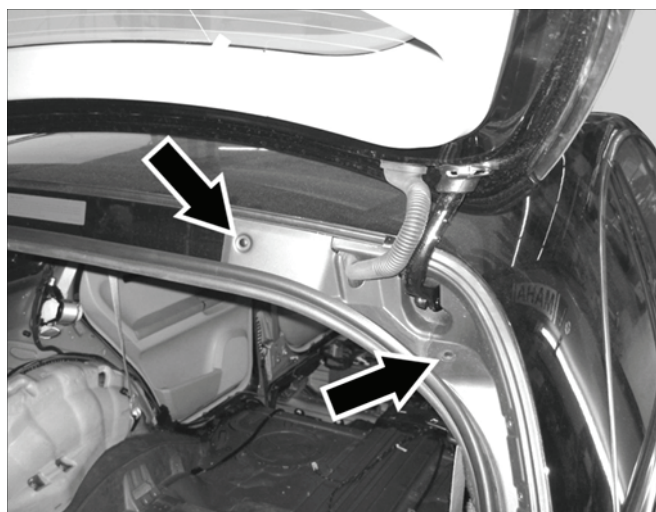
Figure 3

4. Critical installation locations are the D-pillar cover in the rear-end door on the Model 251 (Figure 3).

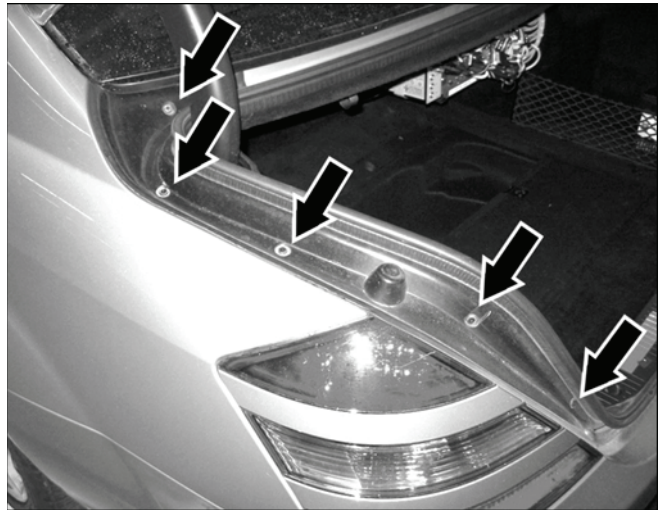
Figure 4

5. Another critical installation location is the body shell cover of the trunk lid as shown on the Model 221 (Figure 4).
6. Other locations include, among others: right rear fender on Model 211; paneling and lining of luggage compartment cover on Model 209 and 211; head protection curtain on Model 219; the A-, B- and C-Pillar paneling on Model X164; and the heater case on Model 221.
