**Connection hole in soft top canvas with
manufacture data up to 22.02.07**

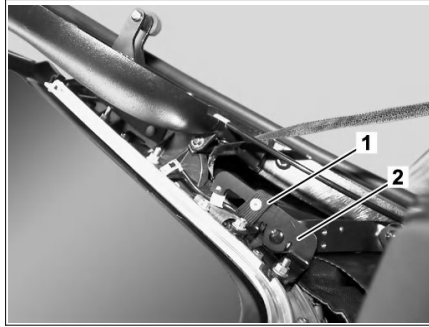
P77.31-2216-01

- 1 Attach short elastic band (1) to old
connection hole on rear window mount
(2).
