| AR82.10-P-4927CLW | Remove/install lamp unit on trunk lid | 27.03.2017 |

Model 205.3/4, 238

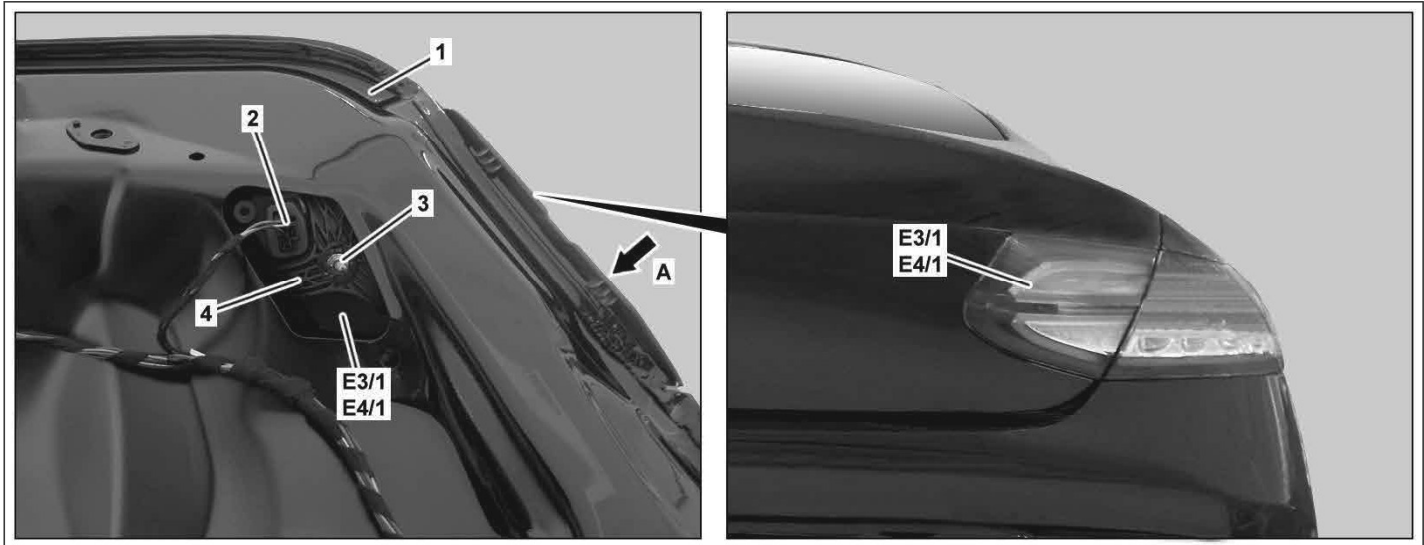
P82.10-7998-08

Shown on model 205.3

| 1 | Trunk lid | 4 | Bracket |
| 2 | Electrical connector | E3/1 | Inner left rear lamp unit |
| 3 | Nut | E4/1 | Inner right rear lamp unit |

| 1 | | Remove panel at trunk lid (1) | Model 238.3 Model 205.3 Model 205.4, 238.4 | AR68.30-P-8151LWE AR68.30-P-8151CLW AR68.30-P-8151LWR |
| 2 | | Disconnect electrical connection (2) | | |
| 3 | | Unscrew nut (3) | | |
| 4 | | Remove inner left rear lamp unit (E3/1) or inner right rear lamp unit (E4/1) | | |
| 5 | | Remove bracket (4) outwards from the trunk lid (1) | | |
| 6 | | Position bracket (4) onto inner left rear lamp unit (E3/1) or inner right rear lamp unit (E4/1) | | |
| 7 | | Screw on nut (3) approx. 4 turns | | |

| 8 | Insert inner left rear lamp unit (E3/1) or inner right rear lamp unit (E4/1) into trunk lid (1) | <p>ⓘ Do not apply pressure to the lens of the inner left rear lamp unit (E3/1) or the inner right rear lamp unit (E4/1). Otherwise damage may occur.</p> <p>ⓘ Ensure that the inner left rear lamp unit (E3/1) or the inner right rear lamp unit (E4/1) is seated correctly (arrow A).</p> | |
| 9 | Tighten nut (3) | | |
| 10 | Connect electrical connector (2) | | |
