Date: February 3, 2015  
Order No.: P-B-47.10/63b  
Supersedes: P-B-47.10/63a, January 16, 2015  
Group: 47

**SUBJECT: Model 211, Model Years 2003- 2009 and  
Model 219, Model Years 2006- 2011  
Fuel Odor In the Area of the Fuel Tank**

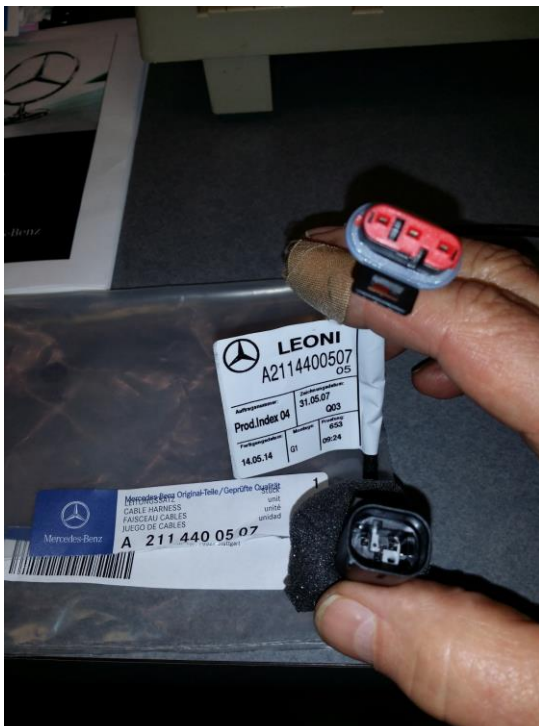
**Figure 4 (Fuel tank sending unit jumper harness)**

<sup>1)</sup> Older vehicles with 2 prong connectors on fuel tank sending unit (with integrated fuel filter) require jumper harness (Figure 4) to connect new sending unit to existing wiring harness.
