MODEL 211.0 /2 /6 up to 31.5.06

with CODE (614) Bi-xenon headlamp unit

with CODE (615) Bi-xenon headlamp unit with integrated curve illumination

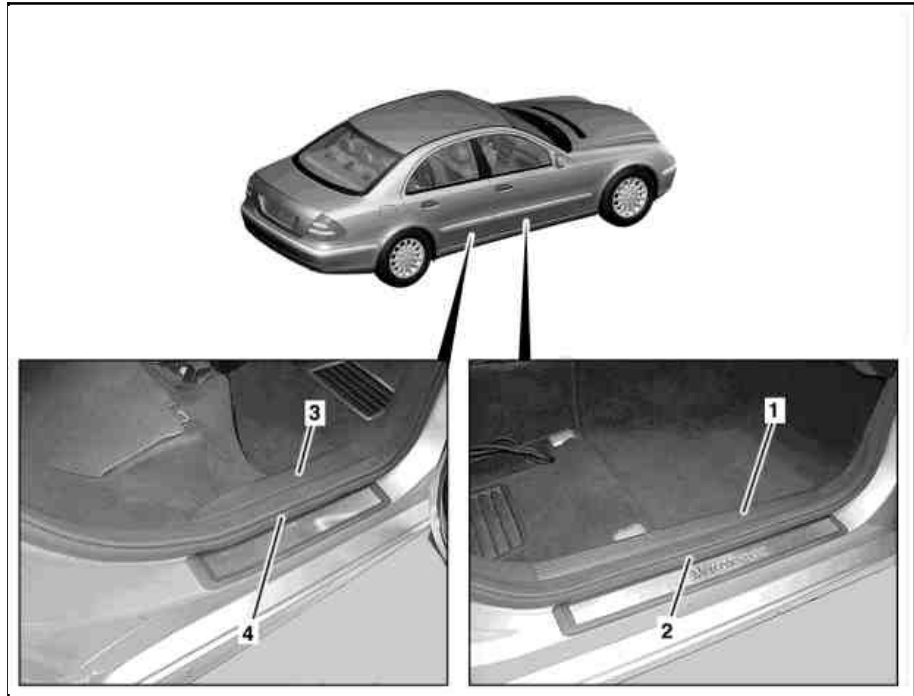
P82.10-3001-06

Shown on model 211.0

- 1 Front entrance paneling
- 2 Front edge guard
- 3 Rear entrance paneling
- 4 Rear edge guard

Remove/install	
⚠	Notes on avoiding damage to electronic components due to electrostatic discharge	AH54.00-P-0001-01A
1	Remove right front seat	AR91.10-P-1000T
2	Detach front edge guard (2) in the area of the front entrance paneling (1)	
3	Remove front entrance paneling (1)	
4	Detach rear edge guard (4) in the area of the rear entrance paneling (3)	
5	Remove rear entrance paneling (3)	
6	Unclip rear footwell air grate (6) (arrow) and

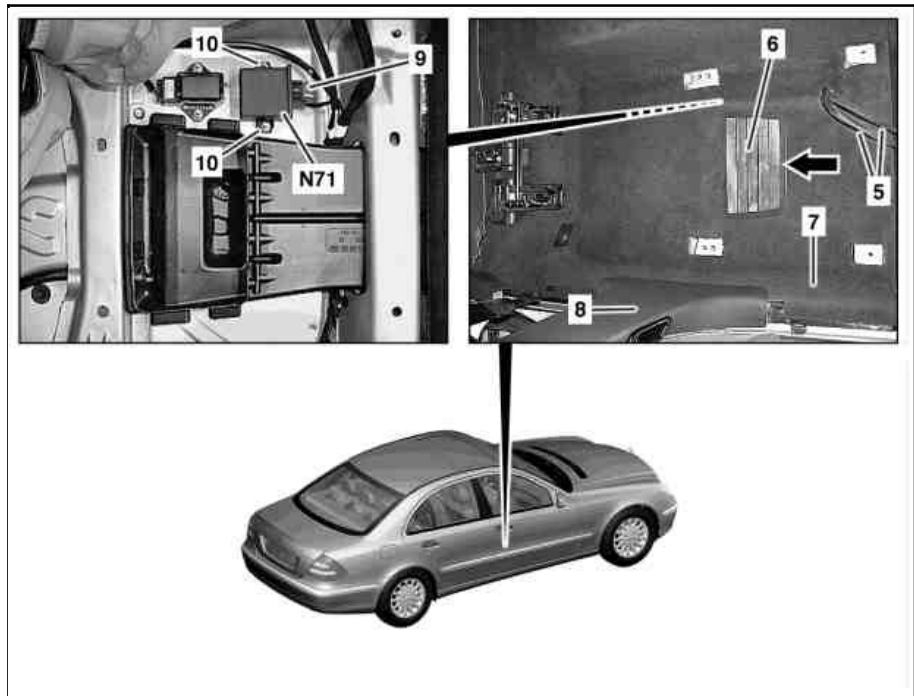
P82.10-3000-06

Shown on model 211.0

- 5 Wiring harness
- 6 Rear footwell air grate
- 7 Rear floor covering
- 8 B-pillar paneling
- 9 Electrical connector
- 10 Nut

N71 Headlamp range adjustment control unit

7	Pull rear floor covering (7) forward under the B-pillar paneling (8)		
8	Lift up rear passenger compartment floor covering (7).		
9	Guide electrical wiring harness (5) out of the rear floor covering (7)		
10	Unscrew nuts (10) and remove headlamp range adjustment control unit (N71)		
11	Disconnect electrical connector (9).		
12	Install in the reverse order		
13.1	Check the headlamp setting; correct it if necessary Check and correct headlamp adjustment	When installing a new headlamp range adjustment control unit (N71).	AP82.10-P-8260T
