# Service Campaign Bulletin

Campaign No. 2008070002, August 2008

SUBJECT: **Models 164, 164.8, 171, 203, 209, 211, 216, 219, 221, 230, and 251  
With Engine 272 or 273, Model Years 2006 - 2007  
Replace V-Belt Upper Guide Pulley**

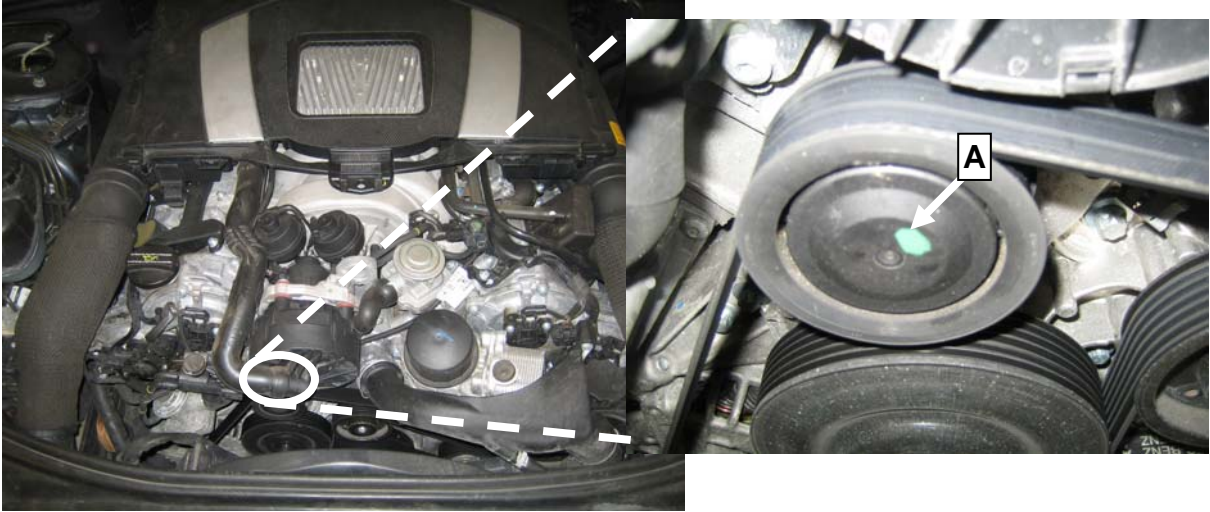
Figure 1

1. Remove engine cover.
2. Remove plastic cap (A, Figure 1) covering pulley bearing and discard.

Do not reinstall cap (A, Figure 1).

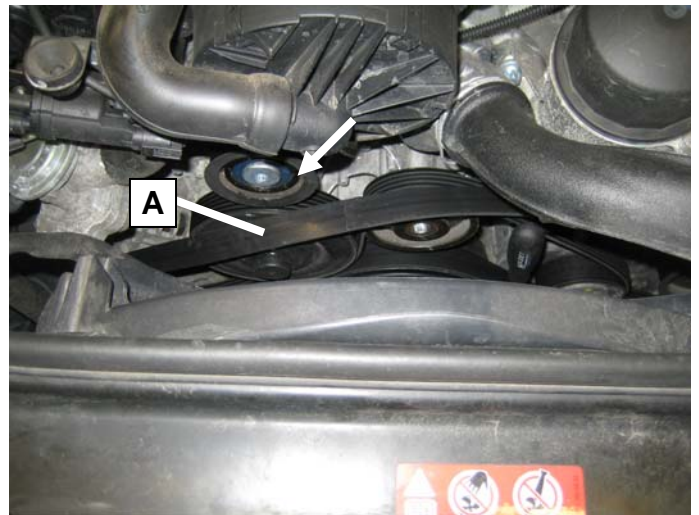
Figure 2

3. Remove V-belt (A, Figure 2) from pulley (arrow); refer to WIS for models:
  - 164/164.8/251: AR13.20-P-0001GZA.
  - 171: AR13.22-P-1202VA.
  - 203/209: AR13.22-P-1202QB.
  - 211/219: AR13.20-P-0001TS.
  - 216/221: AR13.20-P-0001SX.
  - 230: AR13.22-P-1202RX.

- Do not remove V-belt from engine.
  - Do not replace belt tensioner.
4. Replace guide pulley (arrow, Figure 2), torque guide pulley bolt to: 35 Nm.
