MODEL 211.0 /2 /6

XX	Remove/install		
1	Detach instrument panel top section (8)		AR68.10-P-1020T
2	Remove stowage box	i Remove only until bolt (4) next to air duct	AR68.20-P-2320T
		(5) is accessible.

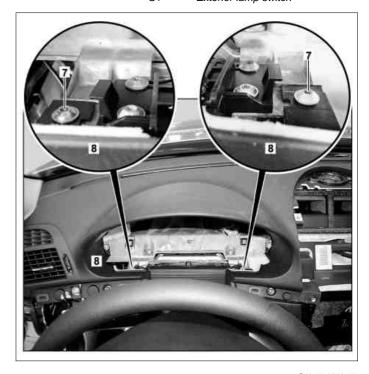
P68.10-3811-09

- 1 Left instrument panel bottom section
- 2 Air duct
- 3 Bolts
- 4 Bolts
- 7 Bolts
- 8 Dashboard top section

- 5 Air duct
- 6 Release handle

B10/4 Interior air temperature sensor F34 Interior fuse box N73 EIS [EZS] control unit S1 Exterior lamp switch

(3)	Information on machining/treating magnesium components		AH60.00-P-0023-01R
8	Remove bolts (4)		
9	Remove left instrument panel bottom section (1) from air duct (5)		
10	Unhook hand brake release cable from release handle (6)		
11	Remove bolts (7)		
12	Remove interior fuse box (F34) from left instrument panel bottom section (1)	Leave electrical lines installed on interior fuse box (F34).	
13	Disconnect electrical connectors from EIS control unit (N73), rotary light switch (S1) and in-car temperature sensor (B10/4)		
14	Remove left instrument panel bottom section (1)		
15	Install in the reverse order
