Date: June 10, 2015  
Order No.: P-B-47.10/63c  
Supersedes: P-B-47.10/63b, February 3, 2015  
Group: 47

**SUBJECT: Model 211, Model Years 2003- 2009 and  
Model 219, Model Years 2006- 2011  
Fuel Odor In the Area of the Fuel Tank**

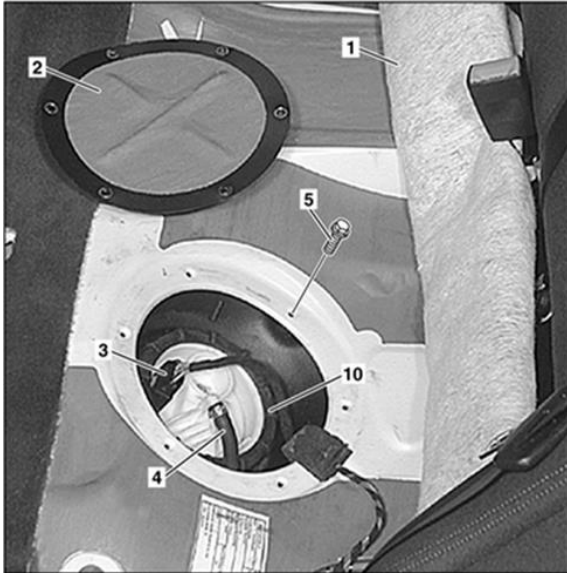
Figure 1

Remove screws (5, Figure 1) and take off both fuel tank access covers (2).
  -

**Note:**  
During assembly, do not install the covers (2) until after running engine and checking for fuel leaks.

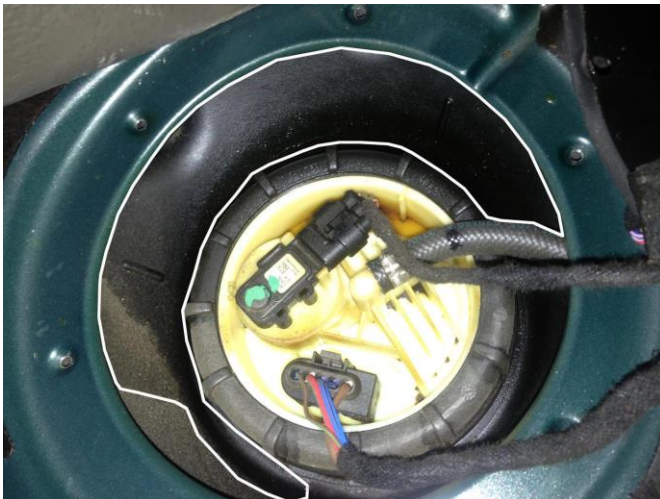
**Figure 3** (Fuel residue outlined)

**Note:** Fuel residue (outlined, Figure 3) and/or liquid fuel must be visible in photo.

- Provide symptom string: Power Generation / Fuel systems / Fuel system odor / Odor
- Attach (detailed) photographs of the suspect area to the case. (see example, Figure 3).

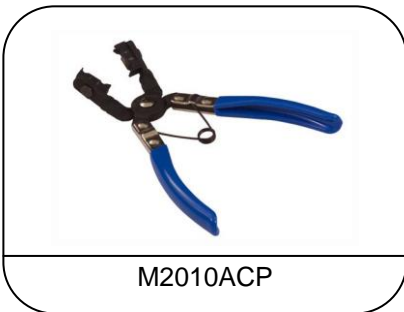
Assenmacher® Tool: Angled  
Fuel/EVAP Clamp Pliers

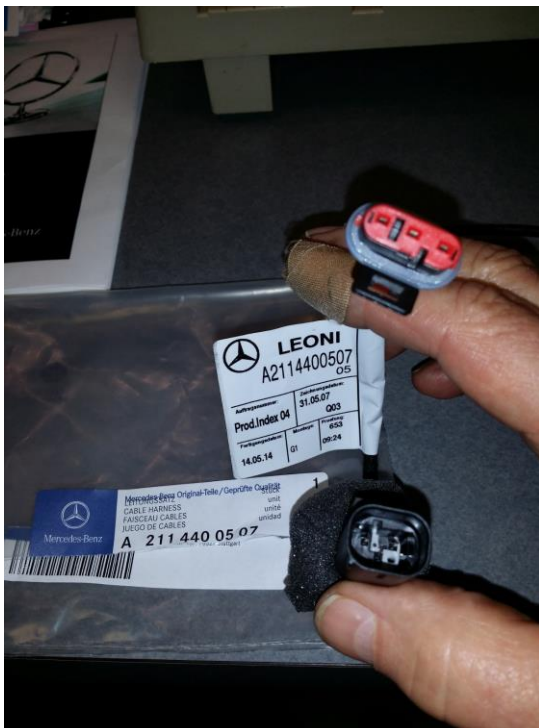
**Figure 4** (Fuel tank sending unit jumper harness)

<sup>1)</sup> Older vehicles with 2 prong connectors on fuel tank sending unit (with integrated fuel filter) require jumper harness (Figure 4) to connect new sending unit to existing wiring harness.
