DTB

Date: March 6, 2008
 Order No.: P-B-27.55/50g
 Supersedes: P-B-27.55/50f dated March 24, 2006
 Group: 27

**SUBJECT: Model 203.040/061/064/065/081/084/261/264/281/284/740/747/764
 Model 209.365/375/376/465/475
 Model 211.065/070/076/083/265/283
 Up to Production Date 09/2003
 Harsh Engagement Possibly Followed by Droning/Buzzing Noises During Light
 Acceleration Between Engine Speed of 1200 – 2500 RPM**

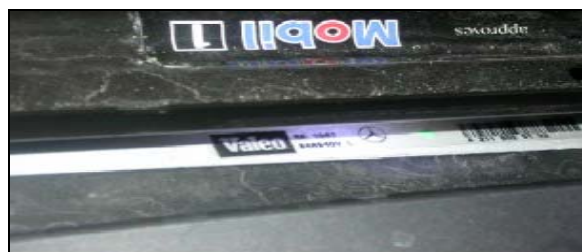
Figure 1 P-B-27.55/50

- a. the vehicle was produced before 09/2003,
- b. the radiator is manufactured by “Valeo”, refer to Figure 1 for identification,
- c. old crimping method used to assemble the radiator end tanks resembles Figure 2.

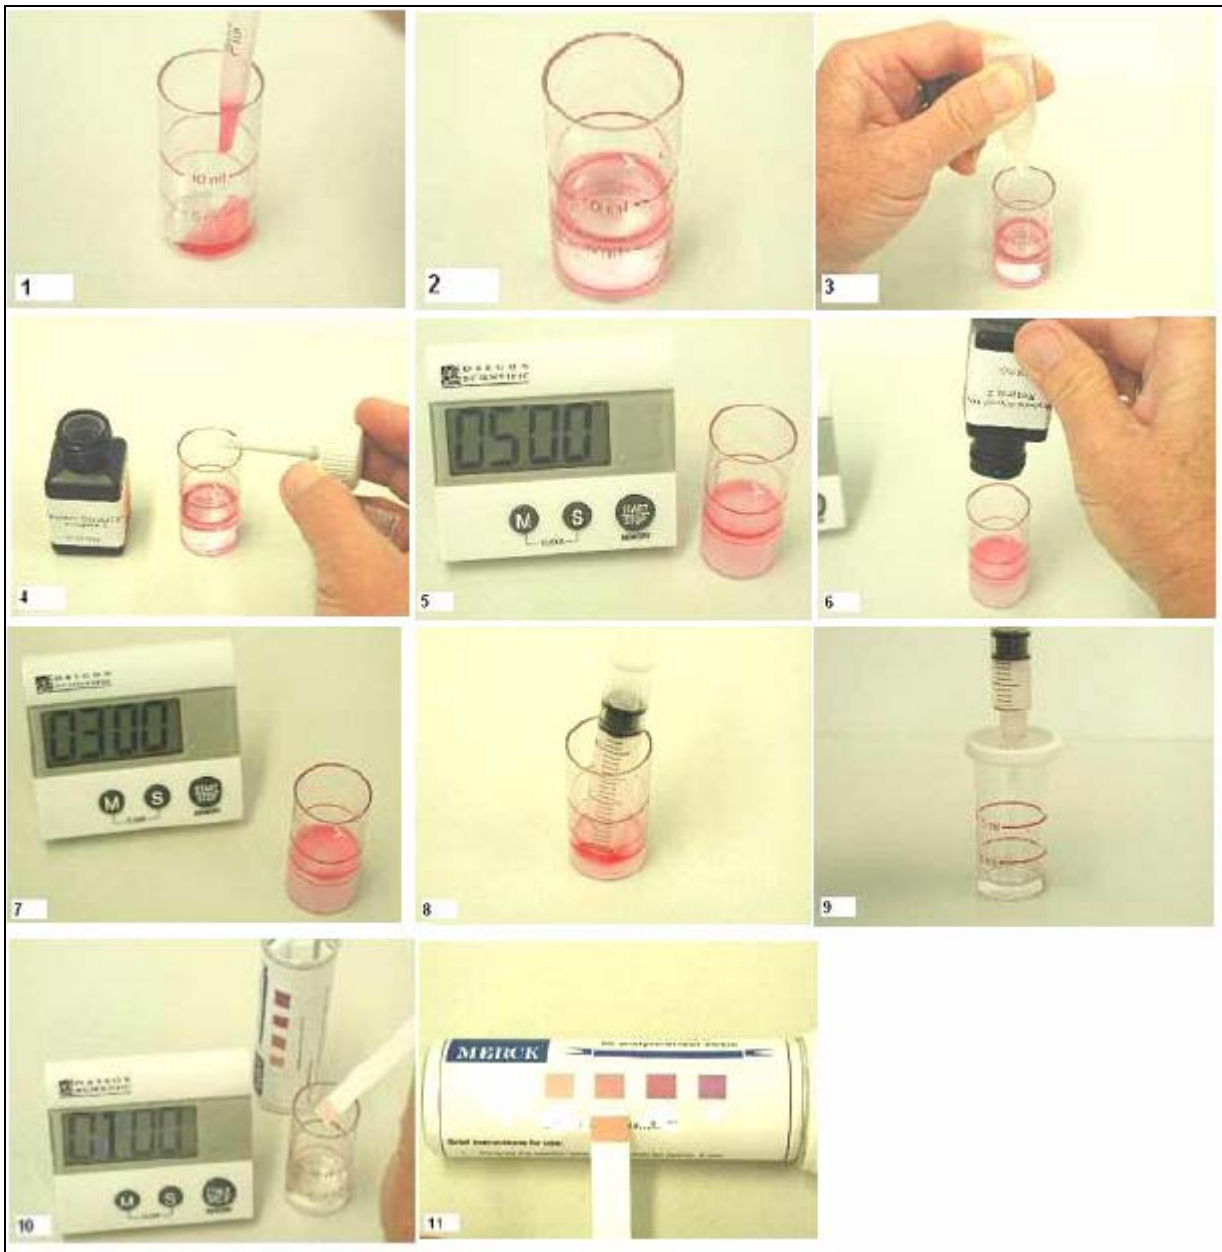
Figure 4

1. Fill 0.5 ml of ATF with the pipette in the small glass container (Figure 4, 1).
2. Fill with distilled water to 5 ml (Figure 4, 2).
3. Add 1 drop of "Tenside" (Figure 4, 3).
4. Add 1 micro spoon of "Periodic acid" and rock the small glass container (Figure 4, 4).
5. Allow to stand for 5 minutes (Figure 4, 5).

6. Add 10 drops of "Natronlauge" or Caustic Soda Solution (Figure 4, 6).
7. Allow to stand for 3 minutes (Figure 4, 7).

8. The sample is now divided into 2 layers; an upper and a lower layer. Immerse the syringe so that the end tip is into the lower layer of the sample and take up approximately 4 ml. of the lower layer using the syringe (Figure 4, 8).
9. Pour the fluid taken up through the filter into a clean small glass container (Figure 4, 9).
10. Immerse test sticks into the filtered solution for approximately 2 seconds, shake the stick and wait for a reaction time of one minute (Figure 4. 10).
11. Compare the color of the test sticks with the color chart on the test stick tube (Figure 4, 11).

i **Note:** The colors of the color chart tube correspond to the amount of glycol contamination of the ATF. After completion of the test, the liquid in the two glass containers should be handled as a hazardous waste. Store in a sealed container and dispose of in accordance with all Federal, state and local hazardous waste regulations.

1. Up to 100 mg/liter of glycol contamination do not perform any repair (considered normal due to condensed water and not a leak).
2. As of 100 mg/liter of glycol contamination, replace radiator. Clean and flush the transmission with the torque converter and transmission oil cooler lines. Refer to WIS Document AR27.55-P-0100A.
3. If the condition is still reproducible after the flush routine, replace the torque converter.
