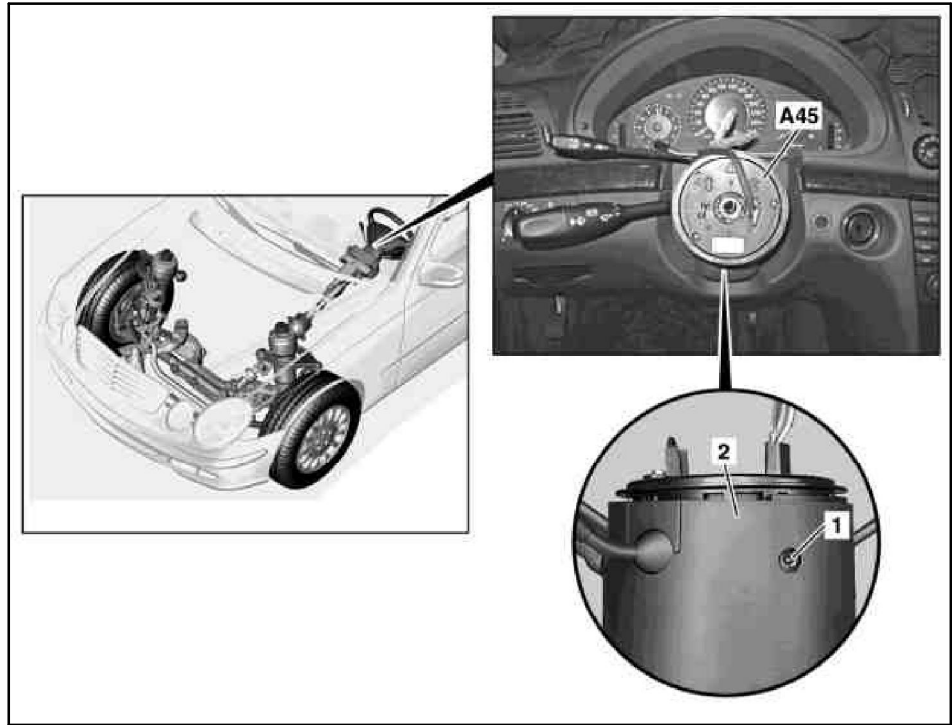
P54.25-3397-06

1 Unscrew screw (1) .

**i** Bolt (1) is secured to prevent it from falling out.

2 Disconnect steering column switch module (2) complete with fanfare horns and airbag clock spring contact (A45) from jacket tube.

ⓘ When the steering wheel is detached the fanfare horns and airbag clock spring contact (A45) must not be twisted otherwise this can be damaged.
