Campaign No. 2005070007, May 2006

SUBJECT: **MODELS 211, 230**
MODEL YEAR 2004
INSPECT SBC HYDRAULIC UNIT, REPLACE AS DIRECTED

This Recall Campaign has been initiated because DCAG has determined that on the affected vehicles (see VIN range below) the SBC brake system may shift to the hydraulic back up mode due to the loosening of the ground wire harness connection over time, or due to premature failure of the hydraulic pump. On Model 211, dealers will install a bracket and replace the ground wire, and if required, replace the hydraulic pump and suction hose. On Model 230, dealers will install a bracket and replace the ground wire, replace the suction hose, and if required replace the hydraulic pump.

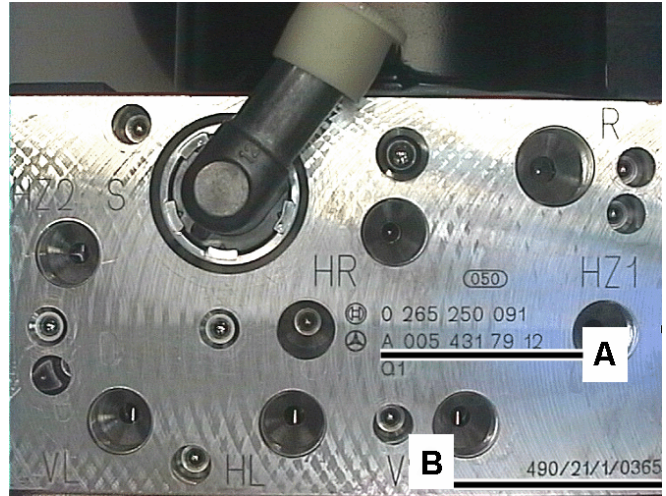
Figure 1

1. Check if part number (A, Figure 1) is listed in the table below:
 - If the part number (A) **is** listed, proceed to step 2.
 - If the part number (A) is **not** listed proceed to step 3.

2. Check (refer to table below) if the production number (B, Figure 1) is within the listed production number range for the relevant part number (A):
 - If the production number (B) is **not** within the production number range proceed to step 3.

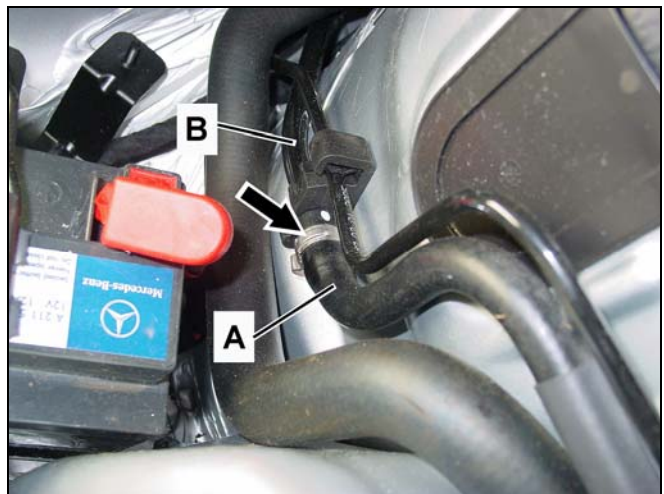
Figure 3

Do not use sharp-edged tools (e.g., screwdriver) to remove suction hose (A, Figure 3) from SBC suction line (B), this may cause damage to the suction line (B) and possible SBC brake system malfunctions.

- Carefully detach suction hose (A, Figure 3) from the suction line (B) using a plastic wedge (Example: Special Tool: W110 589 03 59 00).

- When removing suction hose (A, Figure 3), do not bend suction line.
- To prevent brake fluid from running out and to prevent contamination in the brake system, the suction hose (A, Figure 3) and line (B) are to be plugged using suitable plugs from the stop plug kit (Special Tool: W129 589 00 91 00).
- Discard old suction hose (A) and clamp (arrow) after removal.

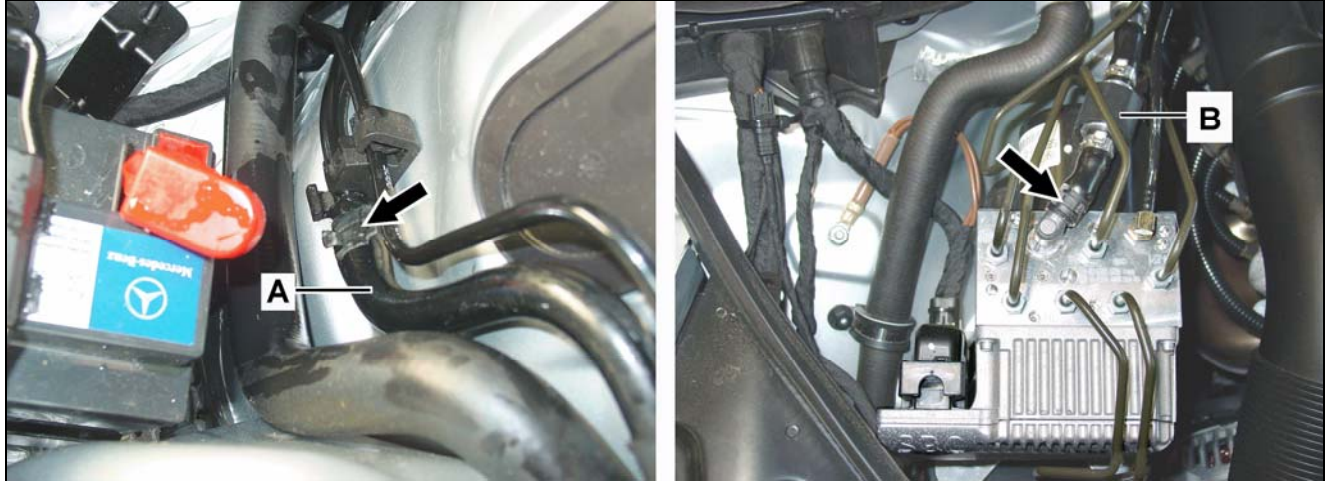
Figure 4

- Check if a pulsation damper (B, Figure 4) was installed on suction hose:
 - If pulsation damper (B) was **not** installed: Install new standard suction hose (A) to suction line, secure with new hose clamps (arrows).
 - If pulsation damper (B) **was** installed: Install new suction hose (A) with double pulsation damper to suction line, secure with new hose clamps (arrows).

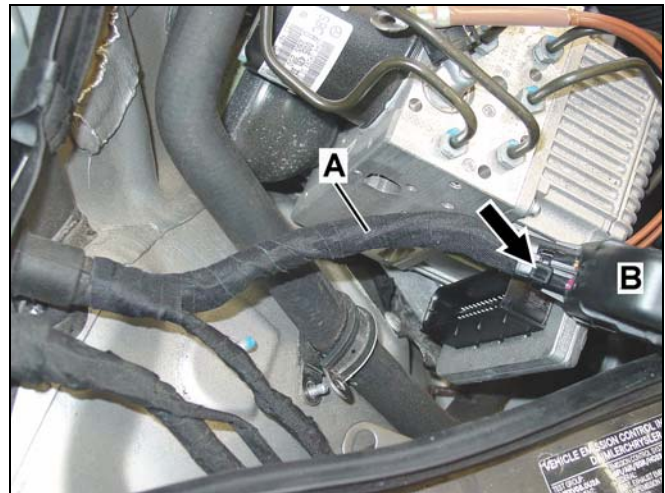
Figure 5

- Remove cable tie (arrow, Figure 5) securing SBC wire harness (A) to SBC connector housing (B).

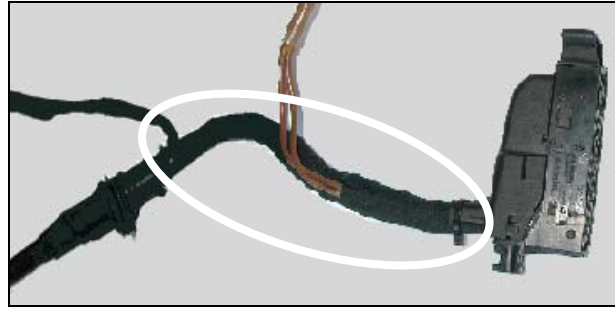
Figure 6

12. Remove fabric tape (circled area, Figure 6) from wire harness up to rubber grommet.

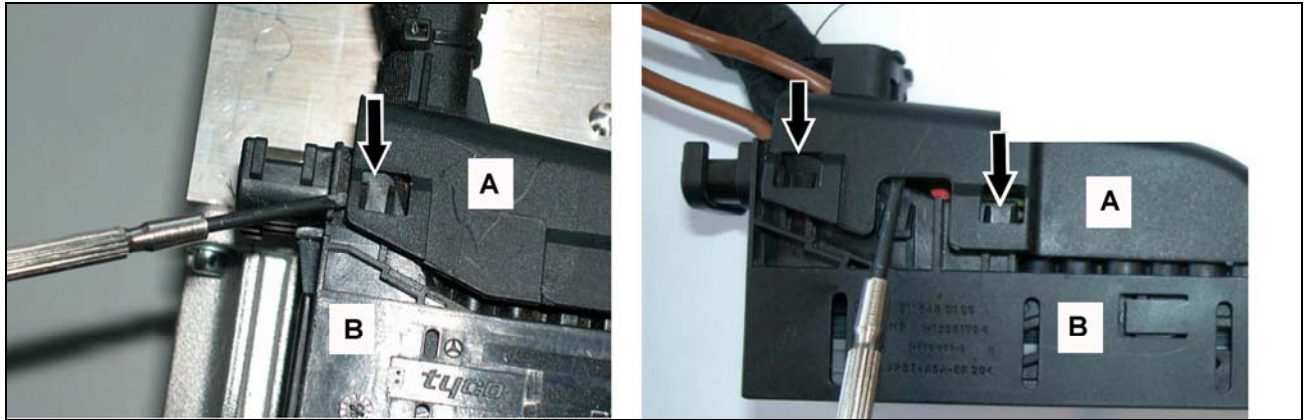
Figure 7

13. Remove SBC connector housing (A, Figure 7) cover:

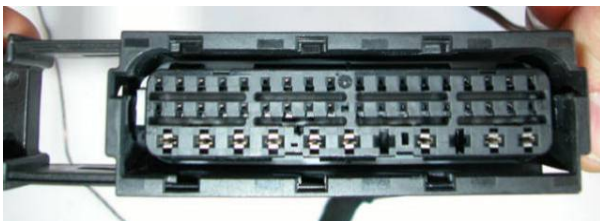
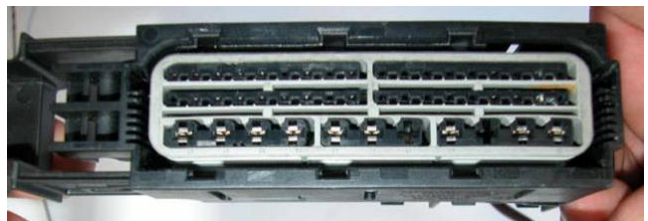
There are two different versions of the SBC wiring harness connector (Figure 8a, b) installed in vehicles involved with this campaign.

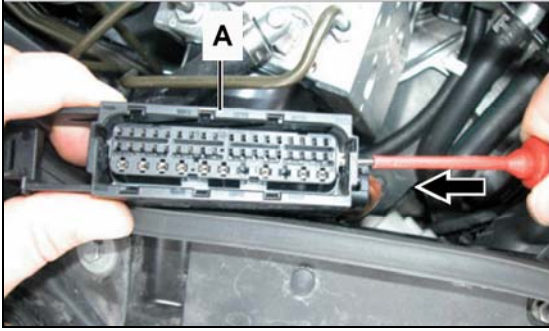
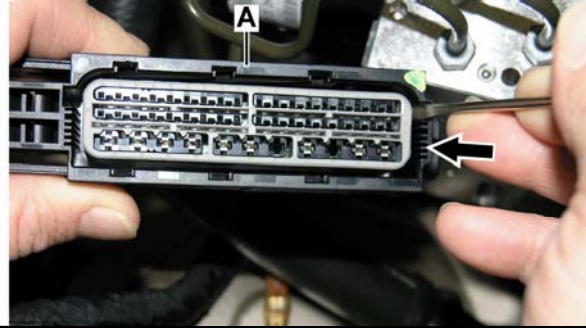
14. Open the (gray) secondary lock in the SBC connector housing (A, Figure 9) by sliding the lock in the direction indicated by the arrows (Figure 9) using a small screwdriver.

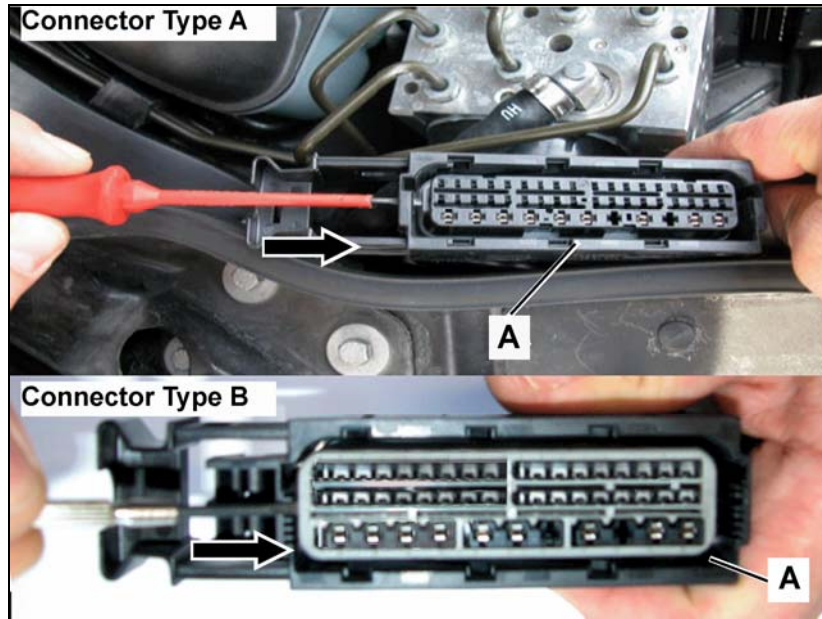
Figure 11

17. Close the (gray) secondary lock of the SBC connector housing (A, Figure 11) by sliding the lock in the direction indicated by the arrows (Figure 11) using a small screwdriver until it locks into place.
18. **Loosely** wrap the exposed SBC wire harness using fabric tape (arrows, Figure 12). **Do not** wrap the ground wiring harness (A) into the SBC wire harness.

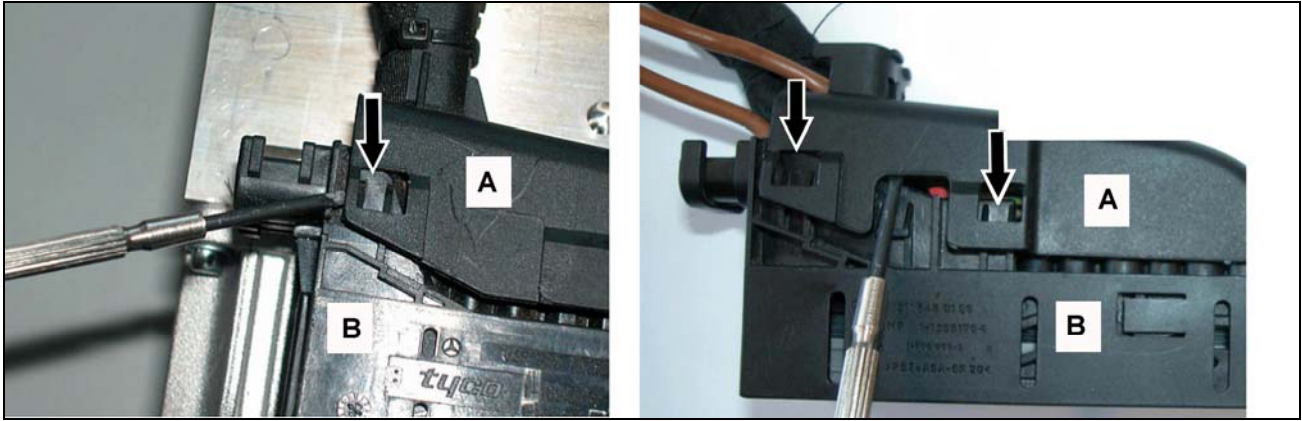
Figure 13

19. Reinstall the SBC wire harness connector cover (A, Figure 13) in reverse order.

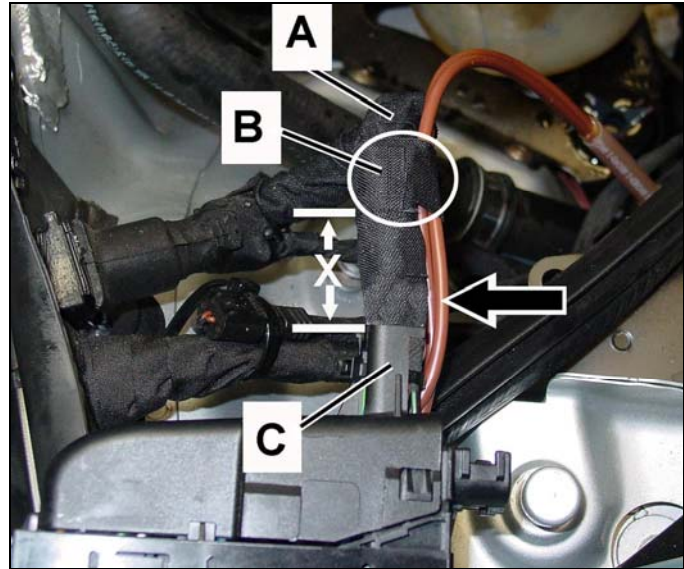
Figure 15

21. Secure ground wiring harness (arrow, Figure 15) to SBC wire harness (A) using two layers of fabric tape (B) in the circled area. Start taping approximately 35 mm (X = 35 mm, Figure 15) from end of connector cover receptacle (C).

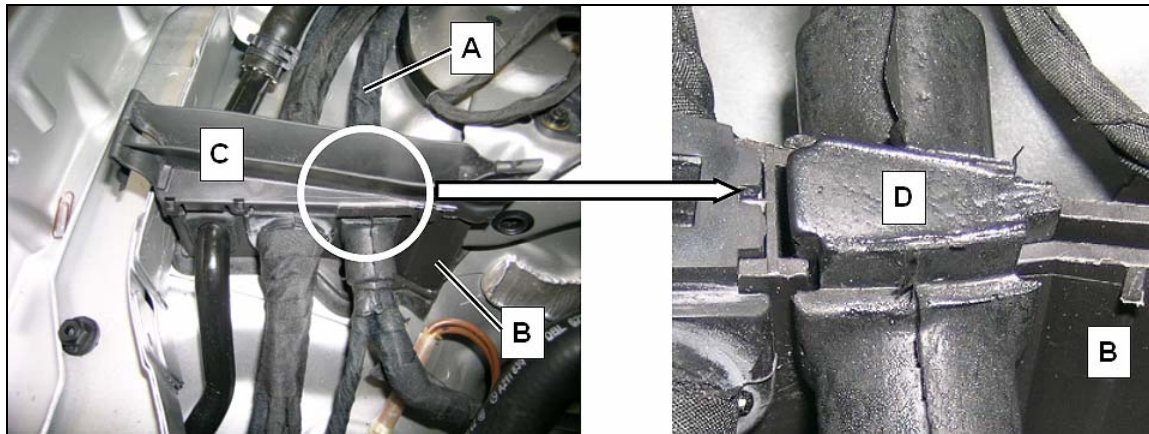
Figure 16

22. Remount the SBC wiring harness (A, Figure 16) in the wire harness guide (B):

- Remove wire harness guide cover (C) and remove SBC wiring harness with grommet (D) from harness guide (B).

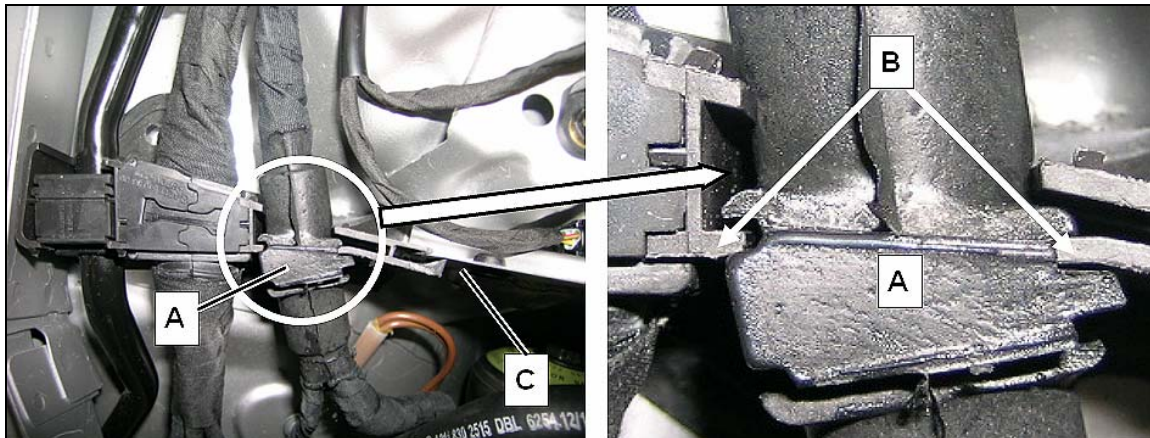
Figure 17

- Reposition SBC wiring harness with grommet (A, Figure 17) into the forward wall opening (B) in the wire harness guide (C).

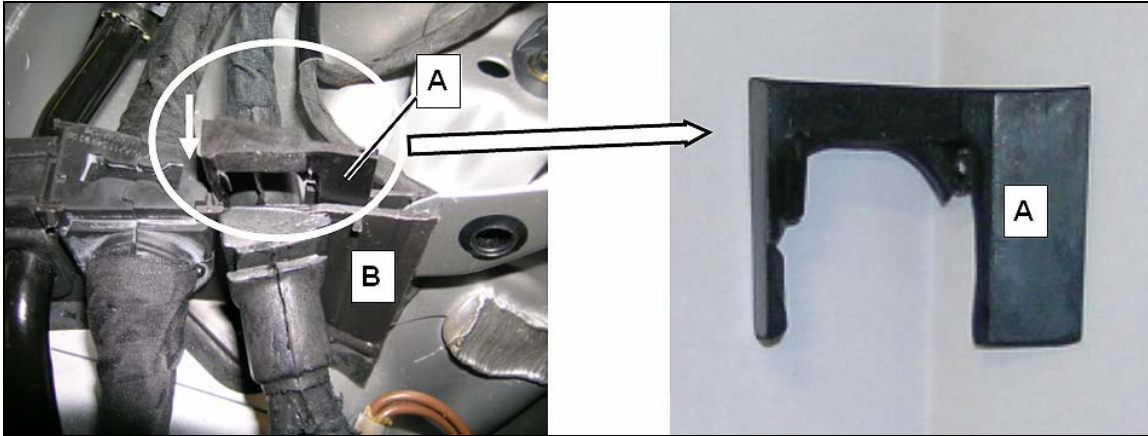
Figure 18

- Insert new routing clip (A, Figure 18) into wire harness guide (B) until top of clip (A) is flush with top of wire harness guide (B).
- Reinstall top of wire harness guide (C, Figure 16).

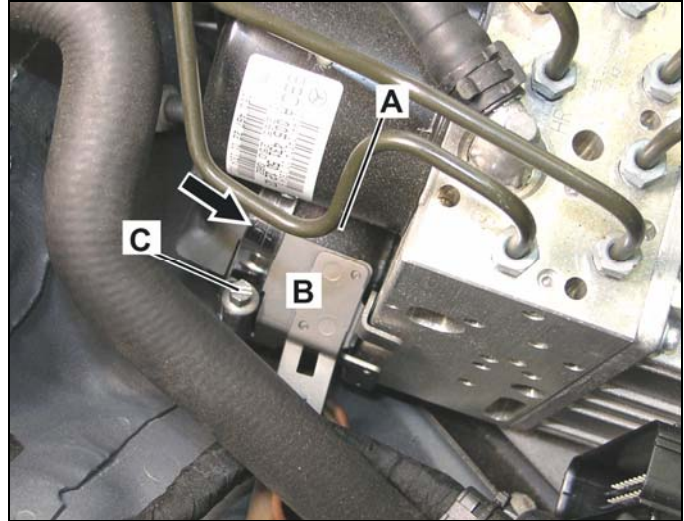
Figure 21

24. Install clamp-on mounting bracket (B, Figure 21) if necessary due to broken self-tapping screw:

- Torque mounting clamp screw (C) to 5 Nm while pressing bracket (B) onto SBC unit (A) (proceed to step 27).

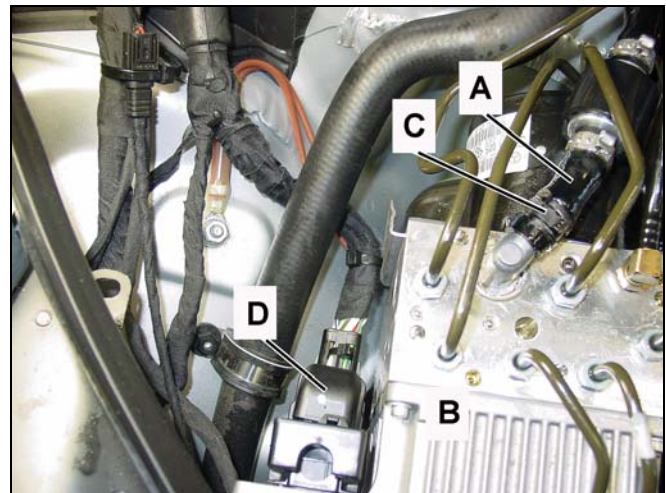
Figure 22

25. Install new SBC hydraulic unit (B, Figure 22) into SBC body mounting grommets.

28. Connect the SBC wire harness connector (D, Figure 22) to the SBC hydraulic unit (B) and secure by engaging locking mechanism.

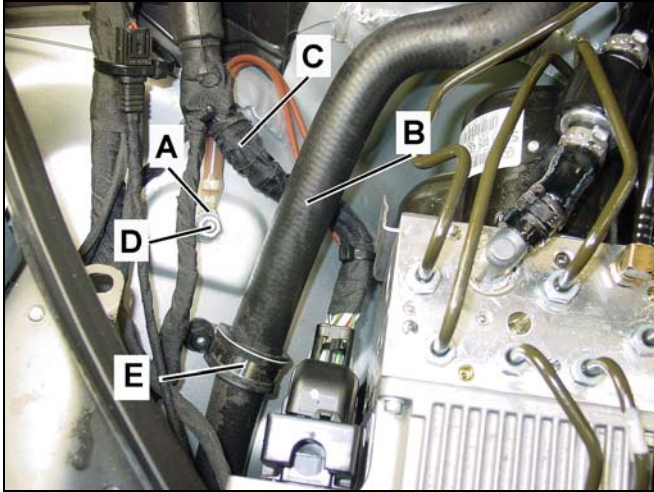
Figure 23

29. Attach hose mounting strap (E, Figure 23) to mounting stud, secure with nut
30. Position ground wiring harness parallel to the vehicle longitudinal axis (X-axis) on the body ground terminal. Torque the M6 nut to 10 Nm.

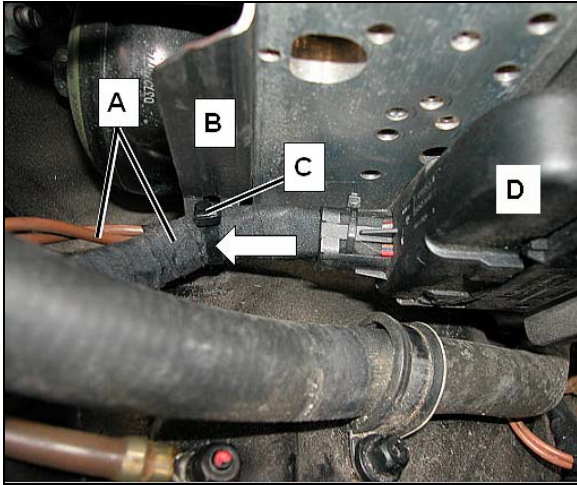
Figure 24

33. Secure ground wiring harness and SBC wiring harness (A, Figure 24) to SBC hydraulic unit bracket (B) with cable tie (arrow). Tighten cable tie (arrow) with Hellermann MK9 cable tie pliers (Special Tool: W 352 589 02 37 00) using **setting 3** on pliers.

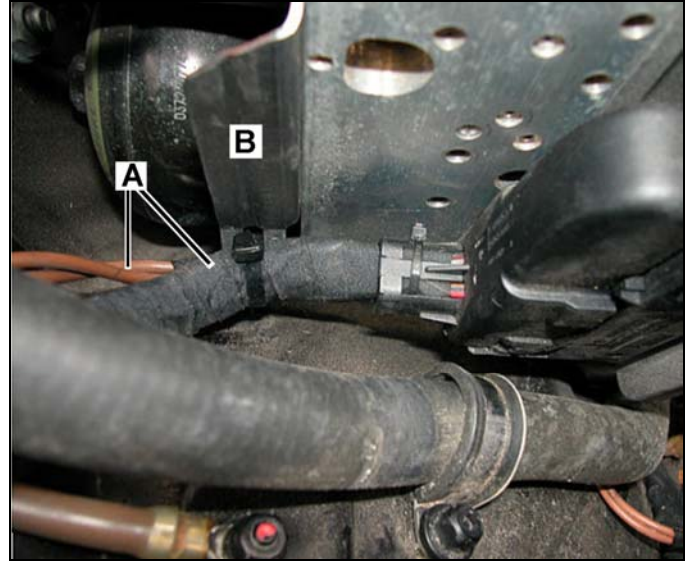
Figure 28

4. Quality measure 4:
- Ensure ground wires (A, Figure 28) are completely wrapped with fabric tape (as performed in step 21) in the area adjacent to the SBC hydraulic unit bracket (B) to ensure that the ground wires do not become chafed. Readjust tape as necessary to prevent chafing.

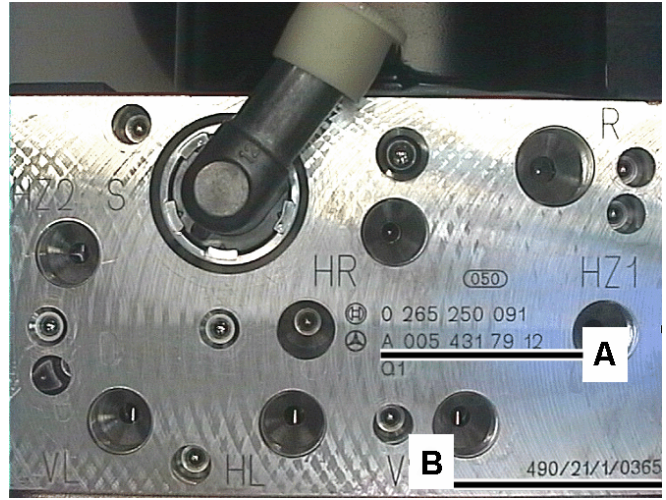
Figure 1

1. Check if SBC hydraulic unit part number (A, Figure 1) is listed in the table below:
 - If the part number (A) **is** listed, proceed to step 2.
 - If the part number (A) is **not** listed, proceed to step 3.

2. Check (refer to table below) if the production number (B, Figure 1) is within the listed production number range for the relevant part number (A):
 - If the production number (B) is **not** within the production number range, proceed to step 3.

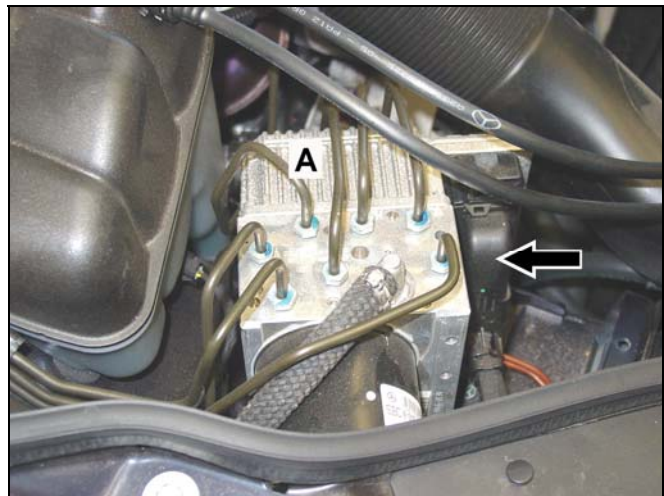
Figure 2a

3. Disconnect SBC hydraulic unit harness connector (arrow, Figure 2a) from SBC hydraulic unit (A) and remove cable tie (B, Figure 3).

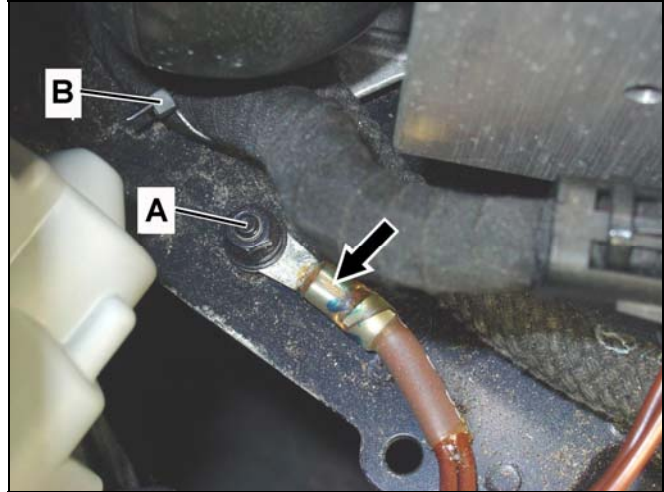
Figure 3

4. Detach the SBC hydraulic unit ground wire harness (arrow, Figure 3) at ground terminal stud (A).
5. Position SBC harness connector (arrow, Figure 2a) away from SBC hydraulic lines to prevent brake fluid from dripping on SBC harness connector and SBC wiring harness.

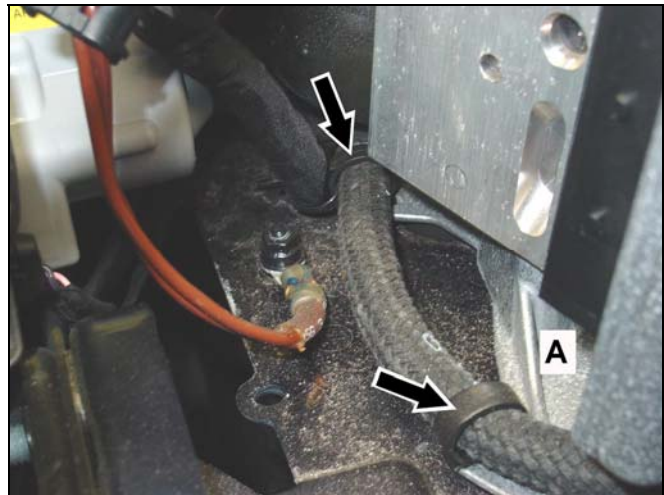
Figure 4

6. Remove omega (arrows, Figure 4) hose clips from SBC hydraulic unit bracket (A).
7. Remove SBC hydraulic unit refer to WIS: AR42.46-P-0010R steps 1 - 3, 5 - 14.

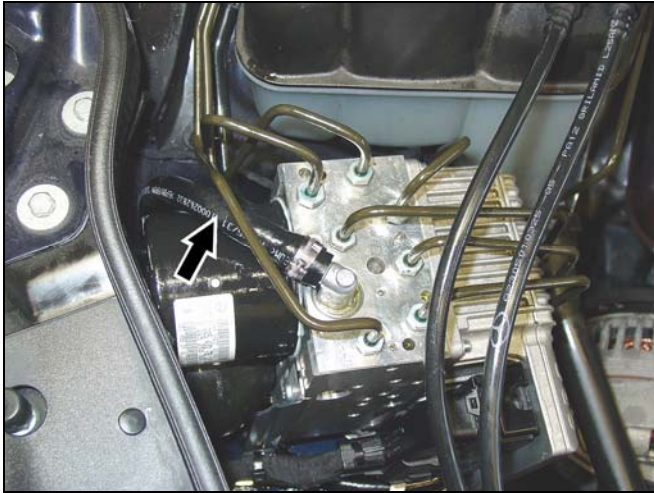
Figure 5

8. Inspect which version of the suction hose is installed on the SBC hydraulic pump:
- If new version (rubber) hose (arrow, Figure 5) is installed, skip ahead to step 10.
 - If previous version (braided) hose (arrow, Figure 6) is installed, proceed to step 9 to replace the suction hose.

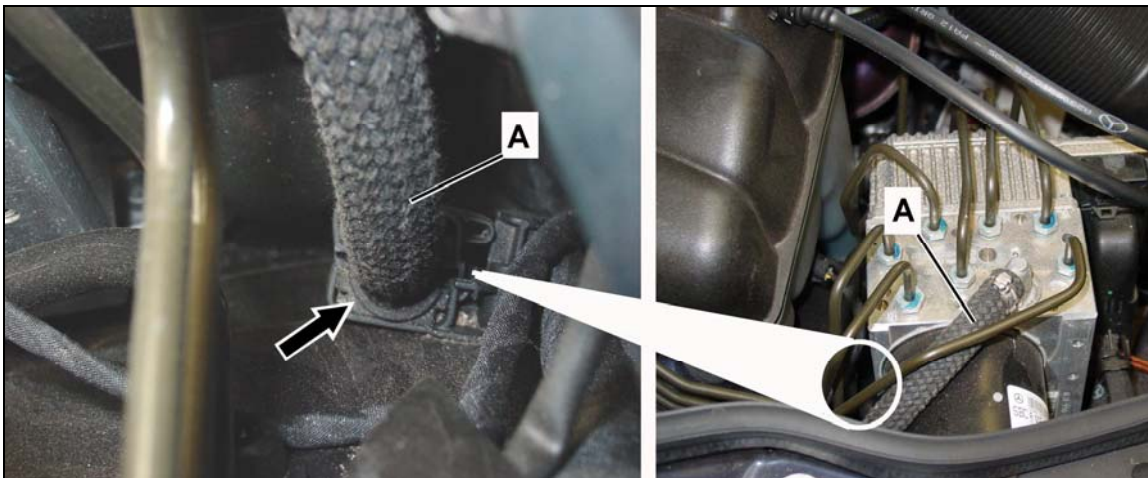
Figure 7

9. Replace suction hose (A, Figure 7):
- Open the suction hose mounting clip (arrow) and remove suction hose (A) from bracket.
 - Remove mounting clip (arrow) from threaded stud and discard.

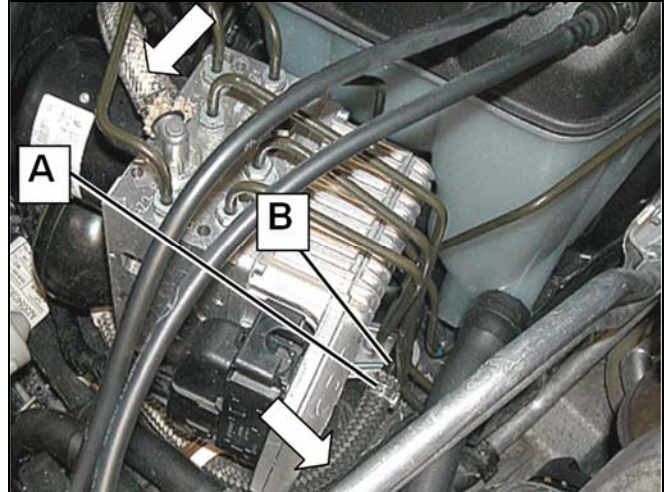
Figure 8 (Shown with SBC hydraulic unit installed)

- Do not use sharp-edged tools (e.g., screwdriver) to remove suction hose (arrows, Figure 8) from suction line (B), as this may cause damage to the SBC brake system.

- When removing suction hose (arrow), do not bend suction line (B).
- To prevent brake fluid from running out and to prevent contamination in the brake system, the suction hose (arrows, Figure 8) and line (B) are to be plugged using suitable plugs from the stop plug kit (Special Tool: W129 589 00 91 00).
- Discard old suction hose (arrow) and clamp (A) after removal.

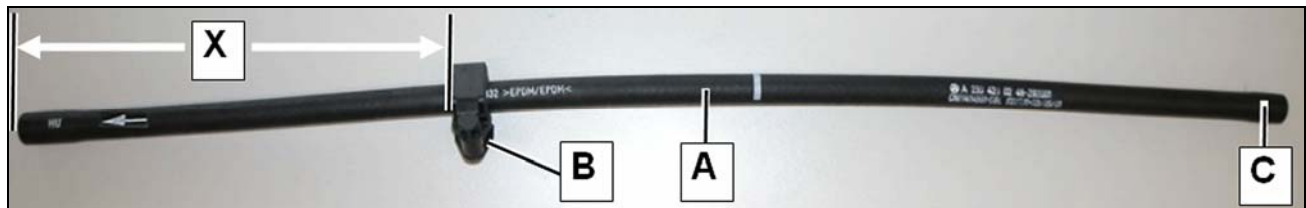
Figure 9 Dimension X = 20 cm

- Verify that the dimension X (Figure 9) on the **new** SBC suction hose (A) equals 20 cm. Adjust (if necessary) by repositioning the mounting clip (B) on the SBC suction hose (A).
- Place new hose clamp onto unmarked side of suction hose (C, Figure 9).
- Connect the unmarked end of the suction hose (C, Figure 9) onto the suction line (A, Figure 10) and secure hose with a **new** hose clamp (arrow, Figure 10).

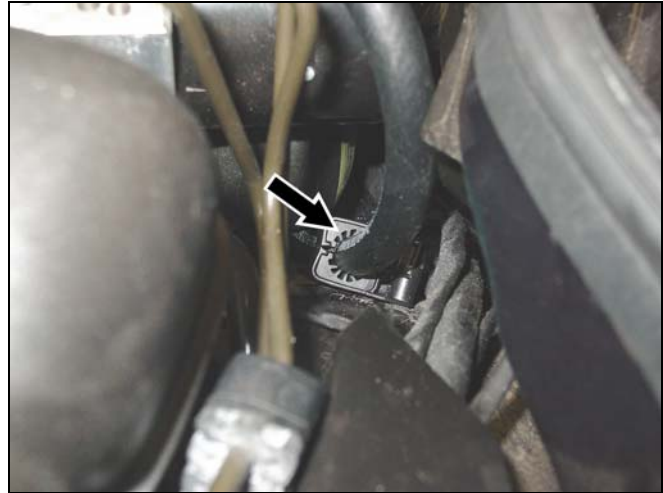
Figure 11

- Install the new SBC suction hose mounting clip (arrow, Figure 11) onto the mounting stud.

To gain better access to mounting clip (during installation); remove the plastic cover over the right head lamp; then tap the clip into place using a socket extension and plastic mallet.

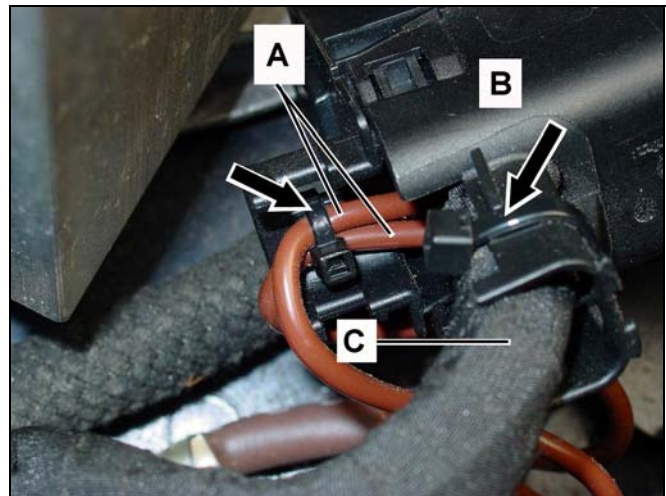
Figure 12

10. Remove cable tie (left arrow, Figure 12) securing ground wires (A) to SBC connector housing (B).
11. Remove cable tie (right arrow, Figure 12) securing SBC wire harness (C) to SBC connector housing (B).

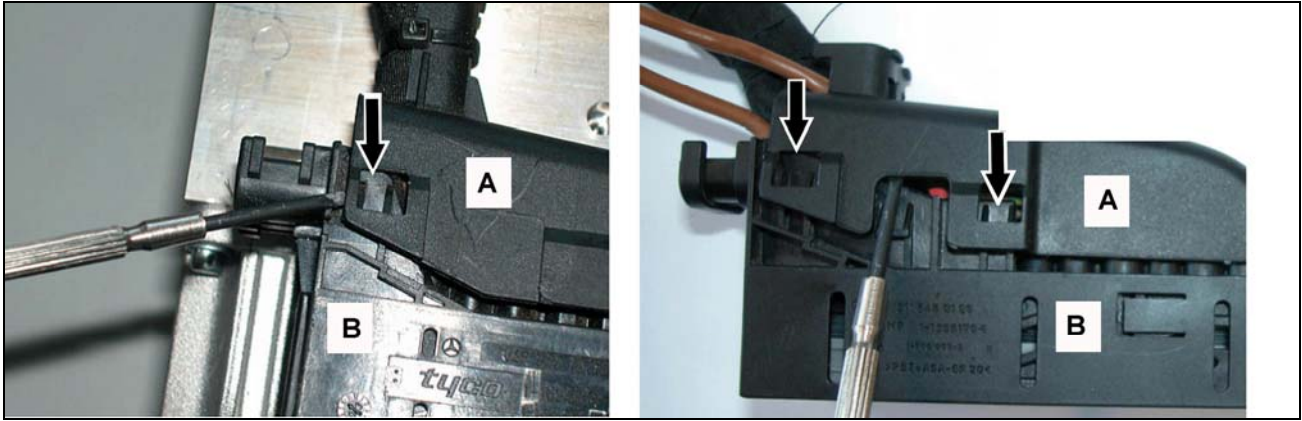
Figure 13

12. Remove SBC connector housing cover (A, Figure 13):

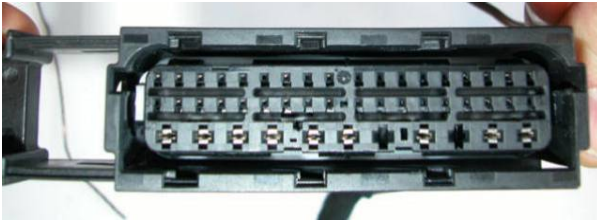
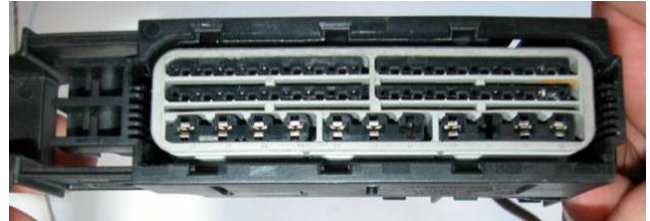
There are two different versions of the SBC wiring harness connector (Figures 14a, b) installed in vehicles involved with this campaign.

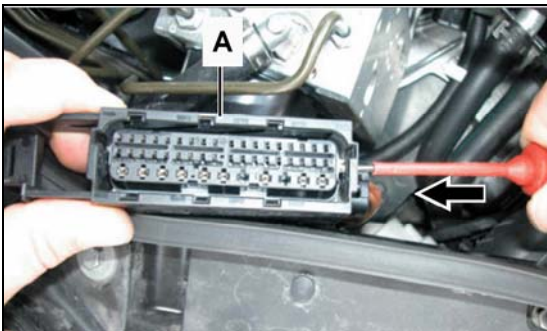
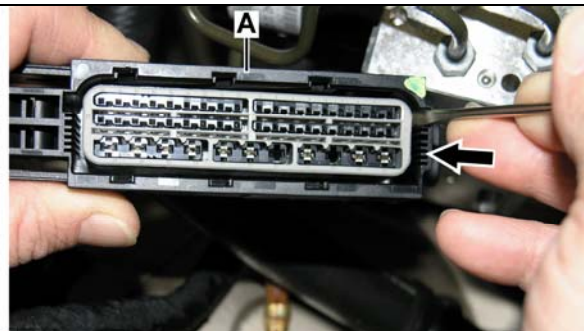
13. Open the (gray) secondary lock in the SBC connector housing (A, Figure 15) by sliding the lock in the direction indicated by the arrows (Figure 15) using a small screwdriver.

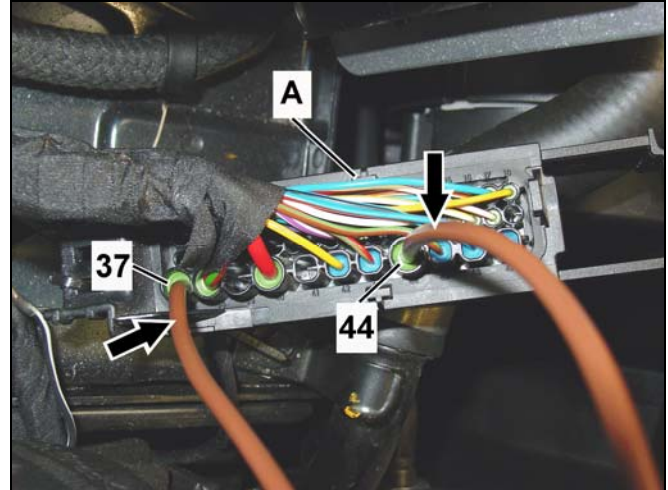
Figure 17

14. Remove SBC ground wires (arrows, Figure 17) from SBC harness connector (A):
 - Unpin SBC ground wire connectors (position 37 and 44) using cable release (Special Tools: W 000 589 13 99 30 and W 220 589 01 99 50) and remove ground wires (arrows) from SBC connector housing (A).
 - Discard old ground wire harness, it is no longer needed.
15. Insert the new ground wire harness (arrows Figure 17) into the SBC connector housing (A):
 - Insert **longer** ground wire into position 44.
 - Insert **shorter** ground wire into position 37.

Ensure ground wire connectors are **properly** locked into place.

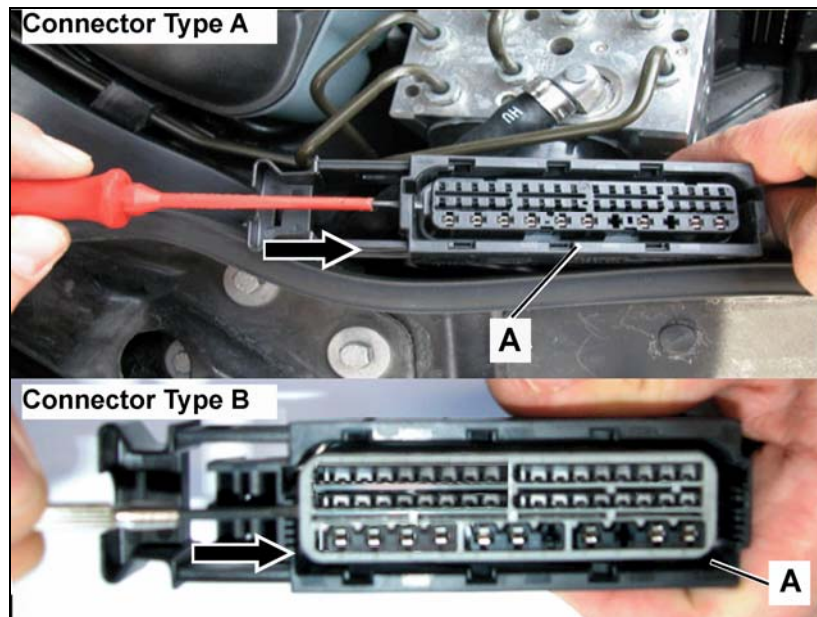
Figure 18

16. Close the (gray) secondary lock of the SBC connector housing (A, Figure 18) by sliding the lock in the direction indicated by the arrows (Figure 18) using a small screwdriver until it locks into place.
17. Reinstall connector cover (A, Figure 13) in reverse order.

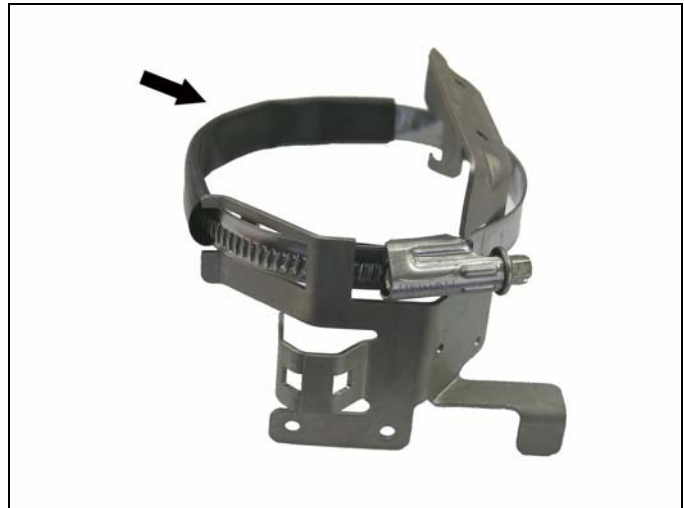
Figure 22

21. Install clamp-on mounting bracket (Figure 22) if necessary due to broken self-tapping screw:

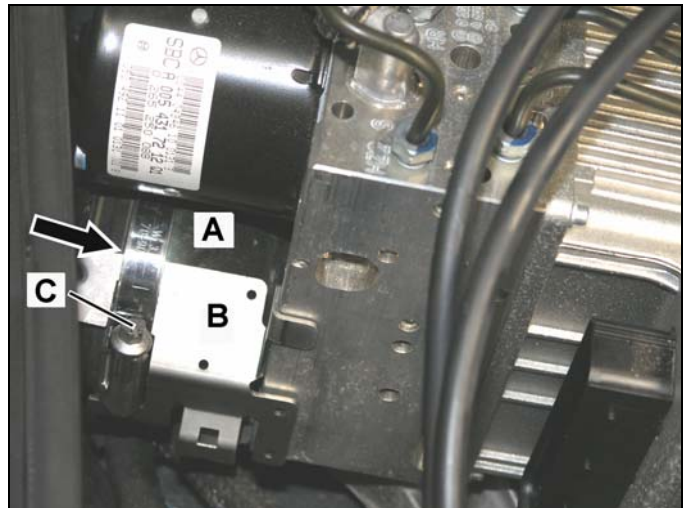
Figure 23

- Position mounting bracket (B) onto SBC hydraulic unit (A) as shown in Figure 23.

- Ensure mounting bracket (B, Figure 23) is flush with SBC hydraulic unit (A).
- Torque mounting clamp screw (C) to 5 Nm while pressing bracket (B) onto SBC unit (A) (Proceed to step 24).
