Campaign No. 2005110001, May 2006

SUBJECT: **MODEL 211, MODEL YEAR 2003-2006**
MODEL 219, MODEL YEAR 2006
MODEL 230, MODEL YEAR 2003-2005
INSTALLATION OF GROUND WIRES AND BRACKET TO SBC WIRING HARNESS

INSTALLATION OF GROUND WIRES AND BRACKET TO SBC WIRING HARNESS

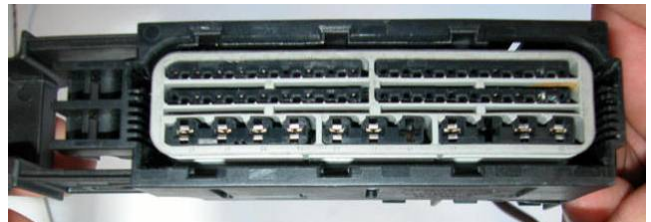
There are two different versions of the SBC wiring harness connector (Figure 7a, b) installed in vehicles involved with this campaign.

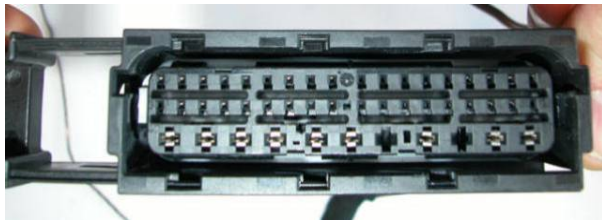
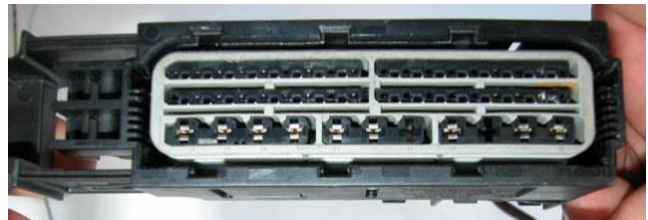
There are two different versions of the SBC wiring harness connector (Figure 8a, b) installed in vehicles involved with this campaign.
