DTB

Date: April 15, 2008
Order No.: S-B-68.30/75
Supersedes:
Group: 68

**SUBJECT: All Passenger Car and Light Truck Models
Surface Damage Caused by Scent Dispenser**

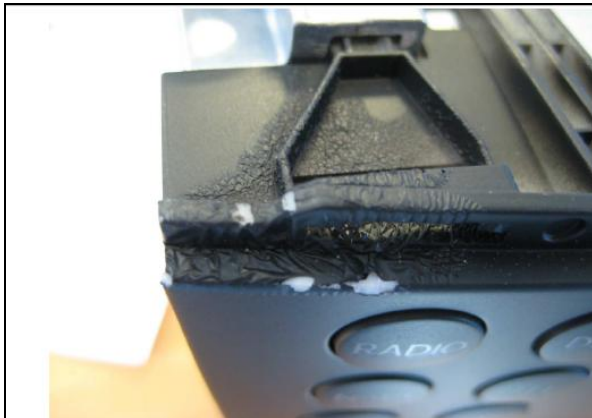
Figure 1

If you receive customer reports of surface damage such as the surface coating loosening on the radio, COMAND, upper control panel or air vents, this may be caused by the use of an aggressive interior scented product (e.g. scented oils) (Figures 1 through 5). During vehicle workshop visits, check whether there is a scent dispenser in the vehicle and inform the customer of any consequential damage caused by the product.
