**Shown on model 204.0**

**Model 212**

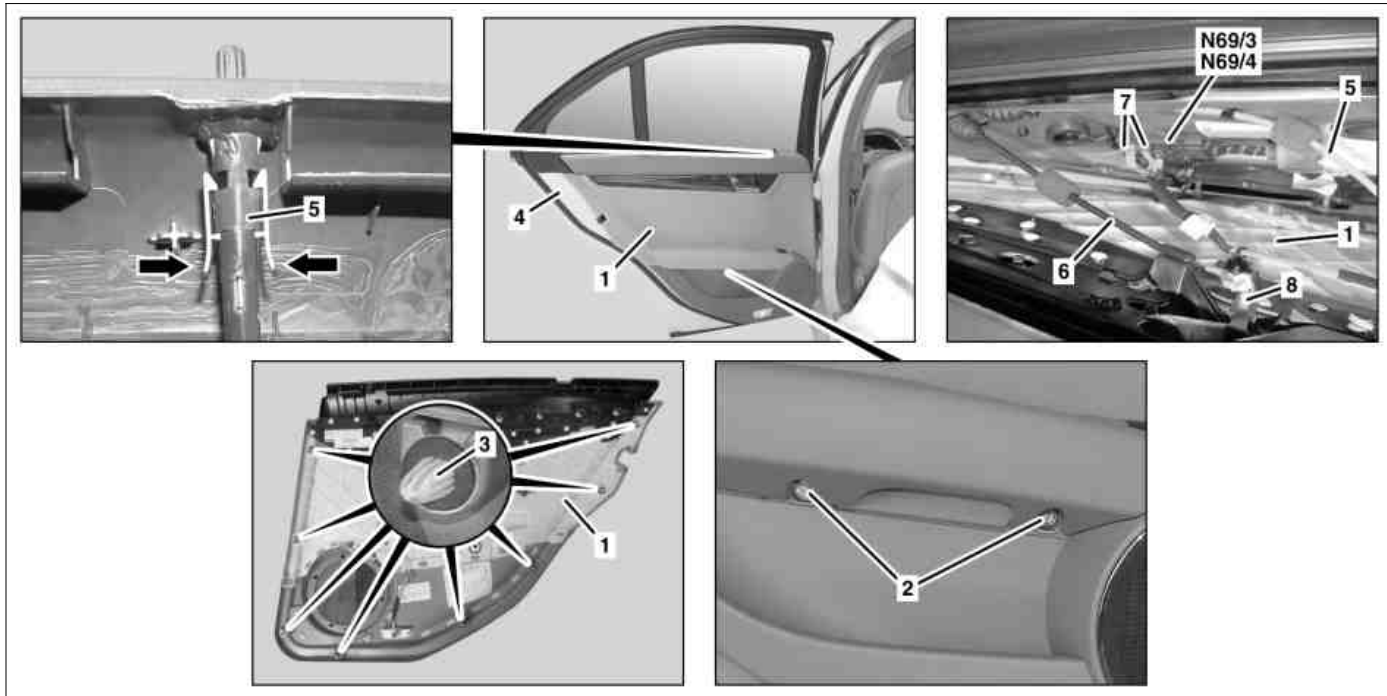
P72.12-2754-09

| 1 Door lining | 5 Bowden cable end safety cap | N69/3 Left rear door control unit |
| 2 Screws/bolts (model 204) | 6 Inside door opener Bowden cable | N69/4 Right rear door control unit |
| 3 Mounting clip | 7 Electrical connectors | |
| 4 Rear door | 8 Inner door handle | |

Remove/install		
1.1	Remove bolts (2)	Model 204.0/2	
1.2	Unclip covers and unscrew bolts (2)	Model 204.9	
1.3	Unclip cover (10) with assembly wedge (9) and unscrew bolts (11)	Model 212	
2	Unclip door liner (1) from mounting clips (3)	<ul style="list-style-type: none"> <li> Assembly wedge</li> <li> Move assembly wedge directly to mounting clips (3). Otherwise the retaining tabs on the mounting clips (3) of the door liner (1) cannot tear out.</li> <li> Assembly wedge</li> </ul>	<p>*110589035900</p> <p>*110589035900</p>
3	Detach door lining (1) from rear door (4) horizontally to side until electrical connectors (7) on left rear door control unit (N69/3), right rear door control unit (N69/4), inside door opener Bowden cable (6) and Bowden cable end safety cap (5) are accessible.	<ul style="list-style-type: none"> <li> Carefully detach door lining (1). Danger of breaking mount on Bowden cable end safety cap (5).</li> </ul>

4	Press shackles together (arrows) and unclip Bowden cable end safety cap (5) from door lining (1)	<ul style="list-style-type: none"> <li> <b>Installation:</b> Ensure that door lining (1) is seated correctly in inner sealing rails.</li> </ul>

5  ⚠	Disconnect electrical connectors (7) from left rear door control unit (N69/3) and right rear door control unit (N69/4) Information on preventing damage to electronic components due to electrostatic discharge		AH54.00-P-0001-01A
6	Unhook inside door opener Bowden cable (6) from inner door handle (8).		
7	Disconnect electrical connector on left rear door sound system tweeter or right rear door sound system tweeter	Model 212 with code (810) Sound system	
8	Install in the reverse order

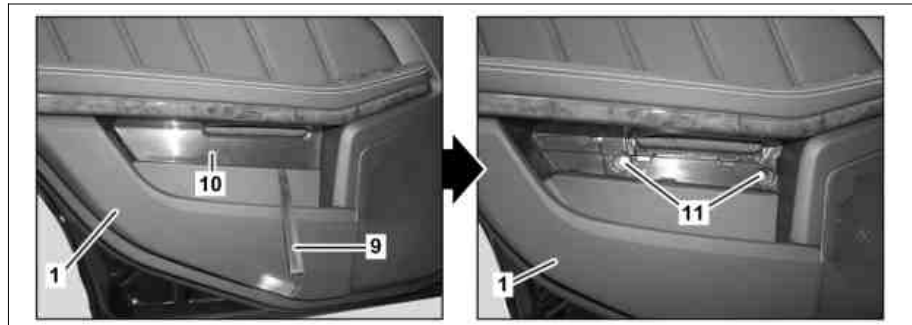
P72.12-2811-04

- 1 Door lining
- 9 Assembly wedge
- 10 Cover
- 11 Bolts
