Removing

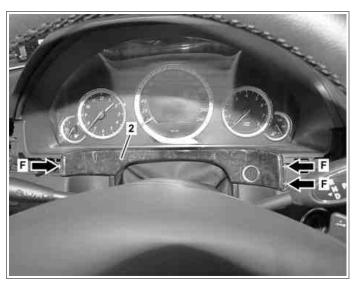
- 6 Unscrew bolt (24).
- 7 Unclip right air vent (25) and remove passenger-side trim part (3).

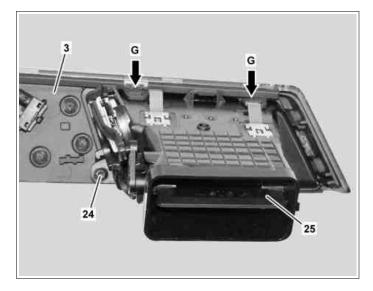
P68.30-3494-11

- 8 Unscrew bolts (26).
- Loosen electrical wiring harnesses (27).
 Only on vehicles with code (877) Ambiance illumination
- 10 Unclip passenger side trim part (3) from top from center air vent (29) (arrows H).

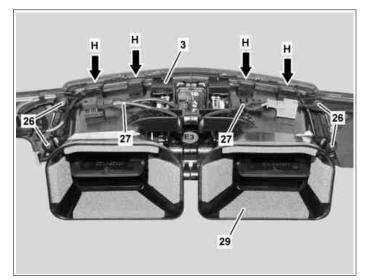
P68.30-3495-11

11 Unclip passenger side trim part (3) from bottom (arrows H) and remove center air vent (29).

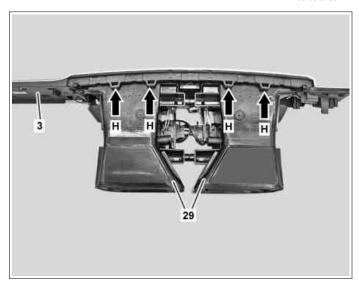
P68.30-3499-11

12 Unclip instrument panel switch group (S6/1) and remove passenger side trim part (3)

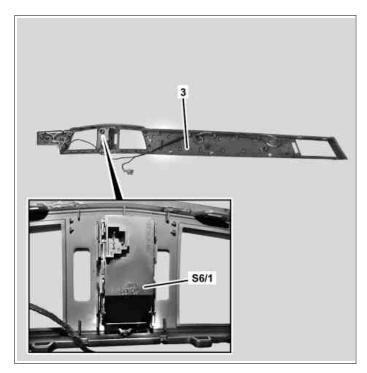
P68.30-3496-12

- $\fbox{\ensuremath{\underline{\mathbf{i}}}}$ Perform following steps on vehicles with code (877) Ambiance illumination.
- 13 Unclip electrical wiring harness (27).
- 14 Unclip fluorescent tube (30) on ambiance illumination and remove.

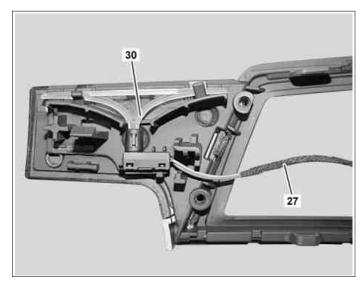
P68.30-3497-11

- 15 Unclip electrical wiring harness (27) and remove.
- 16 Unclip fluorescent tube (31) on ambiance illumination and remove.
 - Due to the length of the fluorescent tube (31) it can break easily, therefore remove ambiance illumination carefully
