MODEL 212.0## /2## (except 212.077 /277) 1#

P68.30-3476-09

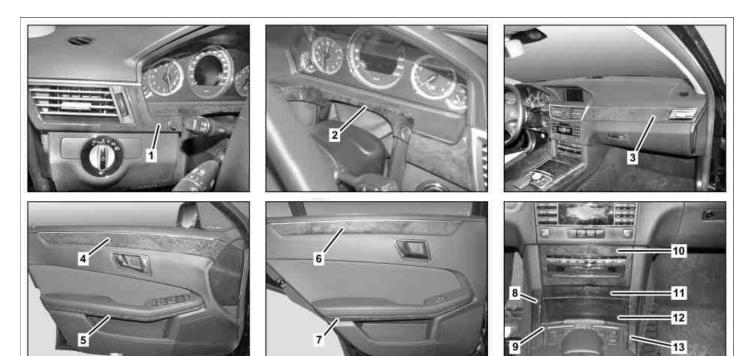
Shown on vehicle with code (279) Electronic drive selection stage

- Left air vent trim part
- Instrument cluster trim part
- 2 3 Passenger side trim part
- 4 Upper front door trim part
- 5 Lower front door trim part
- Upper rear door trim part 6
- 7 Lower rear door trim part
- 8 Left center console trim part
- Center middle console trim part
- Control and operating unit trim part 10
- Front stowage compartment trim part 11
- Rear stowage compartment trim part 12
- Right stowage compartment trim part

×	Remove		
(!)	General notes on retrofitting trim parts		AH68.00-P-0004-01EW
1	Remove front door liner		AR72.10-P-1000CW
2	Remove rear door lining		AR72.12-P-1010CW
3	Remove automatic air conditioning control and operating unit		AR83.40-P-6350EW
4	Remove trim strip on dashboard		AR68.10-P-1180EW
X	Install		
5	Retrofit trim parts (4, 5, 6 and 7) on doors		AN68.30-P-0004-01EW
		3,	*110589035900
6	Retrofit trim parts (8, 9, 10, 11, 12 and 13) on center console		AN68.30-P-0004-02EW
		3	*110589035900
7	Retrofit trim parts (1, 2 and 3) on instrument panel		AN68.30-P-0004-03EW
8	Install remaining parts		
9	Clean installed trim parts with cleaning agent approved by Daimler AG		
10	Connect STAR DIAGNOSIS
