Spark Plug Indexing for Direct Injection Engines

QEC / ES

John Dahlquist
June 19, 2014
Version 3

Mercedes-Benz

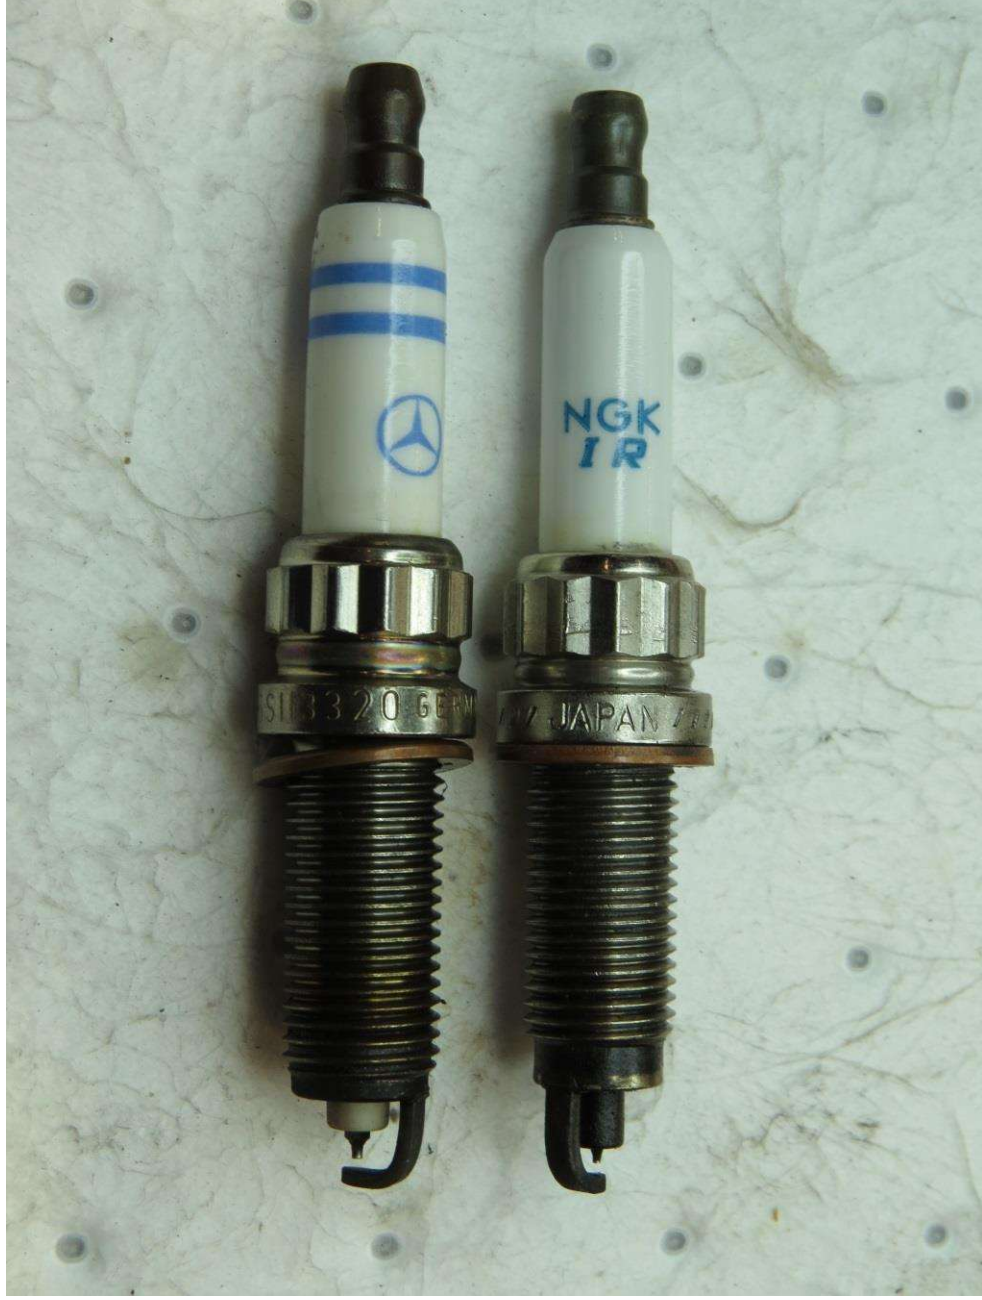
In the picture, an NGK unapproved spark plug is compared to a Mercedes approved spark plug. The NGK plug does not have the correct thread length for proper indexing and it isn't the correct heat range.

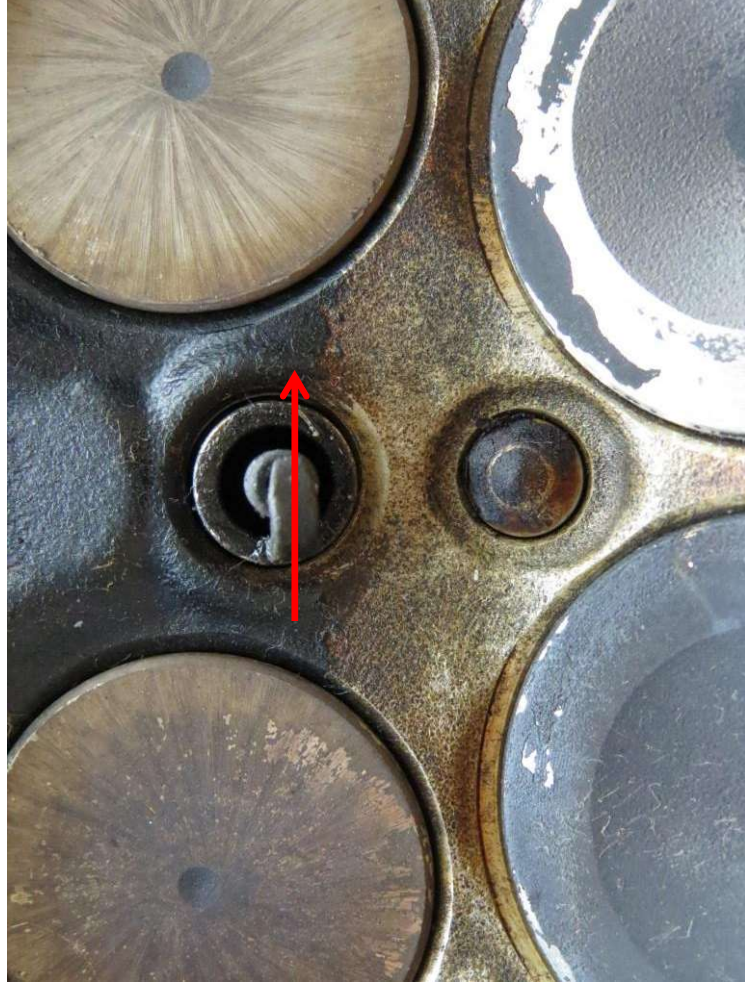
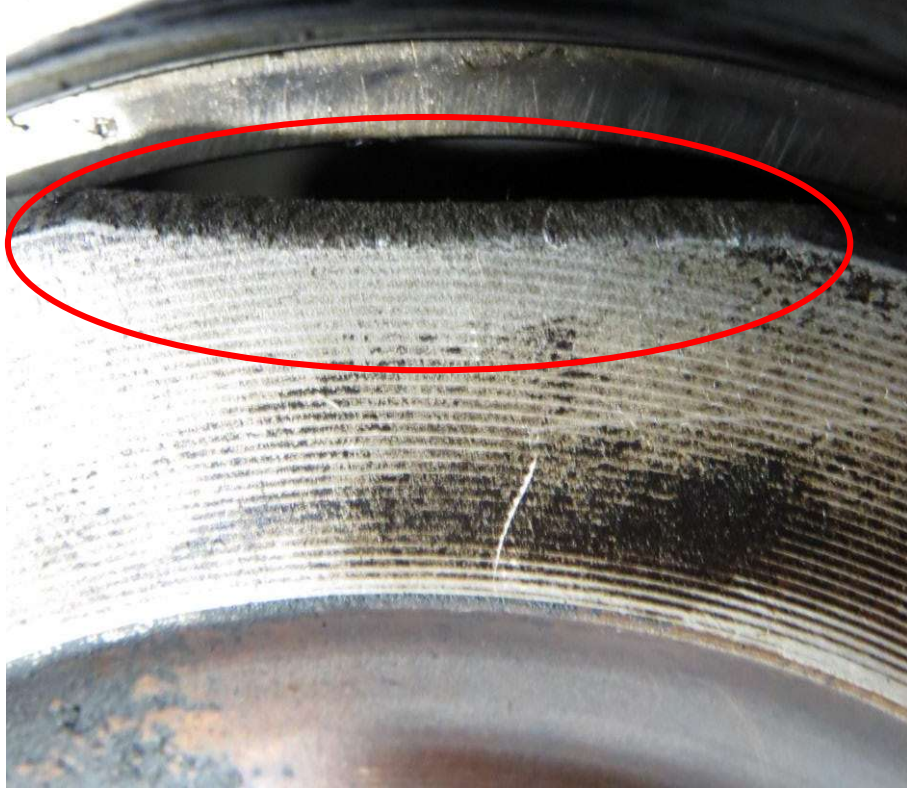
NGK Plug

In this case, the incorrect spark plug caused major engine damage (melted piston) that lead to a complete engine replacement. This is not a warrantable defect.
