MODEL 212.0/1
 MODEL 212.2

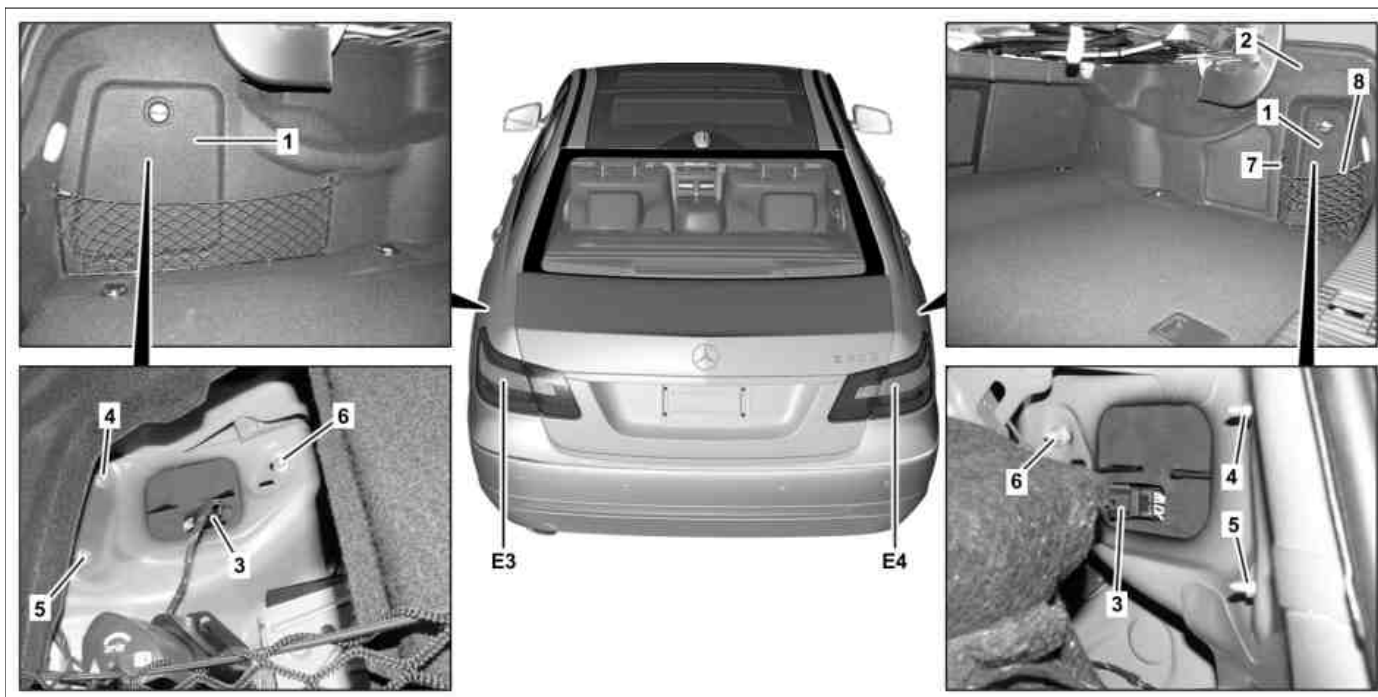
P82.10-5776-09

Shown on model 212.0

| 1 Service flap | 5 Nut | E3 Left rear lamp unit |
| 2 Right side paneling | 6 Nut | E4 Right rear lamp unit |
| 3 Electrical connector | 7 Bracket | |
| 4 Nut | 8 Luggage net | |

7		Unscrew nuts (4, 5, 6)	Installation: To ensure that left rear lamp unit (E3) or right rear lamp unit (E4) is seated correctly, the nuts (4, 5, 6) must be tightened in the following tightening sequence: 1. Nut (4) 2. Nut (5) 3. Nut (6)	
8		Detach left rear lamp unit (E3) or right rear lamp unit (E4) and disconnect electrical connector (3)	MODEL 212.2

9	Remove left rear lamp unit (E3) and right rear lamp unit (E4)		
10	Install in the reverse order
