MODEL 204.0 /2 /3 (except 204.077 /277) with CODE (409) Left/right front multicontour seats

MODEL 207, 212, 218 with CODE (409) Left/right front multicontour seats

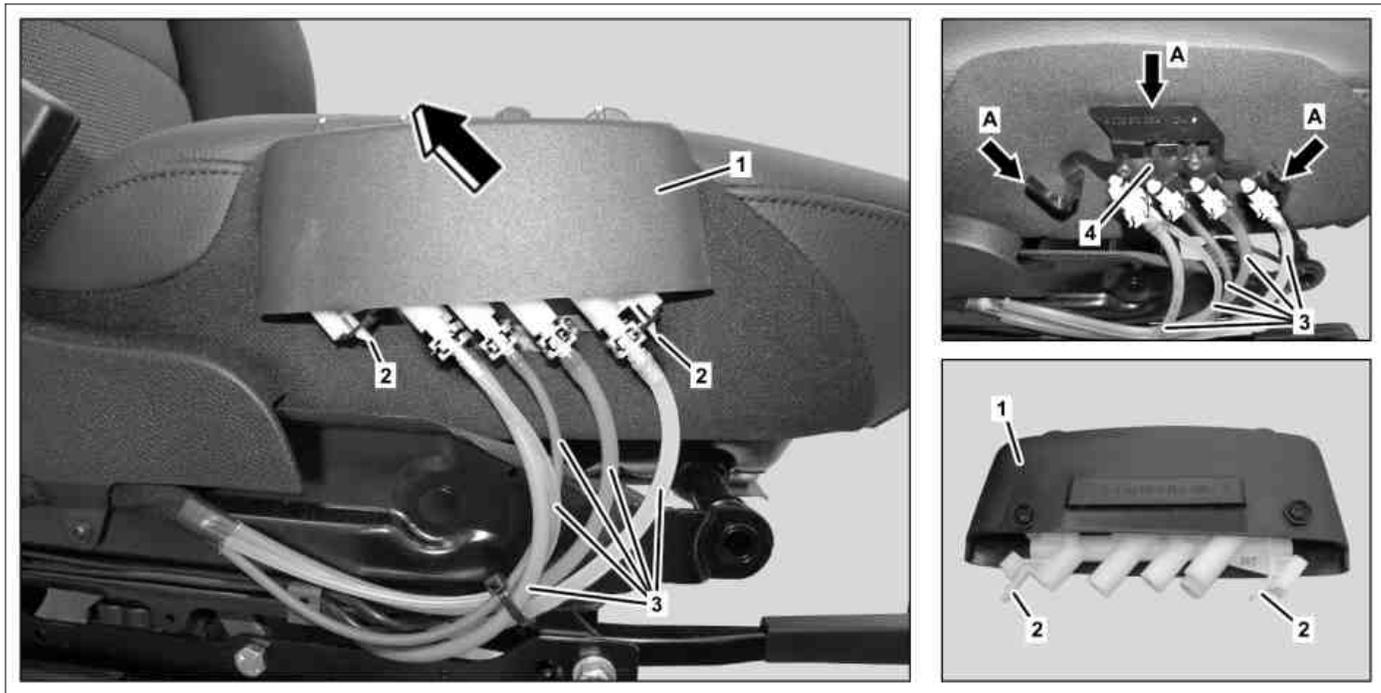
P91.25-2419-09

Shown on model 204, on removed left front seat

- 1 Control valve
- 2 Catch hook

3 Pneumatic lines

4 Bracket

Remove/install	
1		Push both catch hooks (2) inwards, while at the same time pulling the control valve (1), as shown, upwards at an angle out of the holder (4) and the pneumatic lines (3) and remove	i Installation: Check sealing rings of pneumatic lines (3) for damage, replace if necessary. Ensure that control valve (1) is correctly seated in the guides (arrows A) of the bracket (4).
2		Install in the reverse order
