## Vehicle drops at rear axle, vehicles with electronic rear axle level control or AIRmatic

Topic number	LI32.22-P-048597
Version	12
Design group	32.22 Air suspension
Date	07-19-2017
Validity	Model 212.0## with air suspension (SA code 489) up to VIN 212.0## ## 596462 Model 212.2## (wagon) up to VIN 212.2## ## 596462 Model 218 with air suspension (SA code 489) up to VIN 218 ### ## 041409
Reason for change	AMG variants added. Pressure reservoir test added to remedy.

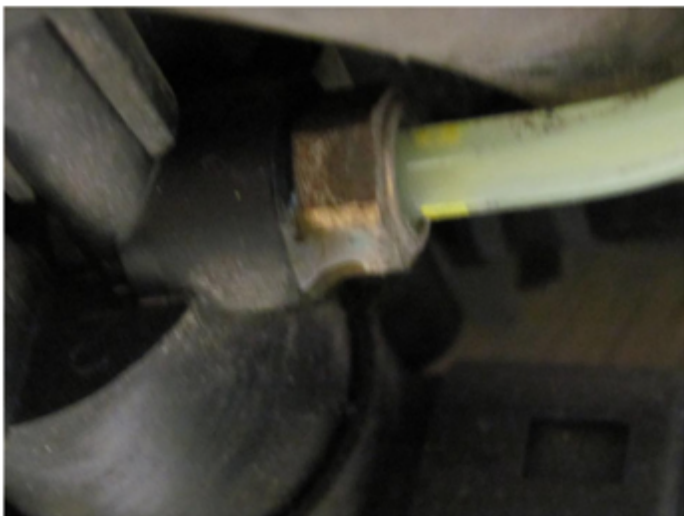
- Unscrew AIRmatic pressure line between compressor and valve unit.
- If water emerges (Figure 1), or if there are visible water droplets at the connection of the pressure line of the compressor or valve unit (Figure 2), the compressor, the valve unit and the air filter of the intake hose must be replaced. If no water is visible, actuate compressor with XENTRY. If water runs out of the connection on the compressor, the compressor, the valve unit and the air filter of the intake hose must be replaced.

- Then unscrew air lines from valve block to air springs on the side of the air suspension strut and blow out with compressed air.
- If the compressed air reservoir is present, disconnect the compressed air line from the reservoir and unscrew the pressure reservoir. If there is water in the reservoir, replace the reservoir and blow out the compressed air line from the compressor side using compressed air.
