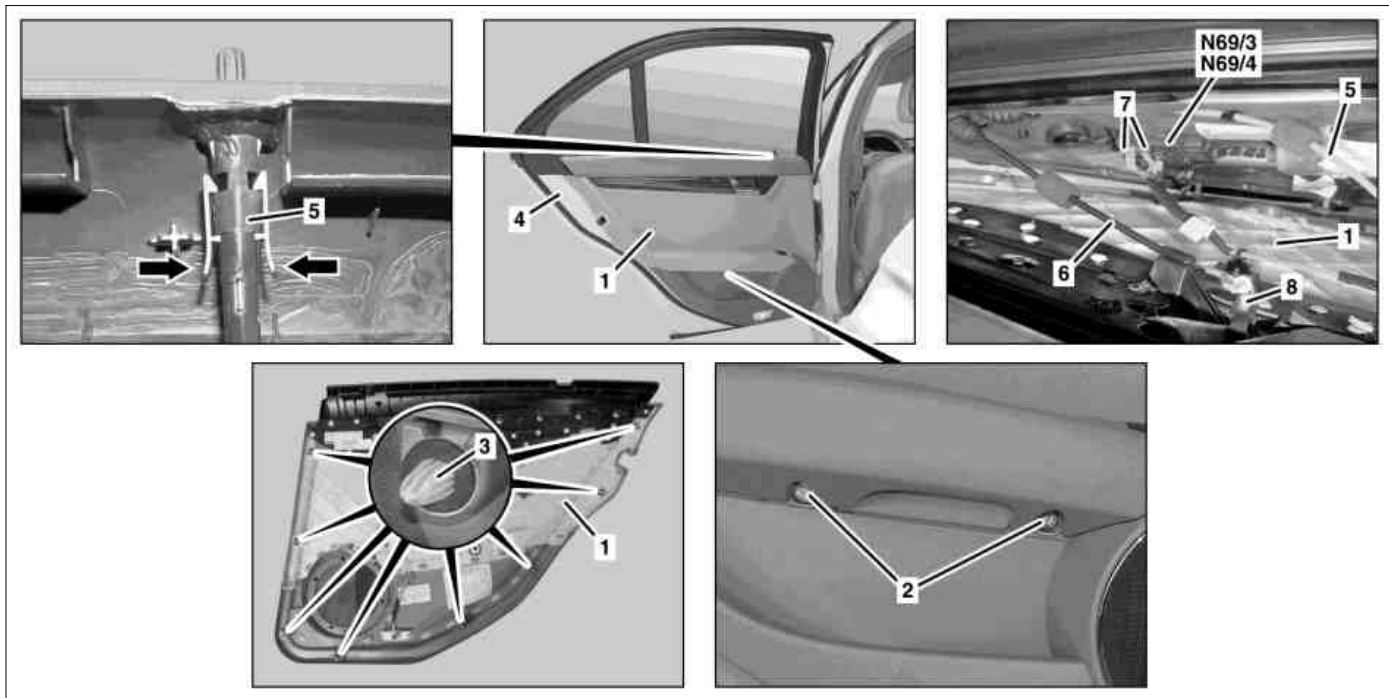
P72.12-2754-09

**Shown on model 204.0**

| 1 Door lining | 5 Bowden cable end safety cap | N69/3 Left rear door control unit |
| 2 Screws/bolts (model 204) | 6 Inside door opener Bowden cable | N69/4 Right rear door control unit |
| 3 Mounting clip | 7 Electrical connectors | |
| 4 Rear door | 8 Inner door handle | |

Remove/install		
1.1	Remove bolts (2)	Model 204.0/2	
1.2	Unclip covers and unscrew bolts (2)	Model 204.9	
1.3	Unclip cover (10) with assembly wedge (9) and unscrew bolts (11)	Model 212	
2	Unclip door lining (1) from mounting clips (3)	<ul style="list-style-type: none"> <li> Move assembly wedge directly to mounting clips (3) and ensure that the retaining tabs on the mounting clips (3) do not tear out of the door lining (1).</li> </ul>	*110589035900
3	Detach door lining (1) from rear door (4) horizontally to side until electrical connectors (7) on left rear door control unit (N69/3), right rear door control unit (N69/4), inside door opener Bowden cable (6) and Bowden cable end safety cap (5) are accessible.	<ul style="list-style-type: none"> <li> Carefully detach door lining (1). Danger of breaking mount on Bowden cable end safety cap (5).</li> </ul>	
4	Press shackles together (arrows) and unclip Bowden cable end safety cap (5) from door lining (1)	<ul style="list-style-type: none"> <li> <b>Installation:</b> Ensure that door lining (1) is seated correctly in inner sealing rails.</li> </ul>

5  ⚠	Disconnect electrical connectors (7) from left rear door control unit (N69/3) and right rear door control unit (N69/4) Information on preventing damage to electronic components due to electrostatic discharge		AH54.00-P-0001-01A
6	Unhook inside door opener Bowden cable (6) from inner door handle (8).		
7	Disconnect electrical connector on left rear door sound system tweeter or right rear door sound system tweeter	Model 212 with code (810) Sound system	
8	Install in the reverse order

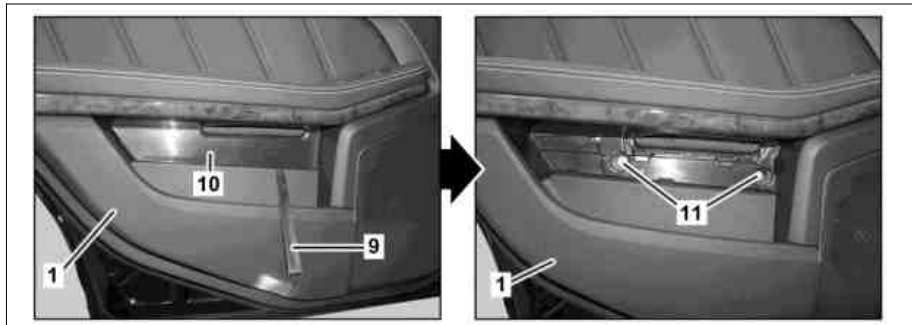
P72.12-2811-04

**Model 212**

- 1 Door lining
- 9 Mounting wedge
- 10 Cover
- 11 Bolts
