ENGINES 157, 276, 278 in MODEL 212, 218

P03.30-2157-05

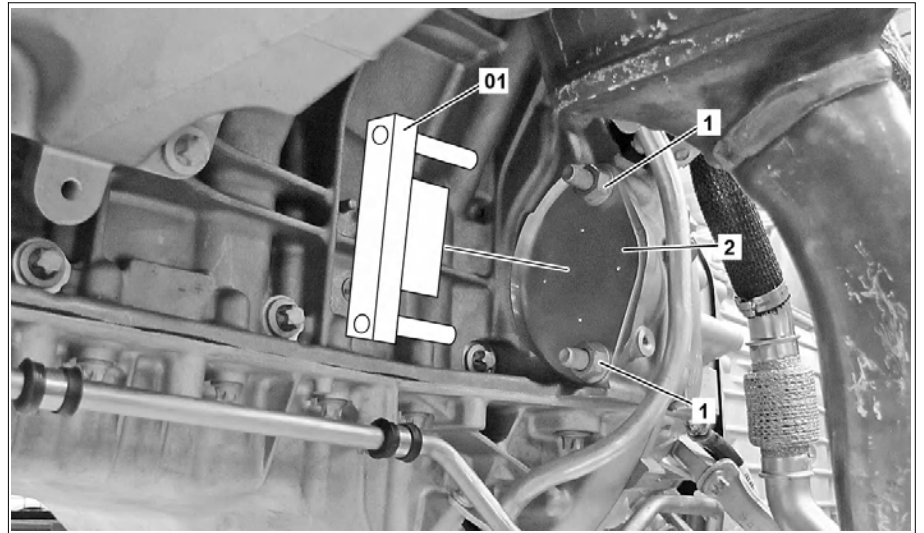
- 01 Retaining lock
1 Nut
2 Cover

Installing, removing		
	Risk of injury to skin and eyes caused by handling hot or glowing objects.	Wear safety gloves, protective clothing and safety glasses, if necessary.	AS00.00-Z-0002-01A
1	Remove bottom engine compartment paneling		AR61.20-P-1105EW
2	Unscrew nuts (1) and remove bolts from transmission bell		*BA27.40-P-1008-01A
3	Remove cover (2) from crankcase		
	Checking		
4	Check splines of ring gear for drive plate	Check splines for wear and damage by rotating engine at the center bolt for crankshaft in its direction of rotation. If necessary: ↓ Replace drive plate. 	AR03.30-P-8001EL *001589650900
5	Risk of injury caused by moving parts that can pinch, crush or, in extreme cases, even sever extremities Insert retaining lock (01) into access opening	No parts of the body or limbs should be within the operating range of the mechanism when moving components. If required, rotate engine further at center bolt for crankshaft in engine's direction of rotation until the retaining lock (01) snaps into place. 	AS00.00-Z-0009-01A *112589034000
