Model 218

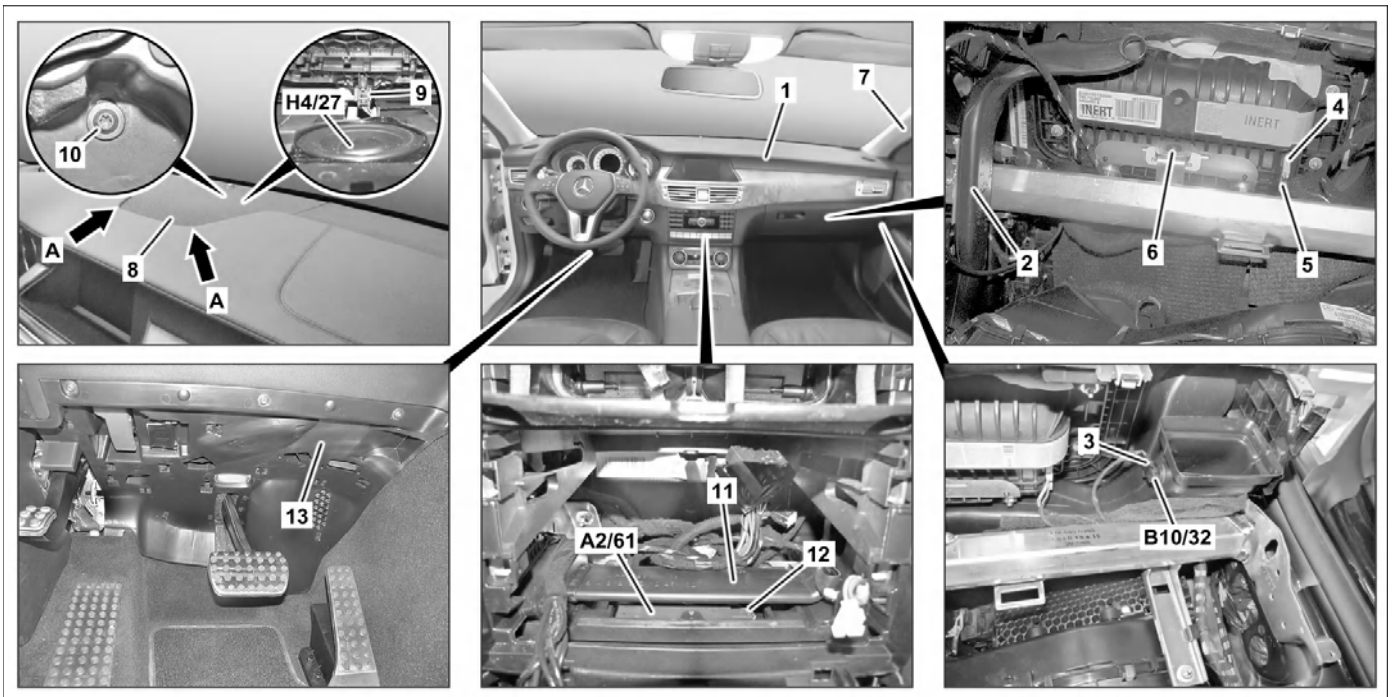
P68.10-4347-09

| 1 | Instrument panel | 7 | Right A-pillar paneling | 13 | Cover |
| 2 | Air duct | 8 | Cover | A2/61 | Interior KEYLESS-GO antenna (with code (889) KEYLESS-GO) |
| 3 | Electrical connector | 9 | Electrical connector (with CODE 220 (PARKTRONIC) or with CODE 235 (Active park assist)) | B10/32 | Right side air outlet temperature sensor |
| 4 | Electrical connector | 10 | Screw | H4/27 | Center instrument panel speaker (with CODE 348 (Emergency call/assist system) or with CODE 350 (Mercedes-Benz emergency call system) or with CODE 355 (Preinstallation for navigation retrofit) or with CODE 359 (TELE AID emergency call system) or with CODE 810 Sound system or with CODE 811 (Advanced Sound-System)) |
| 5 | Electrical connector | 11 | Air duct (with CODE 512 (COMAND APS with DVD changer), with CODE 527 (COMAND with single DVD drive (with navigation)), with CODE 528 (COMAND APS with single DVD drive (with navigation)) or CODE 531 (COMAND APS)) | | |
| 6 | Screw | 12 | Electrical connector (with CODE 889 (KEYLESS-GO)) | | |

| 1 | Adjust air distribution on air conditioning to footwell | i If the air distribution is not adapted to the footwell, the side air vent flaps can be unhooked from the air conditioner housing when removing the instrument panel (1). | |
| 3 | Remove glove compartment | i Installation: Ensure that the air duct (2) is seated correctly on the glove compartment. | AR68.10-P-1400EL |
| 4 | Disconnect electrical connector (3) from right side air vent temperature sensor air outlet (B10/32) | | |
| 5 | Disconnect electrical connector (4) from passenger airbag squib 1 | | |
| 6 | Disconnect electrical connector (5) from passenger airbag squib 2 | | |

| 20 | Remove cover (13) | | |

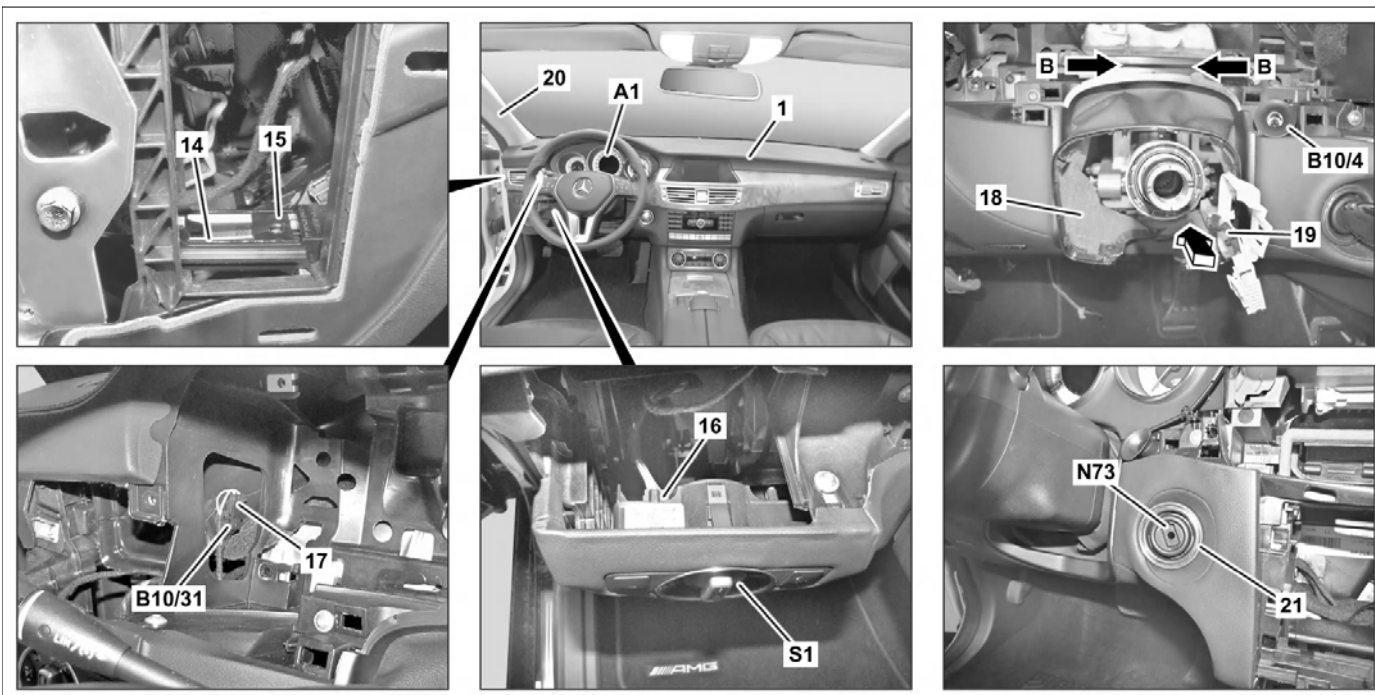
P68.10-4348-09

| 1 | Instrument panel | 18 | Steering column tube cover | B10/4 | Interior temperature sensor |
| 14 | Parking brake cable | 19 | Wiring harness mount | B10/31 | Left side air outlet temperature sensor |
| 15 | Release lever | 20 | Left A-pillar paneling | N73 | Electronic ignition switch control unit |
| 16 | Electrical connector | 21 | Trim ring | S1 | Exterior lights switch |
| 17 | Electrical connector | A1 | Instrument cluster | | |

| 22 | Unhook parking brake cable (14) from release lever (15) and remove release lever (15) from instrument panel (1) | | |
| 23 | Disconnect electrical connector (16) from exterior lights switch (S1) | | |
| 24 | Disconnect electrical connector (17) from left side air vent temperature sensor air outlet (B10/31) | | |
| 26 | Unclip jacket tube cover (18) at both ends from instrument panel (1) (arrows B) and unclip wiring harness bracket (19) toward rear from jacket tube cover (18) | | |
| 27 | Remove steering column tube cover (18) | | |
| 28 | Remove instrument cluster (A1) | | AR54.30-P-6015EL |
| 29 | Remove left A-pillar paneling (20) | Mounting wedge | *110589035900 |
| 30 | Unscrew trim ring (21) from electronic ignition lock control unit (N73) | Claw-type wrench for rosette on ignition/ starter switch | *210589000700 |
| 31 | Press electronic ignition lock control unit (N73) toward inside into dashboard (1) | | |

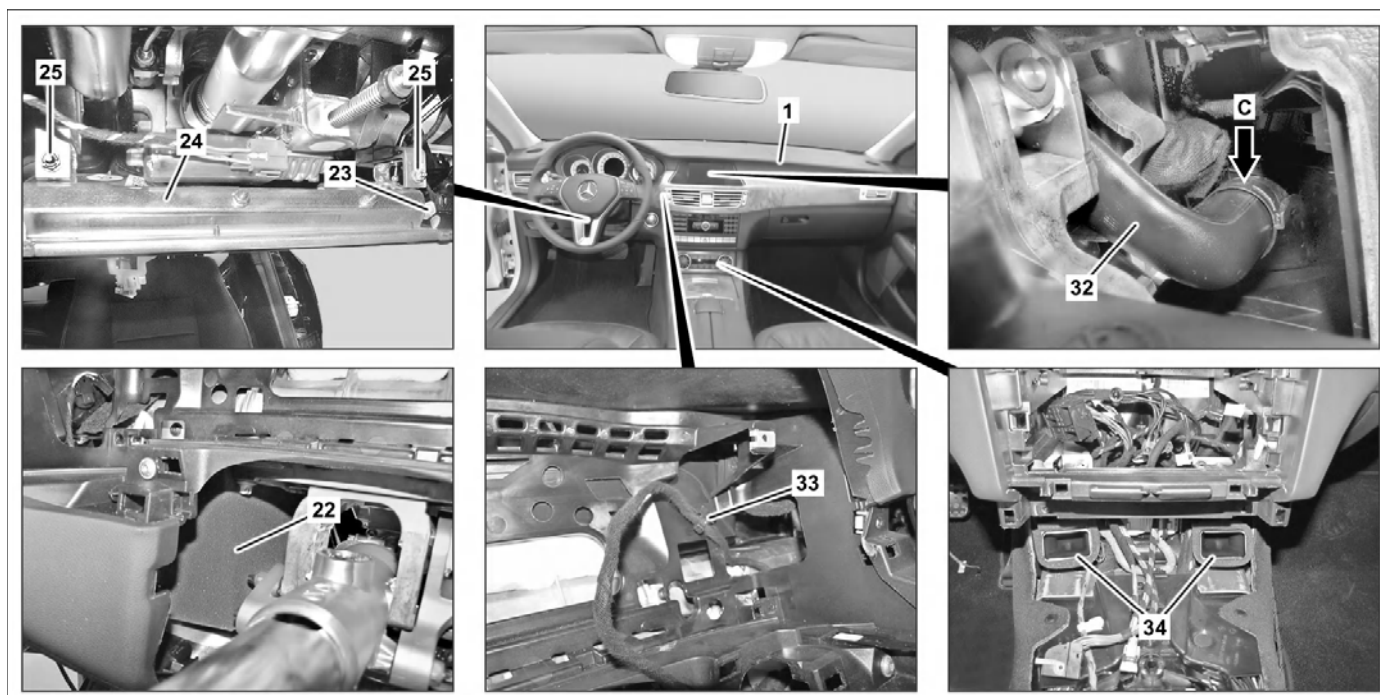
P68.10-4349-09

| 1 | Instrument panel | 24 | Driver kneebag (with 294 (Kneebag for driver)) | 33 | Wiring harness mount |

22 Damping material

23 Electrical connector (with CODE 294 (Kneebag for driver))

25 Nut (with CODE 294 (Kneebag for driver))

32 Air duct (with CODE 512 (COMAND APS with DVD changer), with CODE 527 (COMAND with single DVD drive (with navigation)), with CODE 528 (COMAND APS with single DVD drive (with navigation)) or CODE 531 (COMAND APS))

34 Air ducts

| 32 | Remove soundproofing (22) downward from instrument panel (1) | | |
| 33 | Disconnect electrical connector (23) from driver kneebag squib | Model 218 with code 294 (Kneebag) | |
| 34 | Unscrew nuts (25) at driver kneebag (24) | Model 218 with code 294 (Kneebag) Nut, kneebag to crossmember | *BA91.60-P-1003-01M |
| 36 | Separate air duct (32) from connection (arrow C) | Model 218 with code 512 (COMAND APS with DVD changer) Model 218 with code 527 (COMAND APS with single DVD drive (with navigation)) Model 218 with code 528 (COMAND with DVD changer) Model 218 with code 531 (COMAND APS) | |
| 39 | Unclip wiring harness bracket (33) from instrument panel (1) | | |
| 40 | Remove air ducts (34) | | |

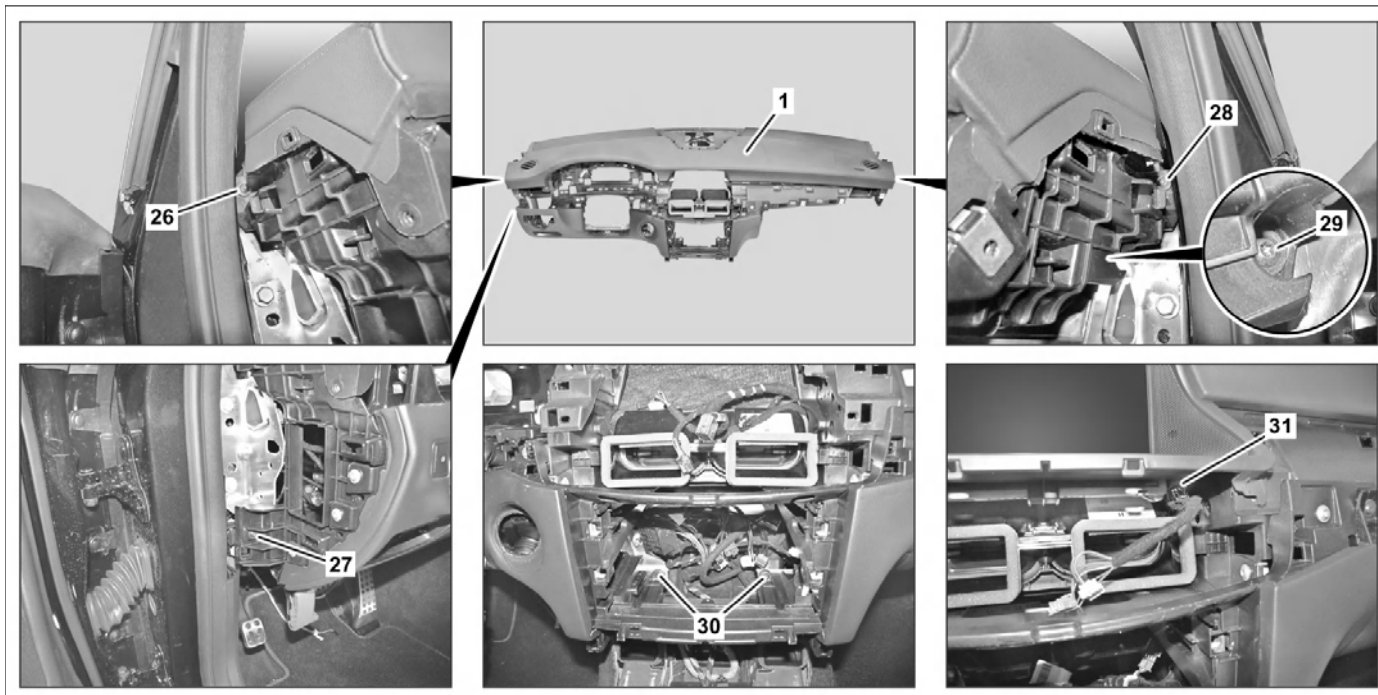
P68.10-4350-09

- 1 Instrument panel
- 26 Screw
- 27 Screw

- 28 Screw
- 29 Screw
- 30 Bolts

- 31 Wiring harness mount

| 35 | Unscrew bolts (26, 27, 28, 29, 30) | | |
| 37 | Unclip wiring harness bracket (31) from instrument panel (1) | | |
