Document title General information on inspecting cylinder walls

Document number ah0100p030001amg

Engine 133, 139, 156, 176, 177, 178, 254, 256.9, 276.8, 654, 656
Engine 159

General information for engines with twin-wire-arc-sprayed coating

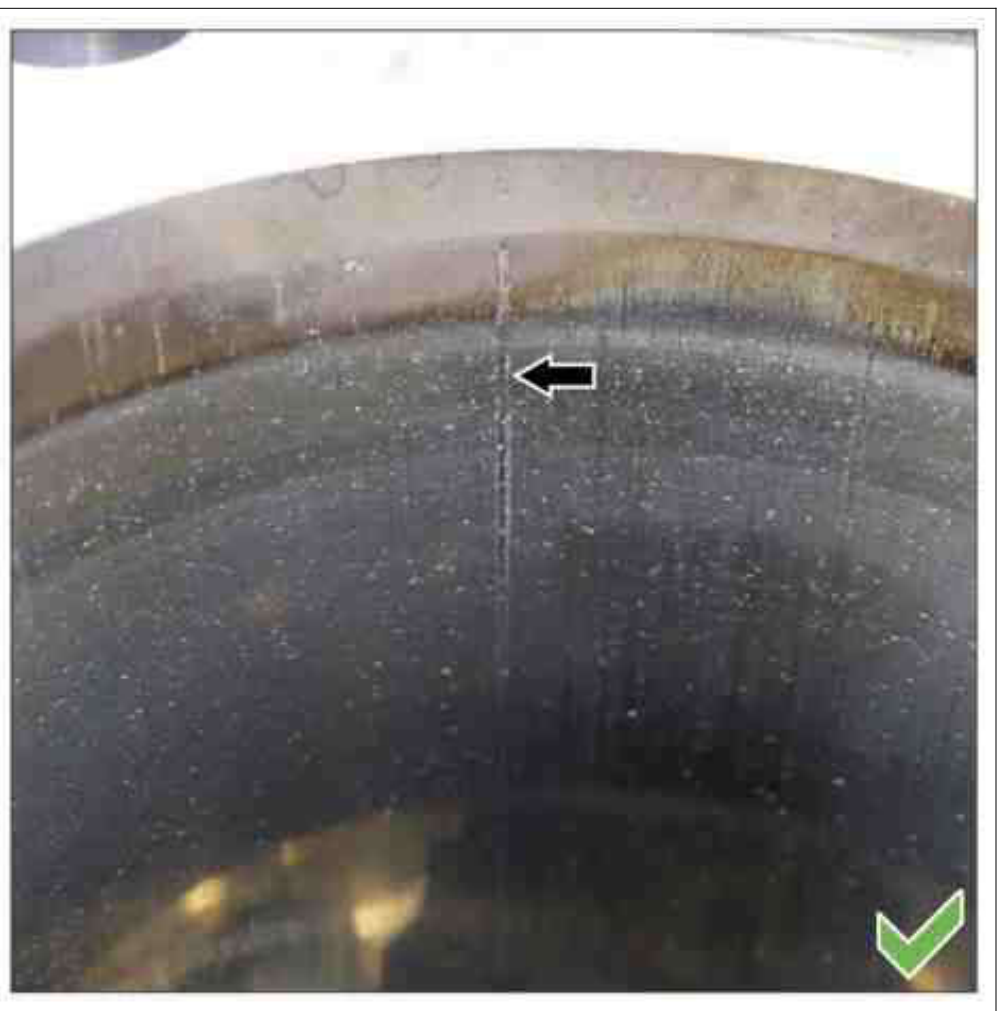
P01.00-3761-79

Individual score marks up to areas of score marks (not with engine 156, 159)

Caused by initial dirt or soiling during operation, e.g. through back pulsation of particles from the catalytic converter or the exhaust system.

i If the compression pressure is within the permissible range, use the crankcase again.

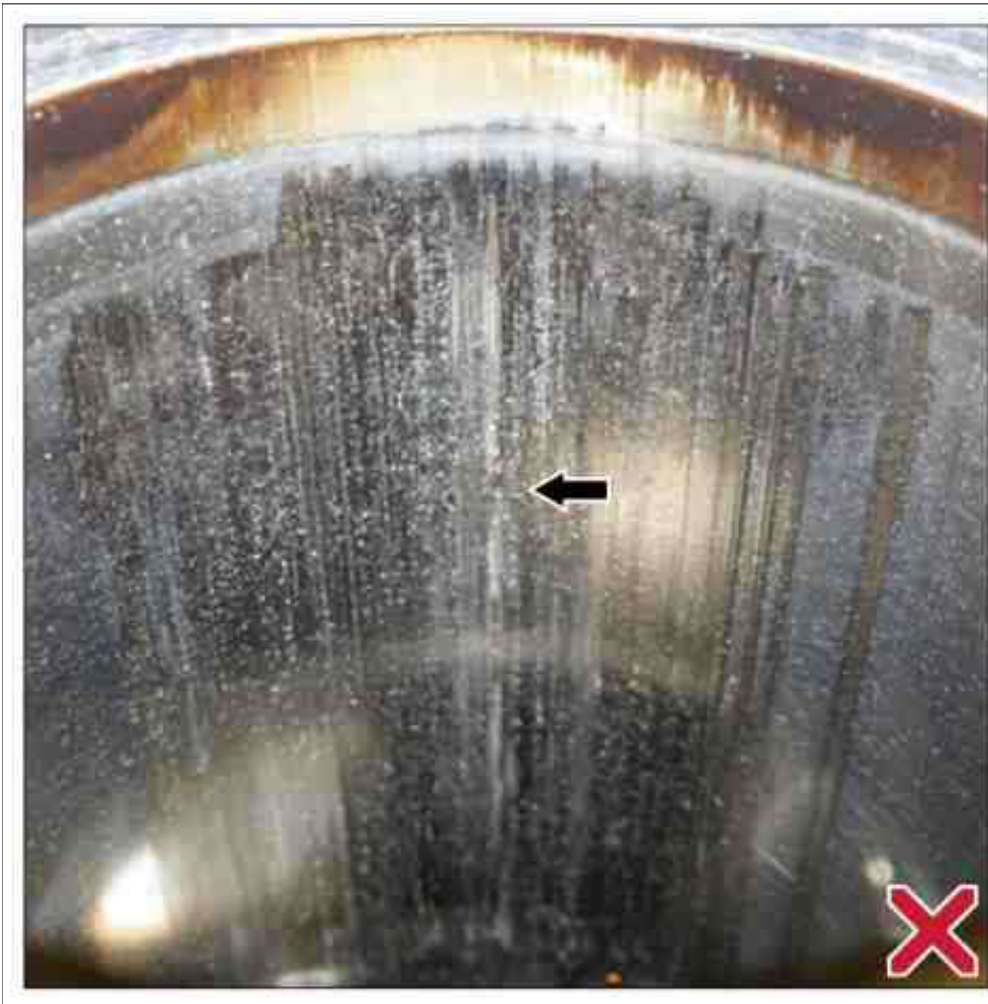
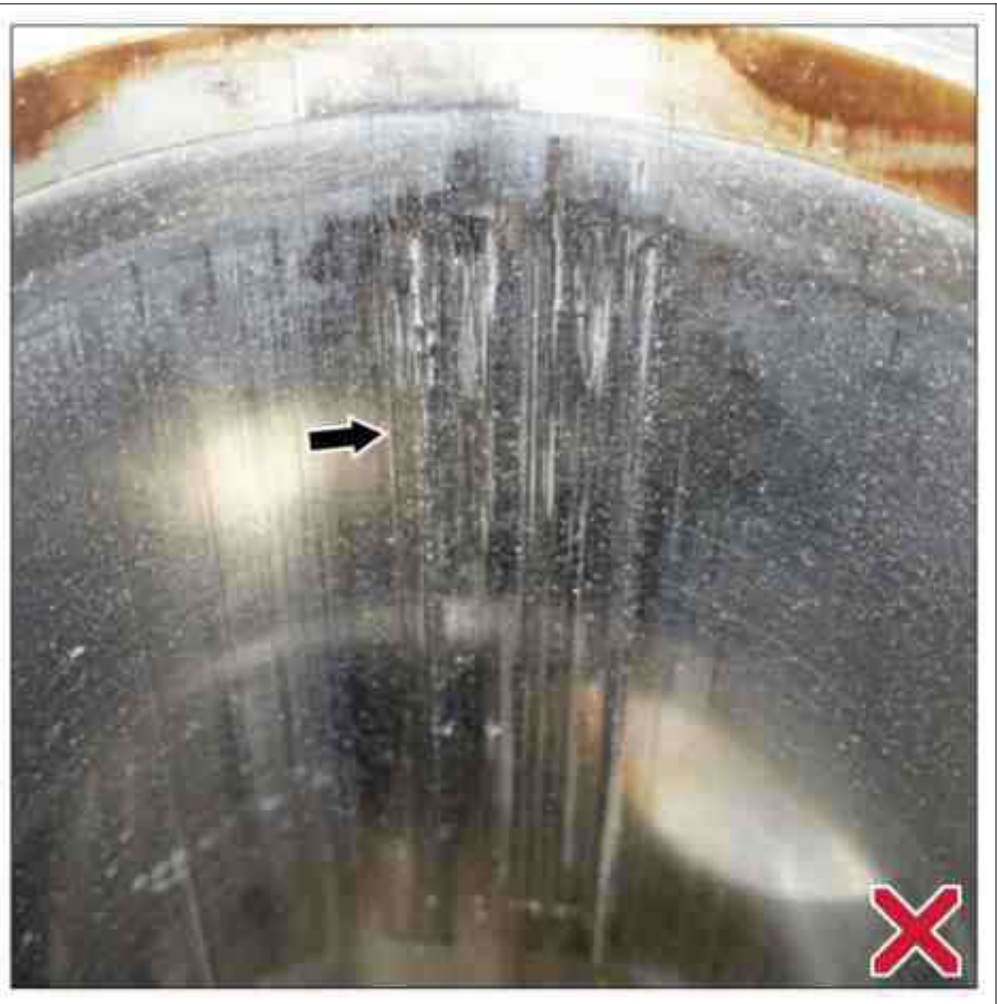
P01.00-3762-79

Piston seizure, ring seizure

Most of cylinder wall perceptibly roughened over the entire length and noticeable seizing marks, cylinder barrel unusable.

i Do not use crankcase again.
