Engine 278

General information for engines with cast-iron cylinder barrels and with Silitec cylinder barrels (aluminum-silicum cylinder barrels), conversion as from March 2015 or as from engine 2789xx 30 266191 for cast-iron cylinder barrels

The following figures and notes are helpful in assessing the cylinder barrels to allow a professional decision to be made about the condition and further use of the crankcase.

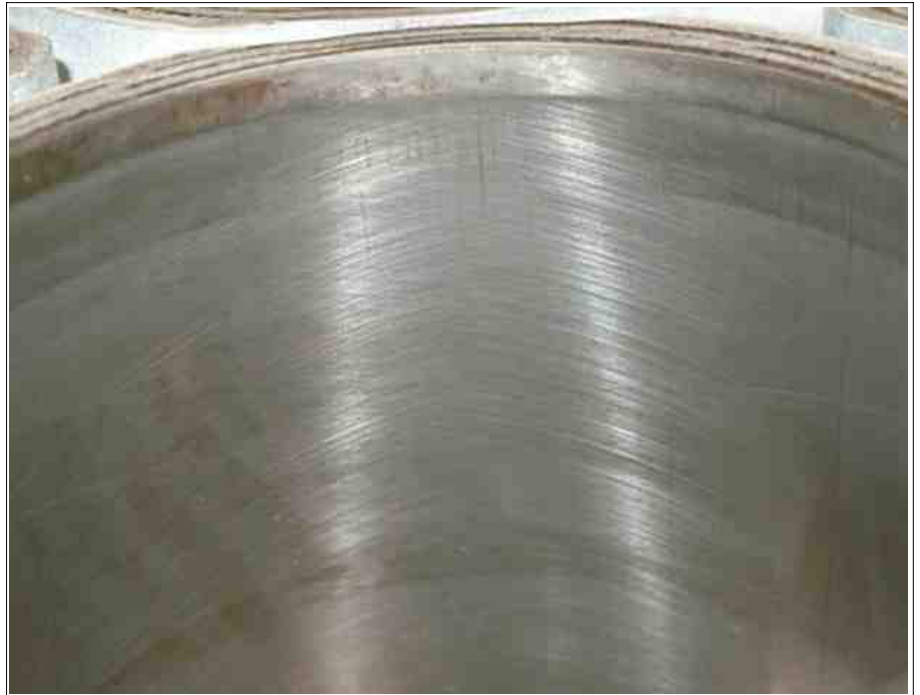
P01.00-3667-76

i A significant degree of scoring in the cylinder barrel with material accumulation can justify an engine replacement. A score mark in the cylinder barrel with significant material accumulation should be documented with representative pictures.

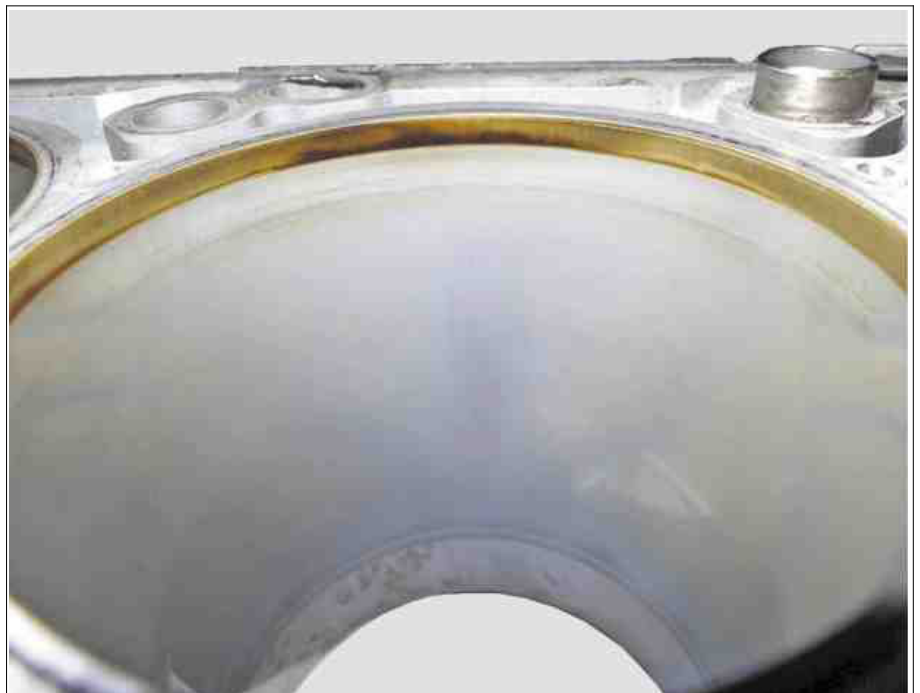
Ideal condition

Matt gray surface, no honing pattern, dry cylinder barrel, no glossy sections or reflecting smooth spots.

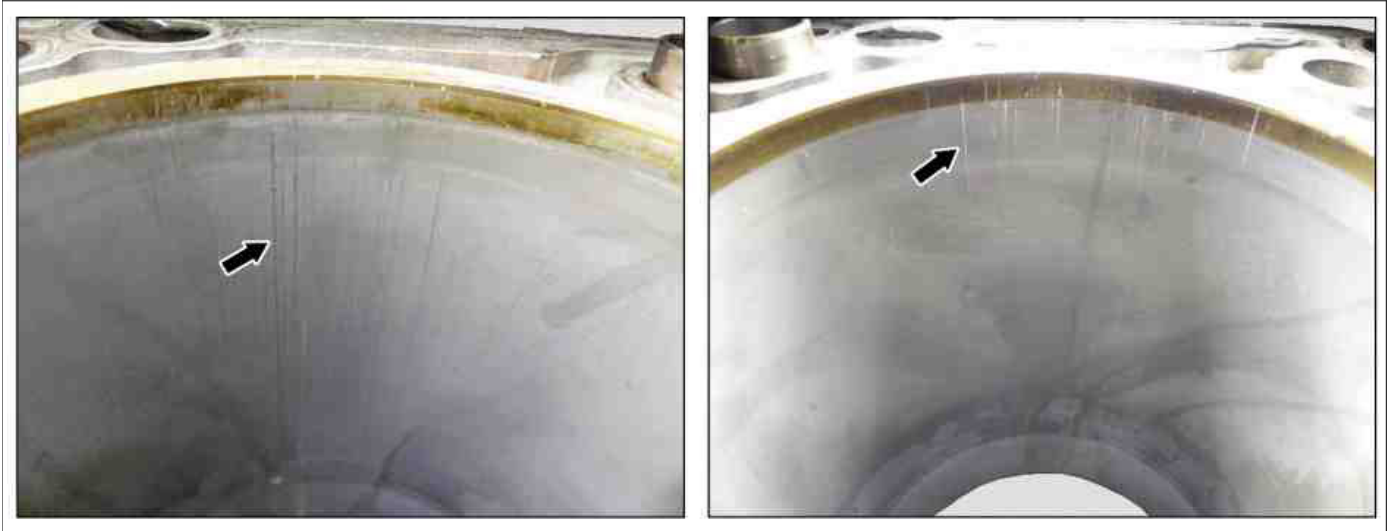
P01.00-3655-78

Individual score marks up fields of score marks

Caused by initial dirt or soiling during operation, e.g. through back pulsation of particles from the catalytic converter or the exhaust system.

Ring shaped imprints

Visible in the upper and lower piston ring reversal area are not a cause for concern.

Reuse crankcase.

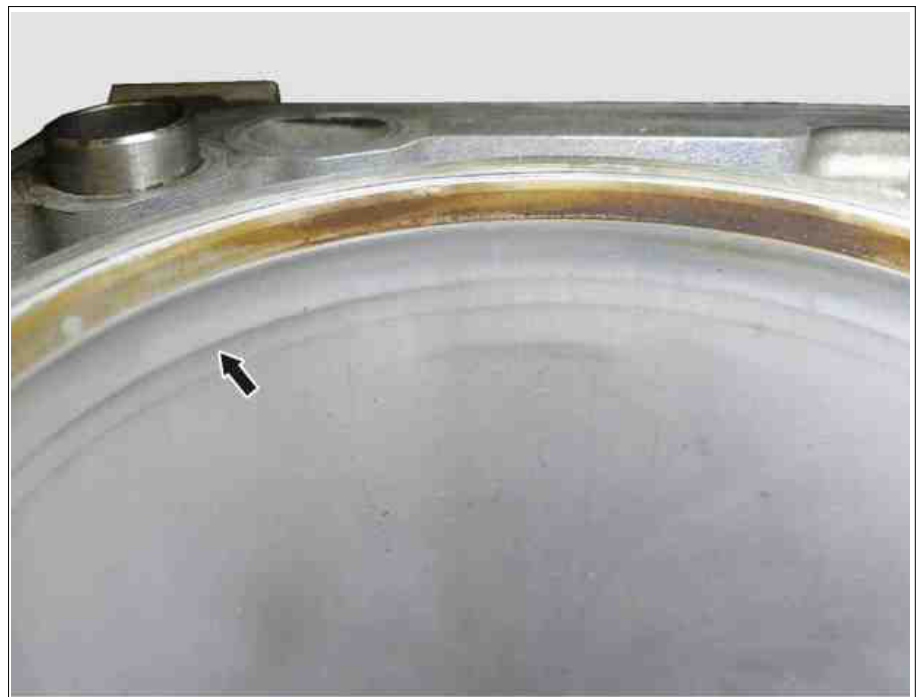
P01.00-3647-76

Little hammer-like structures

Combustion-related or geometric factors that could lead to the ends of piston rings being pressed onto the barrel.

i Reuse crankcase.

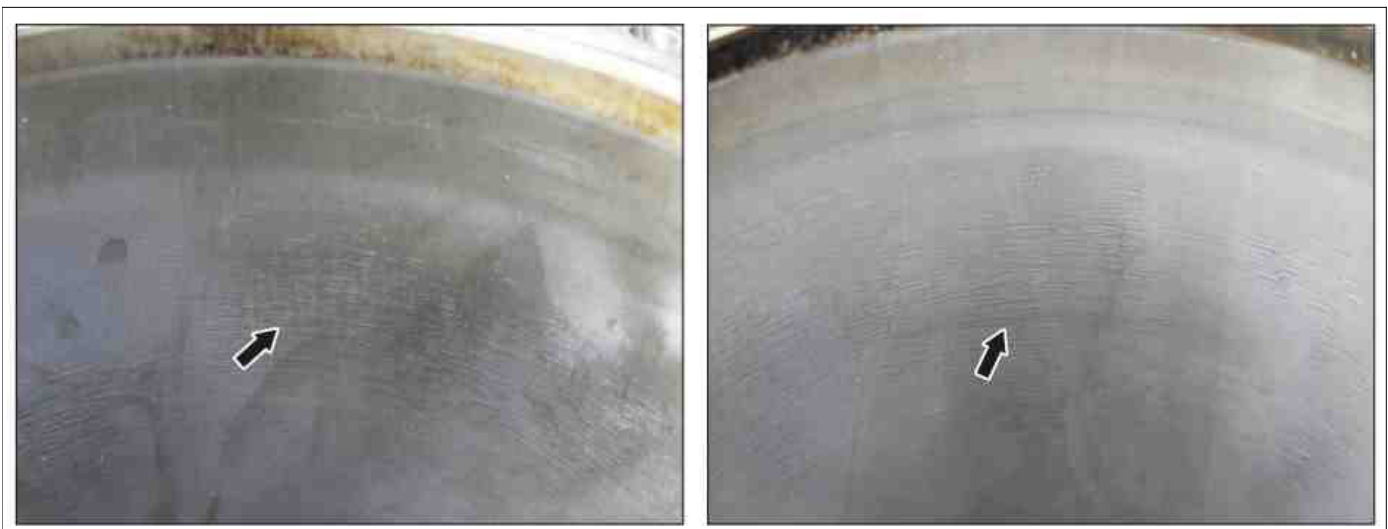
P01.00-3656-78

Brown coloration of cylinder barrel

Brown coloration (oil varnish) over large areas of the cylinder barrel indicates that the engine has been driven at a high temperature level. This is normal and not a cause for complaint.

i Reuse crankcase.

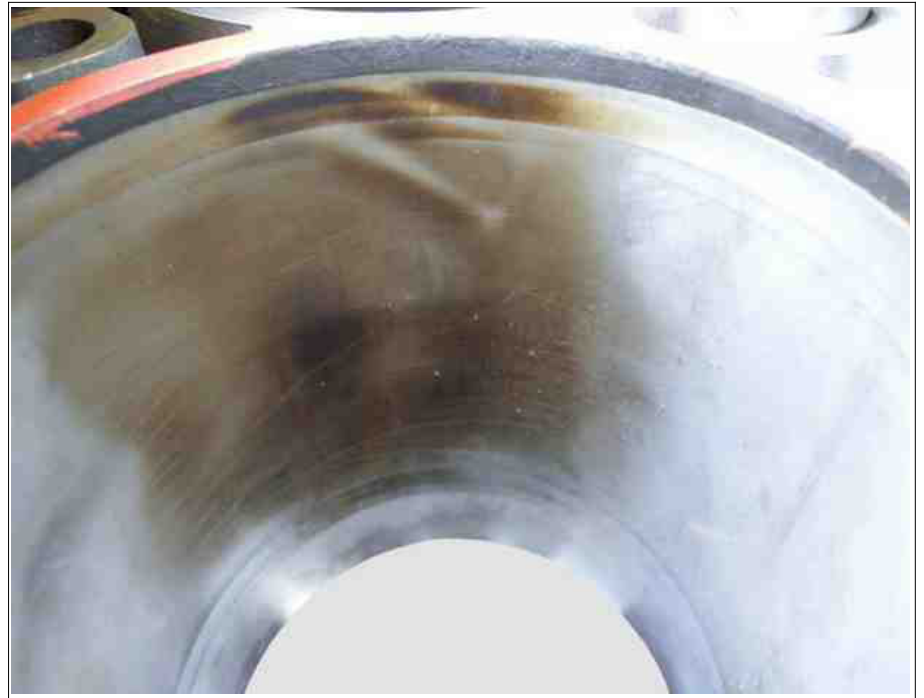
P01.00-3648-76

Glazing, smooth spots

Individual blank points, e.g. in middle of cylinder or in area of cylinder head bolts. Full circle impression at the upper and lower piston ring reversing points.

i Reuse crankcase.

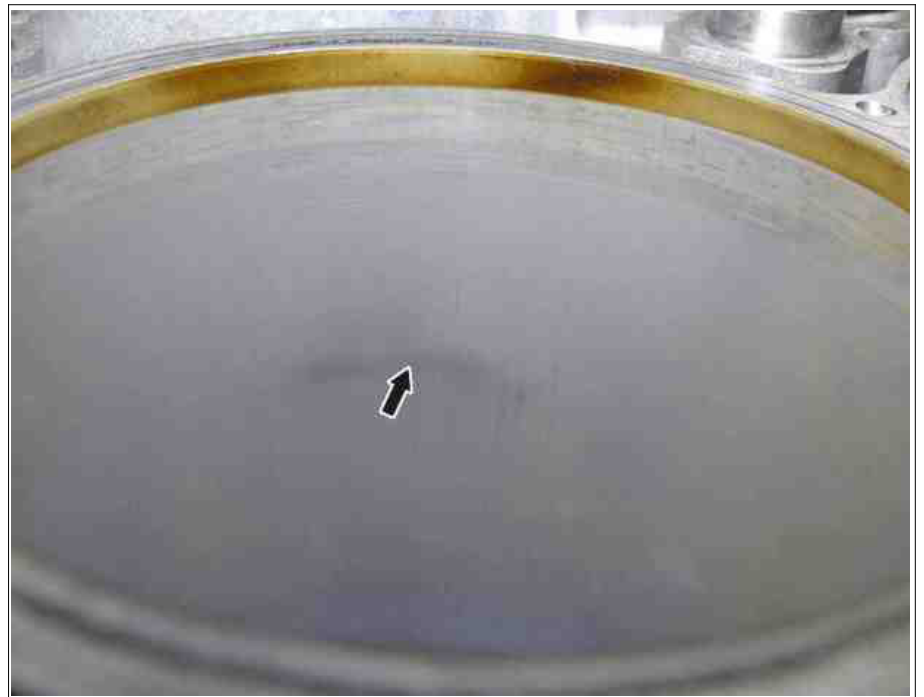
P01.00-3649-76

Optical steaks, friction marks

Starting from first, second or third piston ring, tapering off after approx. 30 mm. Imperceptible friction marks caused by soot particles and the oil film being washed off by fuel, e.g. during frequent cold starts during short-distance driving. These traces of friction marks which occur principally in area of cylinder head bolts and pressure side are not a problem provided they are smoothed.

i Reuse crankcase.

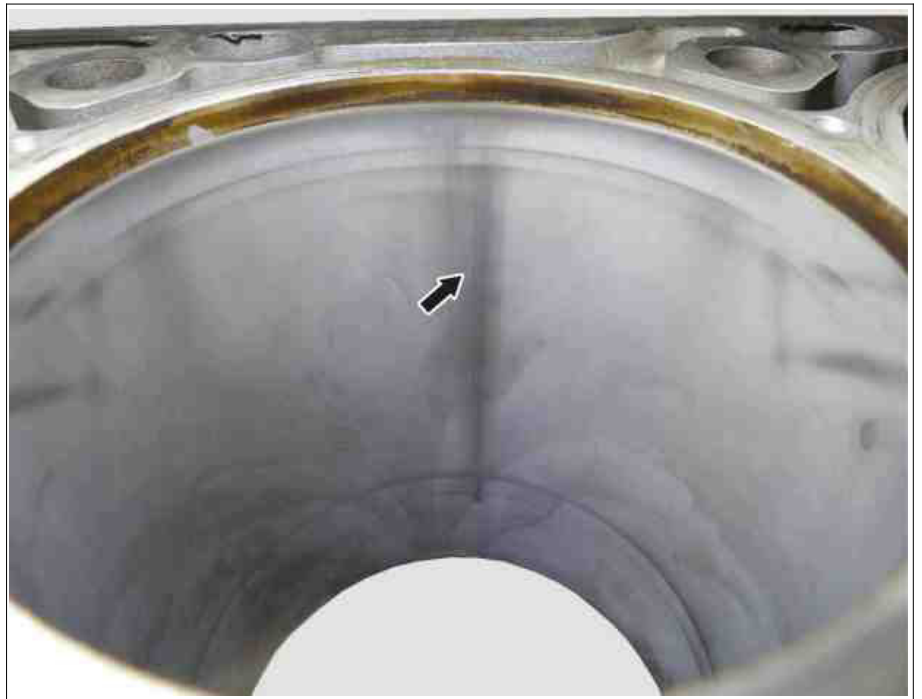
P01.00-3650-76

Noticeable change in valve cooling bore

The cooling bore in the crankcase shows a different coloration to the cylinder barrel.

i Reuse crankcase.

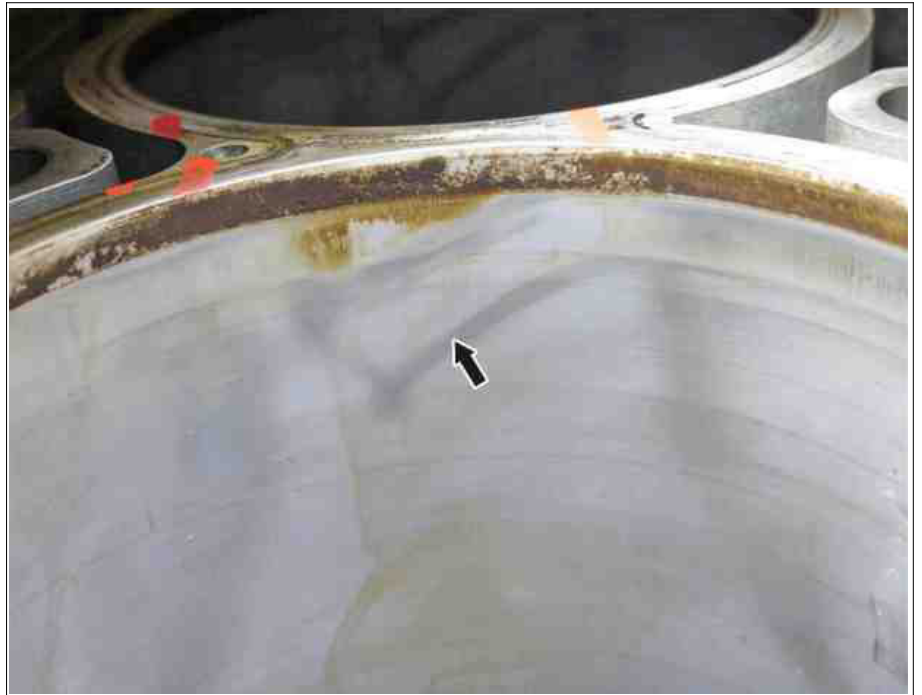
P01.00-3651-76

Corrugated wear of the cylinder barrel

A washboard type surface structure of the cylinder barrel, partially or full perimeter.

i Do not use crankcase again.

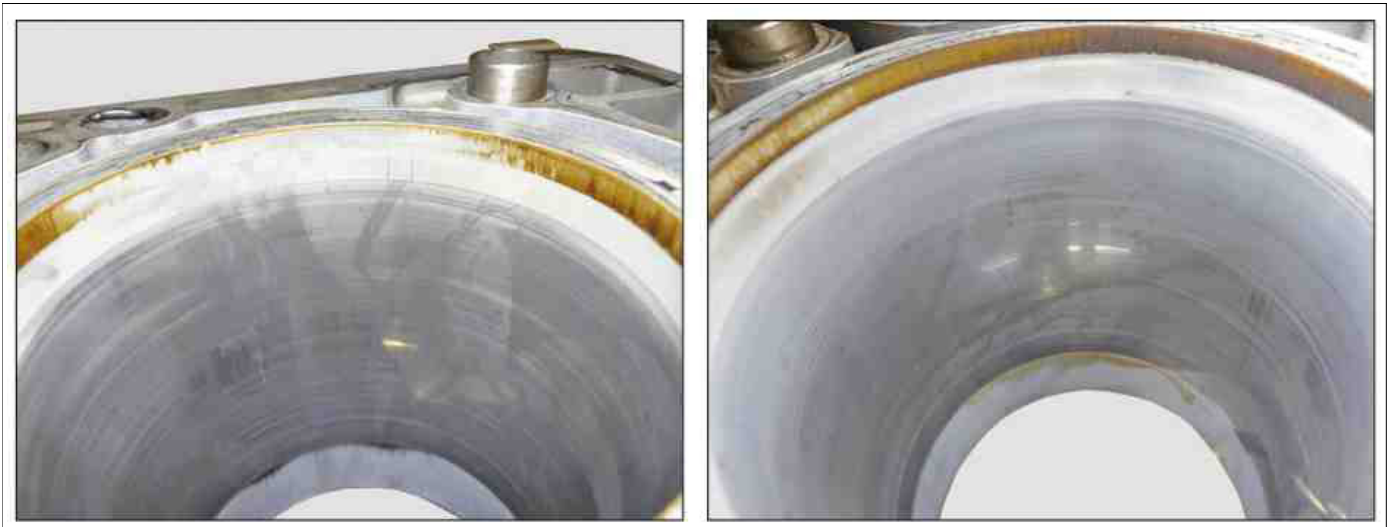
Rough streaks, friction scoring

Starting from first, second or third piston ring, tapering off only in bottom part of cylinder. Friction marks as described under "Optical streaks, friction marks" which have advanced to friction scoring.

i Do not use crankcase again.

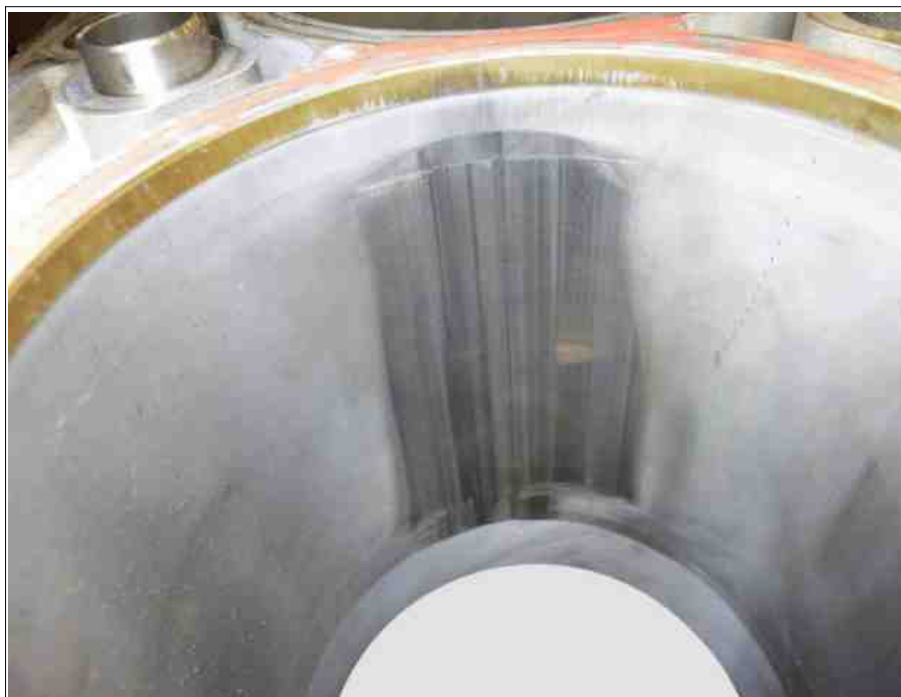
P01.00-3652-76

Piston seizure, ring seizure

Most of cylinder wall perceptibly roughened over the entire length. Material deposits and perceptible scoring marks on cylinder wall and at piston skirt.

Cylinder barrel unusable.

i Do not use crankcase again.

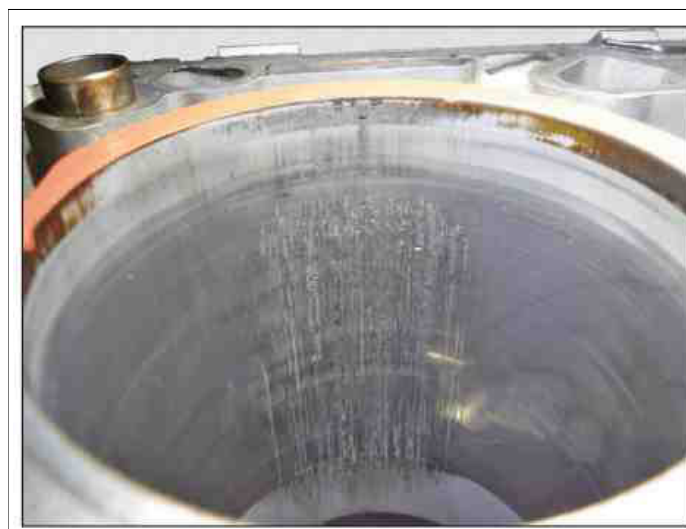
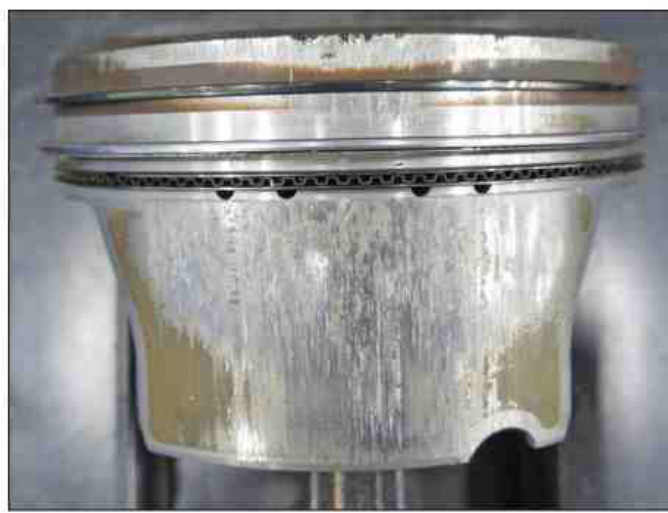
P01.00-3658-78

Defect in cylinder barrel

Defect in barrel of any one cylinder.
Cylinder barrel unusable.

i Do not use crankcase again.

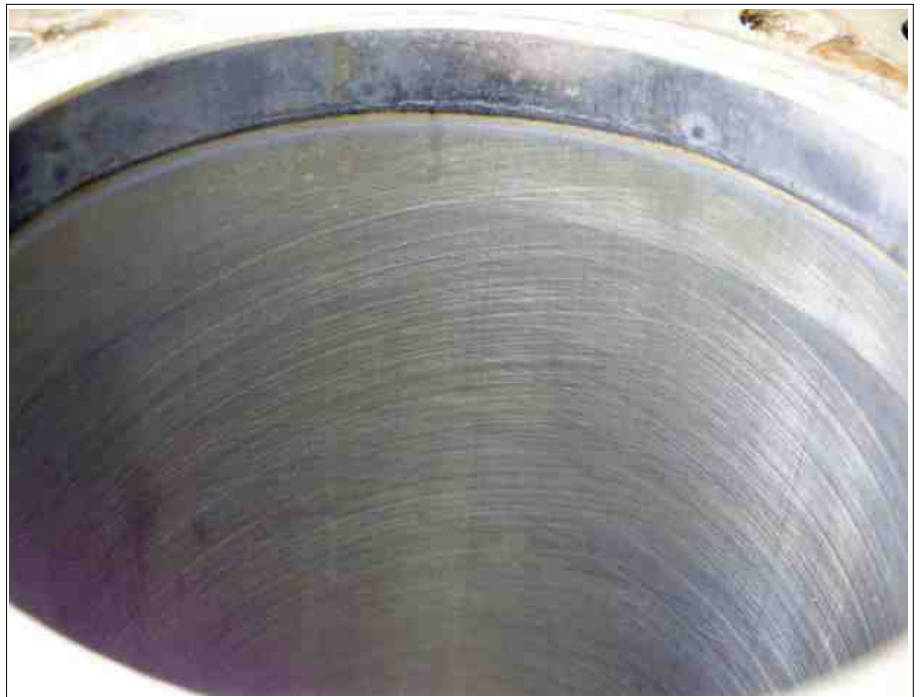
P01.00-3654-76

Glazing, smooth spots

Individual blank points, e.g. in the middle of the cylinder barrel or around the cylinder head bolts.

i Reuse crankcase.

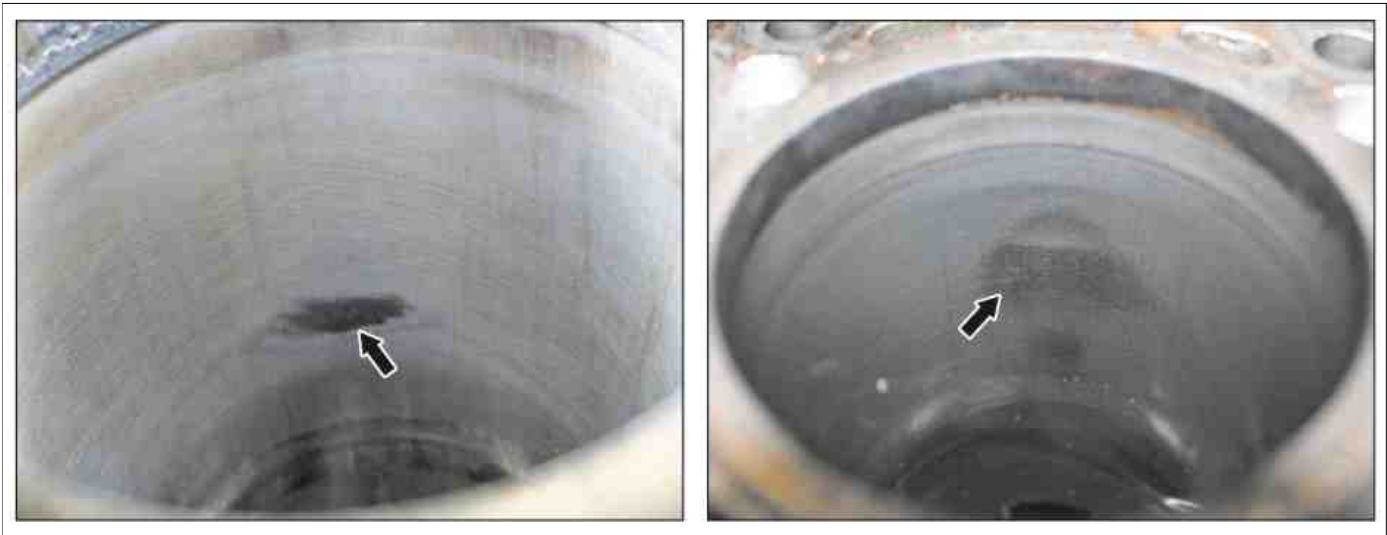
P01.00-3659-78

Continuous individual traces of scratch

Caused by soiling, for example, by the back-pulsation of soot particles from the exhaust system, oil carbon marks. They are imperceptible to the touch.

i Reuse crankcase.

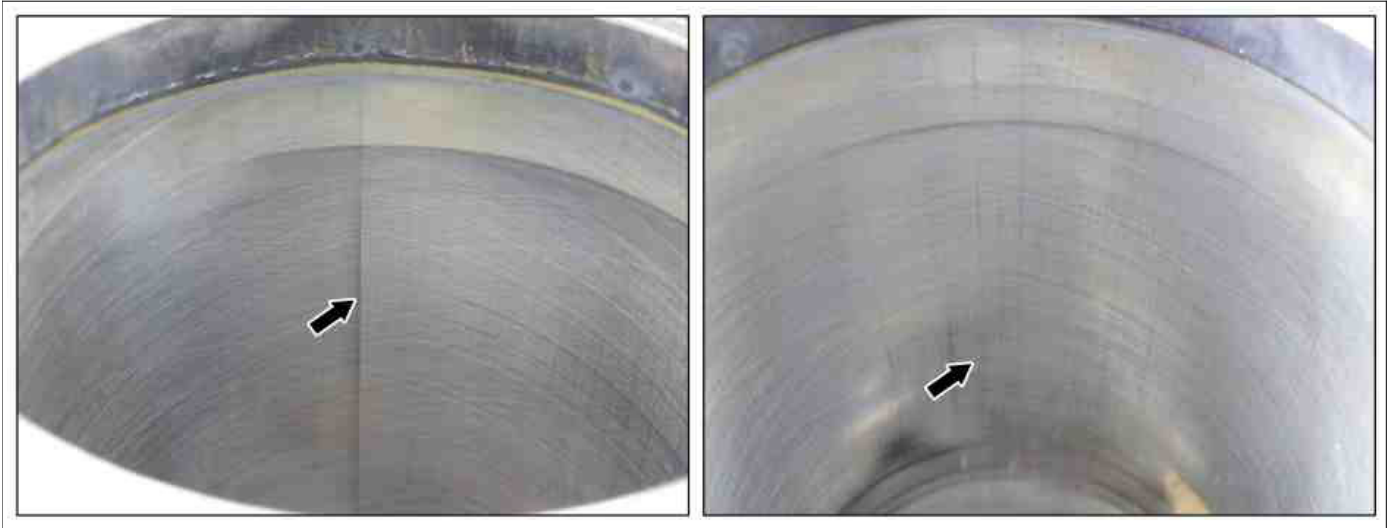
P01.00-3660-78

Brown coloration of cylinder barrel

A brown coloration over large areas of the cylinder barrel is oil varnish and indicates that the engine has been driven at a high temperature level. Oil varnish above piston ring zone is normal and is not a reason for complaint.

i Reuse crankcase.

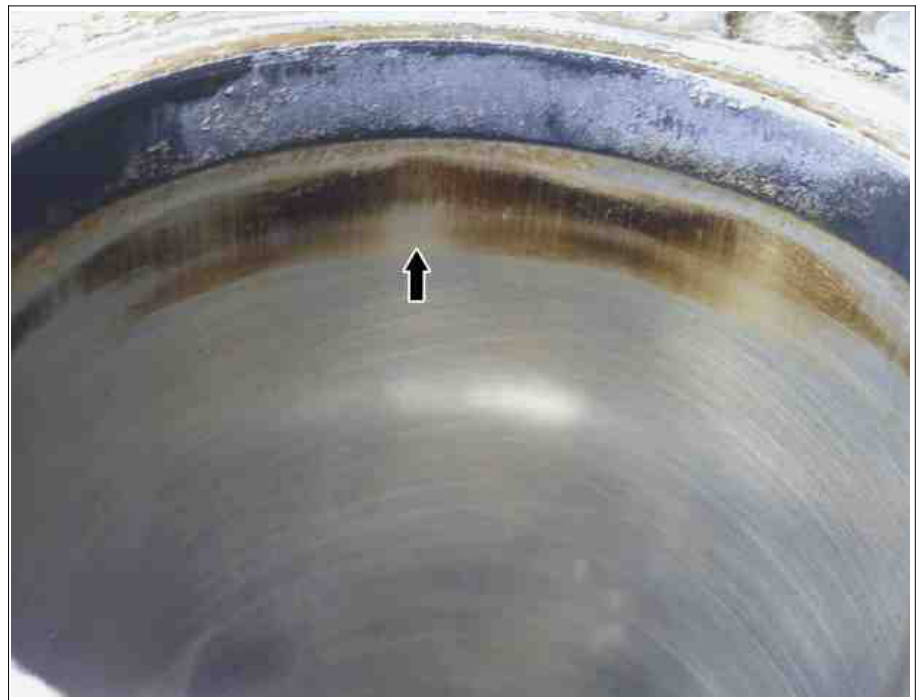
P01.00-3661-76

Visible stripes, friction marks

Starting from reverse area of the upper piston ring tapering downwards. Friction marks that are imperceptible to the touch, caused by oil film being washed off by fuel, the piston rings are not damaged.

i Reuse crankcase.

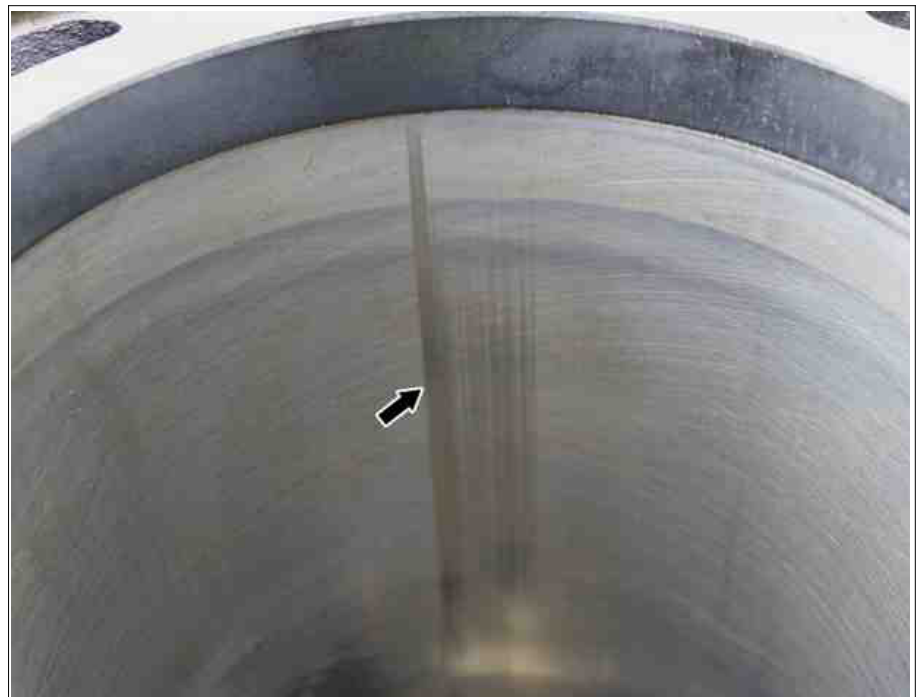
P01.00-3662-76

Ring shaped imprints

Visible imprints on cylinder barrel in the upper and lower reverse area of piston rings are not a cause for complaint.

Reuse crankcase.

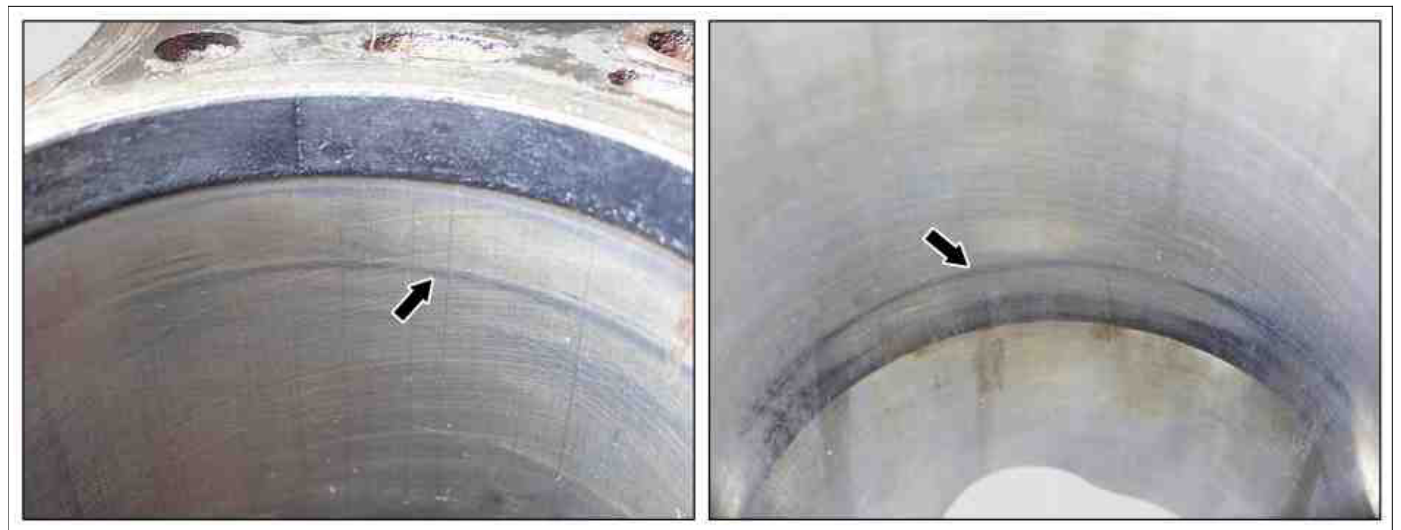
P01.00-3663-78

Rough streaks, friction scoring

Starting from first and second piston ring, tapering to an end only in bottom part of cylinder. Progressive signs of friction lead to friction score marks.

Where these signs of friction are perceptible, the cylinder barrel is unusable. The piston rings may be damaged.

Do not use crankcase again.

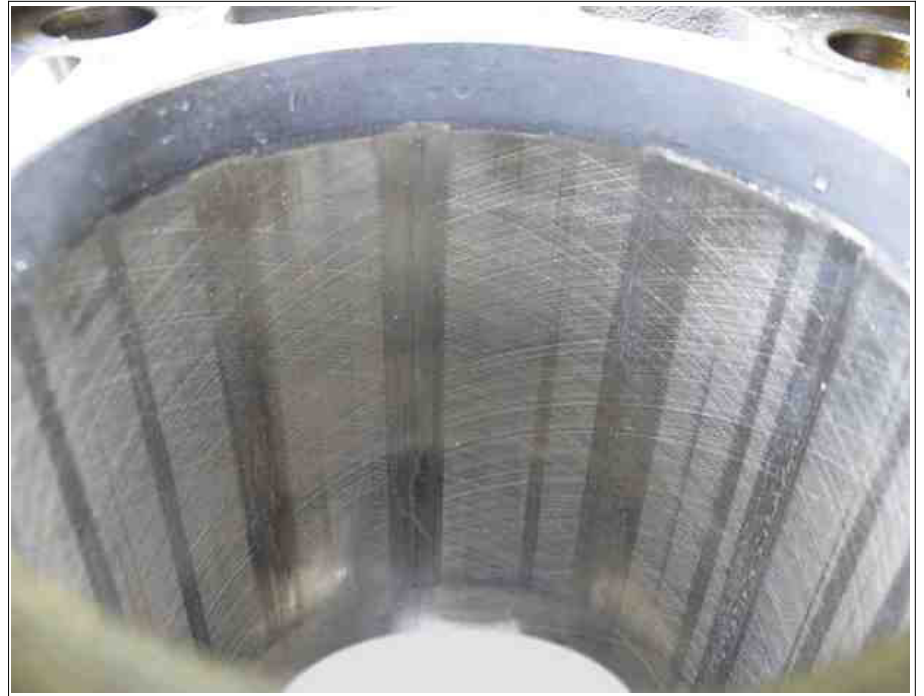
P01.00-3664-76

Piston seizure

Most of cylinder wall perceptibly roughened over the entire length.

Material deposits and perceptible scoring marks on cylinder wall and at piston skirt.

Do not use crankcase again.
