## **Service Campaign Bulletin**

Campaign No. 2017120010, August 2018

SUBJECT: MY17-18 E-Class (213) and GLC-Class (253)

**Check Air Suspension Struts**

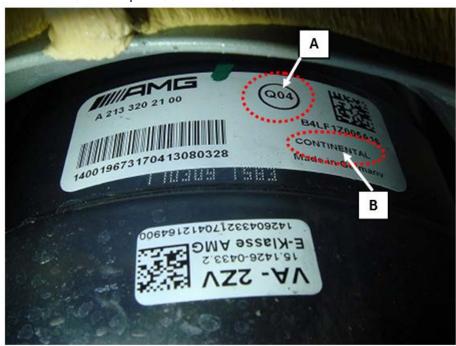
Figure 1

- 1. Lift vehicle with vehicle lift.
- 2. Check Q-status (A, figure 1) on the left and right air suspension strut.
  - The Q-status (A, figure 1) is located on the adhesive label directly on the air spring, recognizable by the supplier name "Continental" (B, figure 1)
    - a. Q-status Q4 or Q5: Perform work procedure.
    - b. Q-status up to Q3 or from Q6: End measure

- 1. Replace the air suspension struts of the front axle (AR32.25-P-1017LWL).
- in the case of complaint, both suspension struts must be replaced.
- Due to the risk of damage, leave all protective caps on the suspension struts until the final assembly or threaded connection of the suspension strut. When tightening the pressure connection (position 11 of suspension strut (2) in WIS document), pay attention to tightening torque and **do not overtighten the threaded connection**, as leaks may otherwise occur.
