Service Campaign Bulletin

Campaign No. 2017100008, November 2017

SUBJECT: **Check Camshaft Cover, Adjust if Necessary**
Models 172, 205, 213, 253 model year 2018

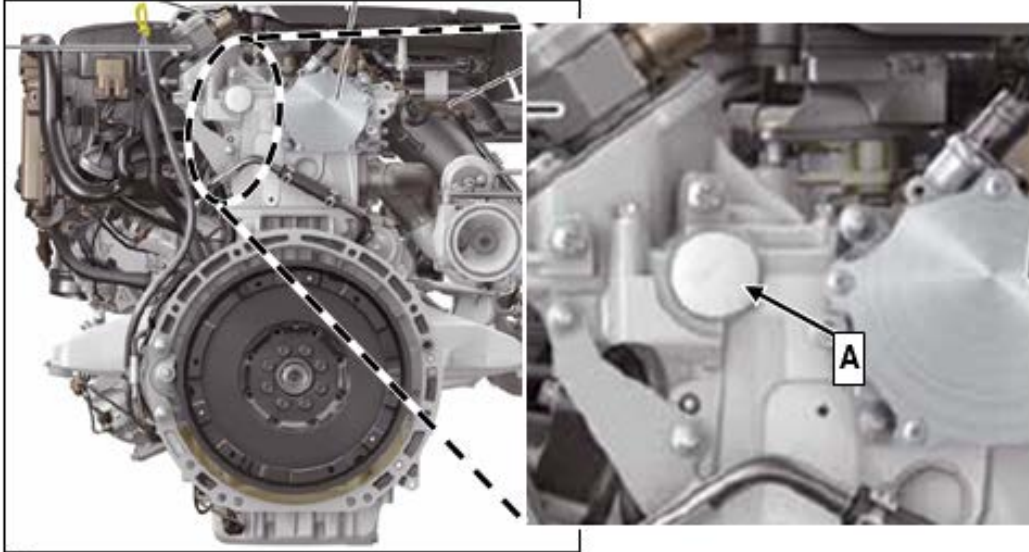
Figure 1

1. Open hood and check cover (A, figure 1) of camshaft.

i The cover **must** be flush **all-round** in the cylinder head housing.
If necessary, press on cover again using a suitable plastic wedge (1, figure 2).
The replacement of the cover is **not** required!
