MODEL 211

P42.45-2331-06

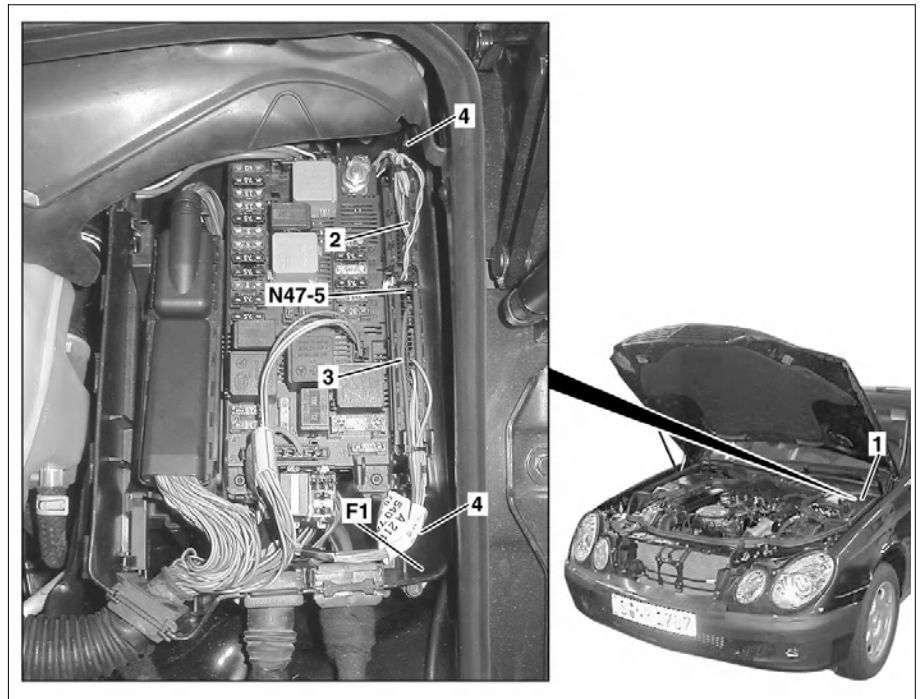
- 1 Cover
 2, 3 Electrical plug socket
 4 Detent
- F1 Fuse and relay box
 N47-5 ESP control unit

☒ ☒	Remove/install		
ⓘ	Notes on avoiding damage to electronic components due to electrostatic discharge		AH54.00-P-0001-01A
1	Remove the left cover in the engine compartment	Vehicles as of 06/06	
2	Remove cover (1) of the fuse and relay box (F1)	i Installation: Check rubber seal in cover (1) and replace if necessary. The cover (1) must seat in the rear of the groove.	
3	Unlock and unplug electrical plug-in couplings (2, 3).		
4	Unlock the catches (4) and remove ESP control unit (N47-5) upwards.		
5	Install in the reverse order		
6	Read out diagnostic trouble code memory using STAR DIAGNOSIS and erase if necessary	STAR DIAGNOSIS diagnosis system	*WH58.30-Z-1048-13A
