## star bulletin

Date:	December 11, 2014
Order No.:	S-B-42.10/123a
Supersedes:	S-B-42.10/123, June 3, 2013
Group:	42

## Version a: Text added. SUBJECT: MY-All, Models All

## **Cleaning Axle Hubs When Installing Brake Discs**

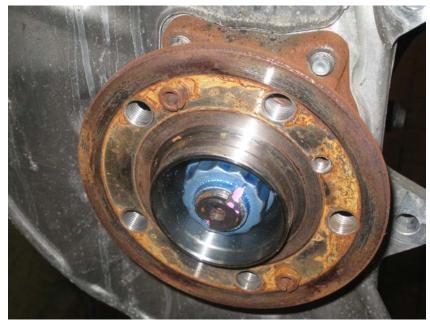
## Figure 1.

It is imperative that when installing brake discs (front or rear) the excessive corrosion / scaling (Figure 1), which may have developed on the axle hub, be removed. Use the "ATE Teves Hub Cleaning Kit" released via automatic delivery to remove the corrosion / scaling over the entire area where the brake disc mounts to the hub flange.

Failure to remove the corrosion / scaling may cause an excessive build-up which can create adverse forces that may result in brake vibrations / judder.

**i** Note: Please reference Special Tools & Equipment Newschannel update dated November 12, 2014 for further information regarding the "ATE Teves Hub Cleaning Kit".
