# Shimming Trailing Arm

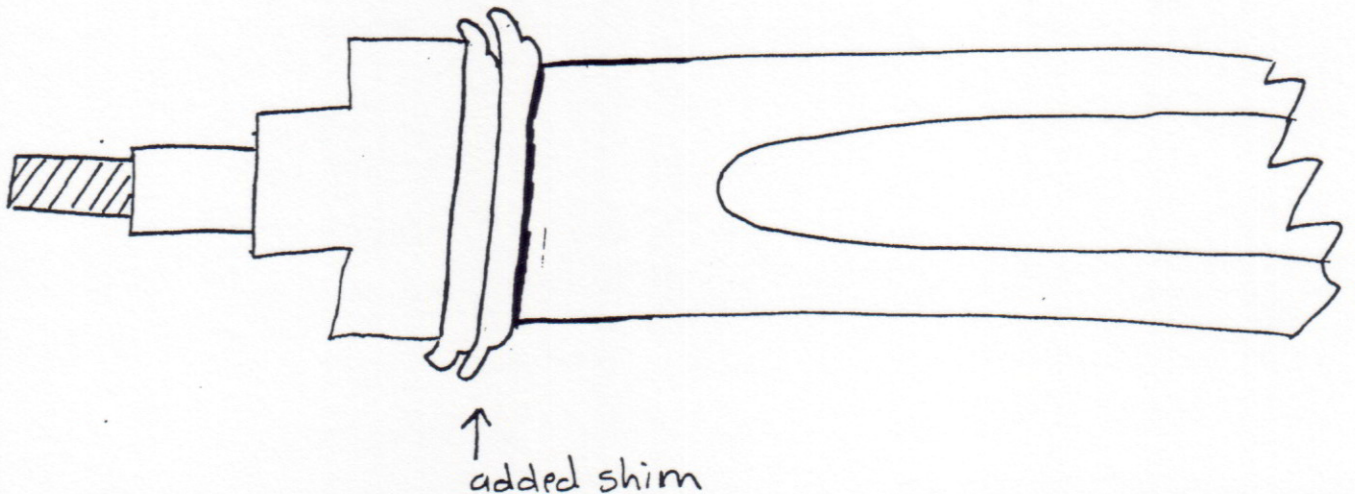
1. With vehicle on a lift, support the Front axle on the right side.
2. Remove the trailing arm.
3. Install a shim (460 352 02 76) as shown in picture below.
4. Reinstall the trailing arm adhering to the torque specifications as supplied on following page.
5. Test drive vehicle for pull. If a pull to the right is still present, shim the RR trailing arm and check the pull for resolution.
6. Check and correct Toe adjustment if necessary.

The pulling right symptom has occurred on some Gwagens in the past. After checking the basics of the system (tire pressure, alignment, and switching tires right to left \*directional tires must be dismounted off of the rim to maintain direction), the following is the next step to perform. **NOTE:** If the vehicle has a drastic pull to the right, the Right Rear trailing arm may need to be shimmed too.
