MODEL 463.243 /244 /245 /246 /247 /249 /270 /271 /322 /323 /332 /333

MODEL 463.248 except CODE (979) Special protection version

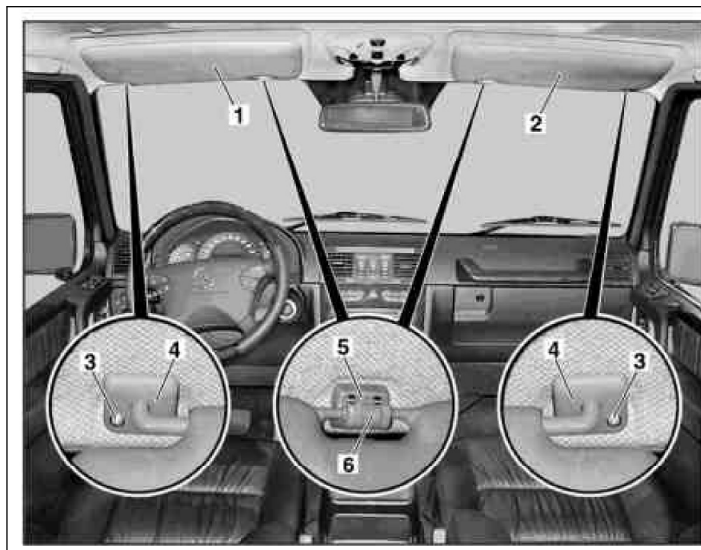
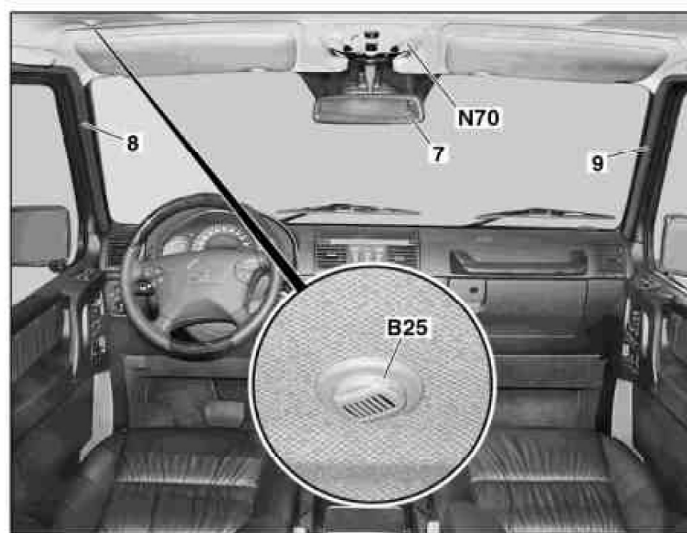
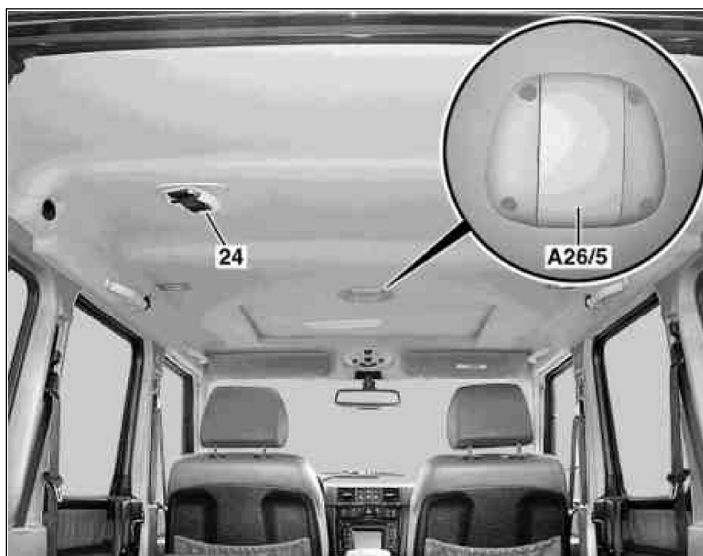
P68.30-2426-08

- 1 Left sun visor  
2 Right sun visor  
3 Bolt  
4 Bracket

- 5 Bearing  
6 Cover  
7 Interior rearview mirror  
8 Left A-pillar paneling

- 9 Right A-pillar paneling  
B25 Hands-free system microphone  
N70 Overhead control panel control unit

- 24 Belt guide  
A26/5 Interior motion sensor transmitter and receiver

</p>	<p><b>Risk of explosion</b> caused by oxyhydrogen gas. <b>Risk of poisoning and caustic burns</b> caused by swallowing battery acid. <b>Risk of injury</b> caused by burns to skin and eyes from battery acid or when handling damaged lead-acid batteries</p> <p>Disconnect battery ground line</p> <p>Notes on battery</p>	<p>No fire, sparks, open flames or smoking. Wear acid-resistant gloves, clothing and safety glasses. Pour battery acid only into suitable and appropriately marked containers.</p> <p>All models</p>	<p>AS54.10-Z-0001-01A</p> <p>AR54.10-P-0003G</p> <p>AH54.10-P-0001-01A</p>
7	Pivot left sun visor (1) and right sun visor (2) to side and unscrew bolts (3) from corresponding brackets (4)		
8	Remove left sun visor (1) and right sun visor (2)

Disconnect electrical connectors	
9	Remove bearing (5) from left sun visor (1) and right sun visor (2)

The bolt is located behind the cover (6) which can be folded downward

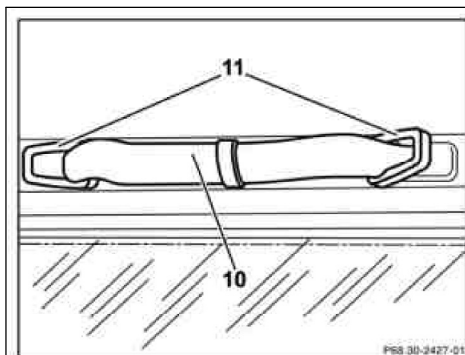
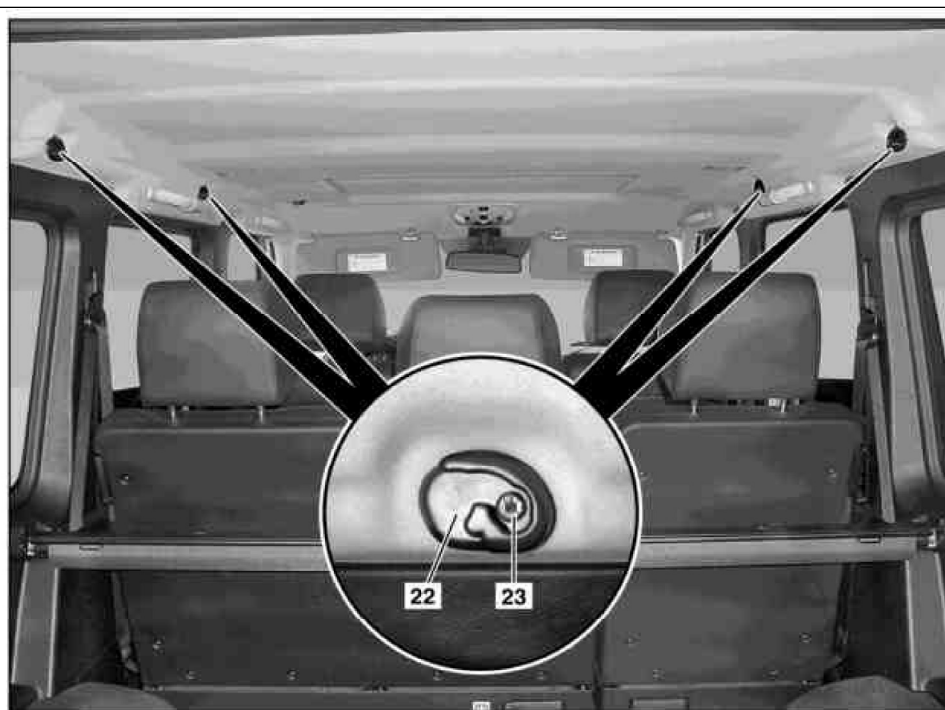
P68.30-2574-09

- 10 Grab handle
- 11 Cover

- 22 Cargo retaining net bracket
- 23 Bolt

19	Remove grab handles (10)

Slide back covers (1) and remove bolts	
20	Remove cargo retaining net bracket (22)

Remove bolt (23).	
21	Remove rear compartment reading lamps		AR82.20-P-1120GR
22	Remove interior motion sensor transmitter and receiver (A26/5)

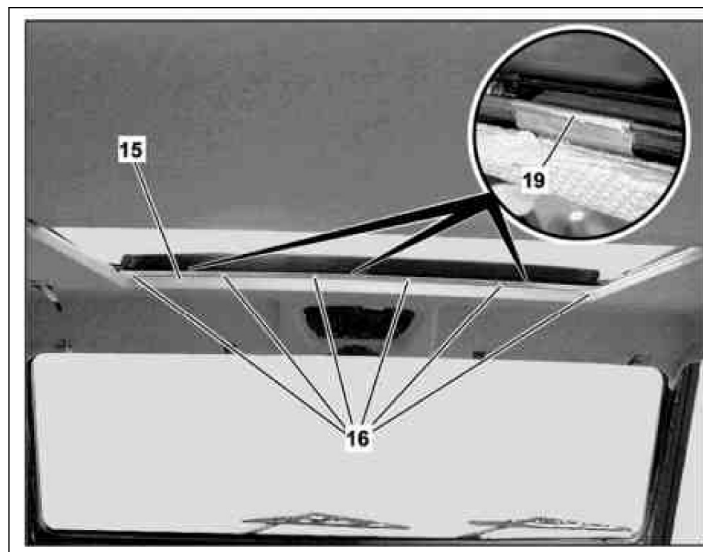
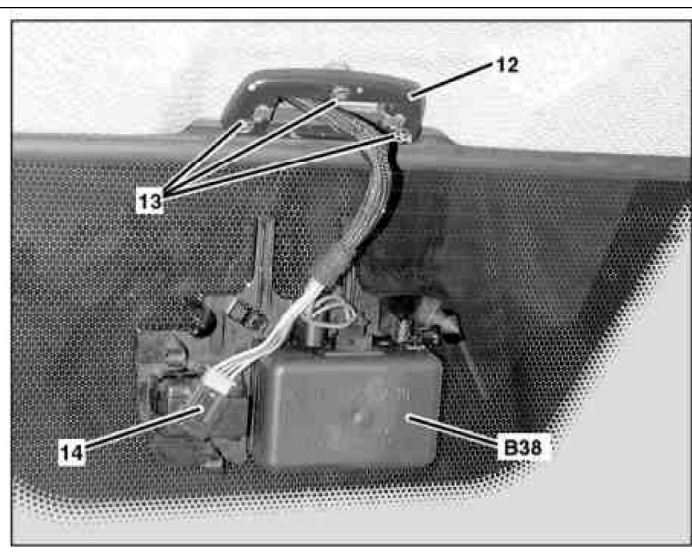
P68.30-2428-08

- 12 Inside rearview mirror bracket
- 13 Bolt
- 14 Electrical connector

- 15 Chrome molding
- 16 Bolt
- 19 Sheet metal clip

- B38 Rain sensor

10	Remove overhead control panel control unit (N70)		AR82.20-P-1000GM
11	Remove inside rearview mirror (7)		AR68.40-P-0001GM
12	Disconnect electrical connector (14) from rain sensor (B38)		
13	Remove inside rearview mirror bracket (12)

Remove bolts (13).	
14	Remove hands-free system microphone (B25) from headliner (21)

The chrome molding (15) is fastened with six bolts (16)	
24	Remove bolts (17) from both guide rails (18)

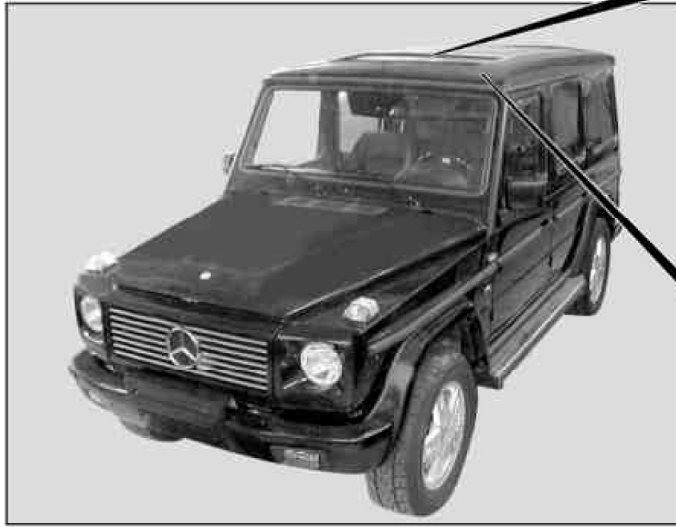
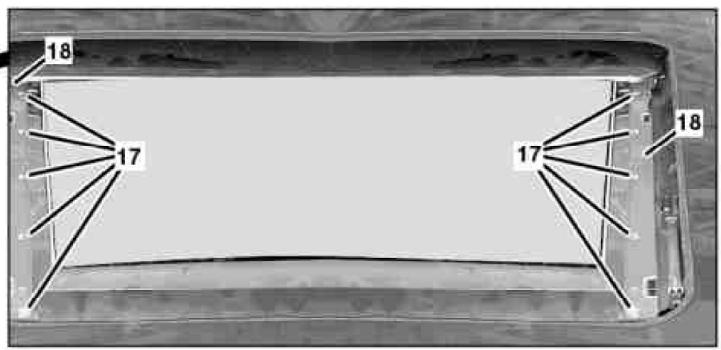
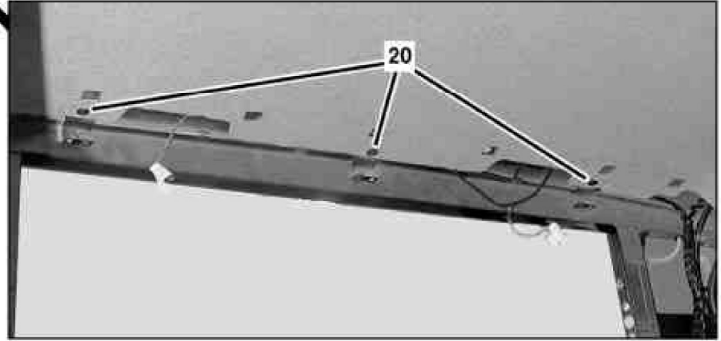
P68.30-2429-09

- 17 Bolt
- 18 Guide rail

- 20 Bolt

Shown on model 463.248

- 19 Sheet metal clip
- 21 Headliner

Only electric tilting/sliding roof, code D27	
25	Remove guide rails (18) and coverings beneath

To do this, detach the sheet metal clips (19).	
28	Unscrew bolts (20) from headliner (21)		
29	Separate Velcro strips (arrows) between outer roof surface and headliner (21)
