Shown on model 164.8 with engine 629

Front end assembly with front reinforcement

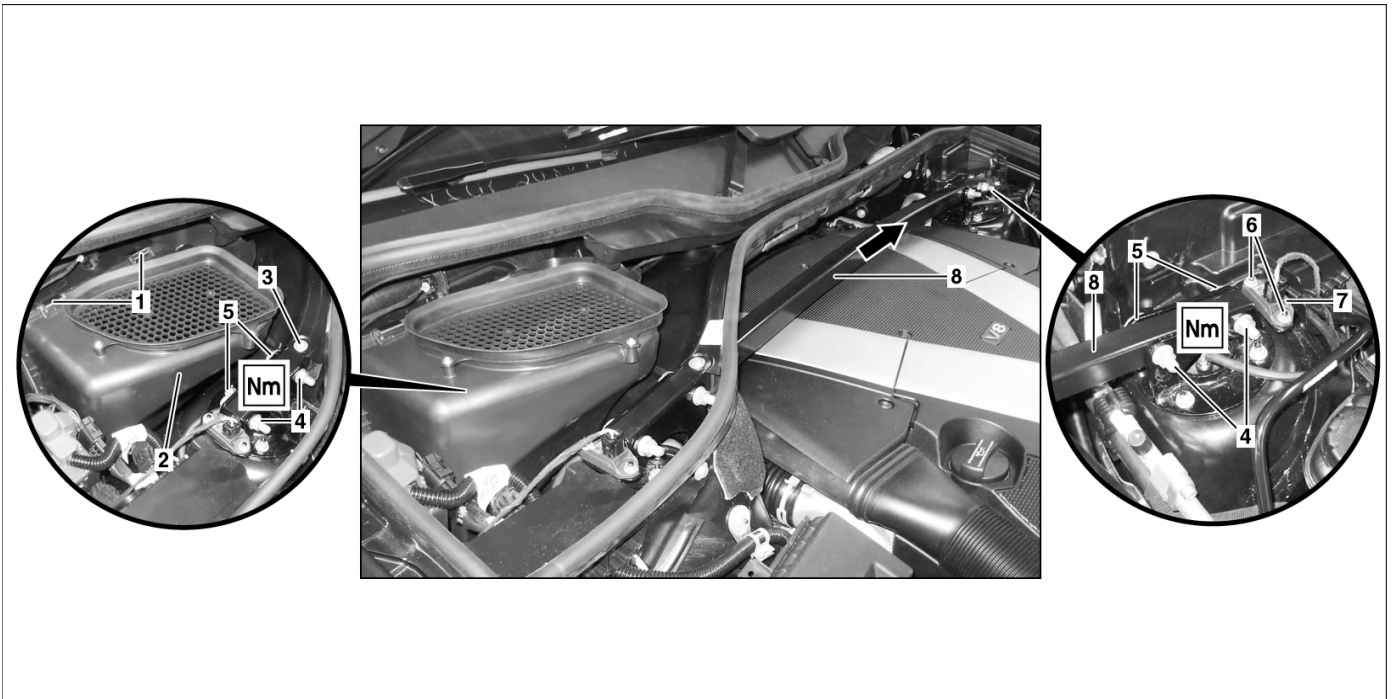
P62.30-2913-09

| 1 | Clips | 5 | Bolts |
| 2 | Air conditioning air inlet | 6 | Nuts |
| 3 | Screw | 7 | Left ADS sensor bracket |
| 4 | Nuts | 8 | Strut tower brace |

Remove/install		
1	Open engine hood		AR88.40-P-1000GZ
2	Loosen clamps (1), remove air conditioning air inlet (2) upward	i Installation: Bottom lug on air conditioning air inlet (2) should reach into corresponding guide.	
3	Unscrew nuts (6), place left ADS sensor bracket (7) to one side	i Do not disconnect left ADS sensor (7) electrically.	
4	Remove bolt (3)		
5	Unscrew nuts (4)	Nm	*BA62.30-P-1005-02D
6	Remove bolts (5) toward rear	i Installation: Wax bolted connections.	*BR00.45-Z-1018-05A
7	Slightly raise strut tower brace (8) on left side and remove left toward (arrow)	i Installation: Check whether rubber seal, through which the strut tower brace (8) runs, is correctly seated.	
8	Install in the reverse order
