Recall Campaign Bulletin

Model X253 Model Year 2018

Seatbelt Latch Plate

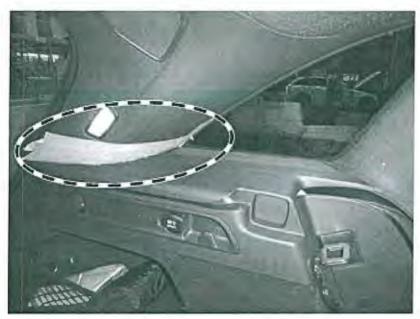
Figure 1

- 1 The operation steps must be performed on both sides of the vehicle.
- 1. Release and remove luggage compartment cover.
- 2. Mask off D-pillar trims in trunk on both sides (Figure 1).

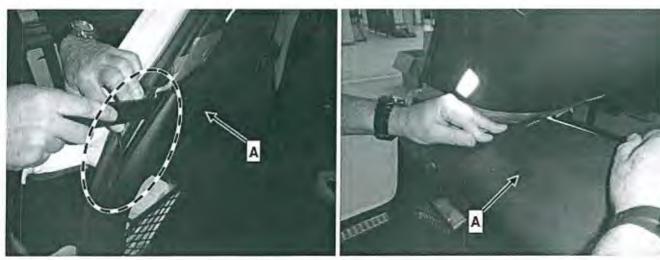
Figure 2 Figure 3

- 3. Release trunk linings (A, figure 2) at rear left and right on D-pillar using plastic wedge and manually unclip in upper area (figure 3).
- Press edge guard (figure 2) only slightly to side.

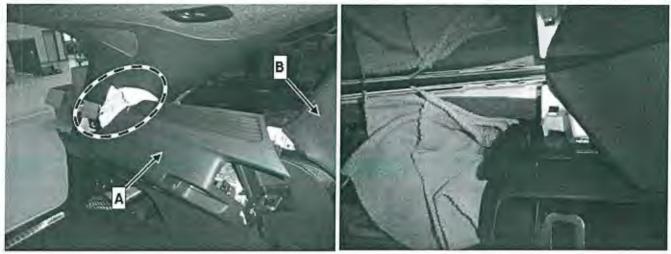
Figure 4 Figure 5

4. Place rag between D-pillar (figure 4) and trunk lining and cover seat belt (figure 5).

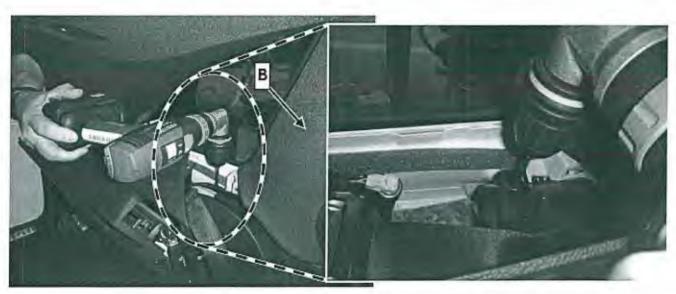
Figure 6

5. Drill hole (Ø 4.5 mm) at bottom in trim on C-pillar (B, figure 6). (Use new pointed drill bit.)

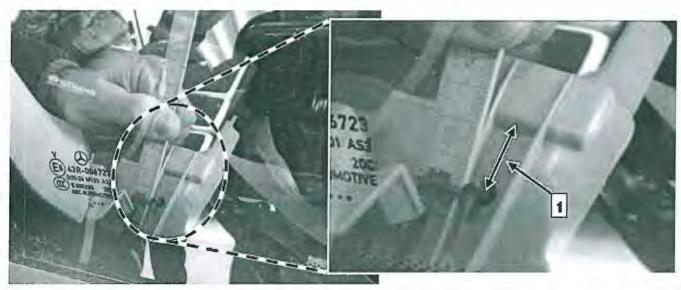
Figure 7

Remove seat belt from drilling area. Clearance (1, figure 7) approx. 23 mm at center.

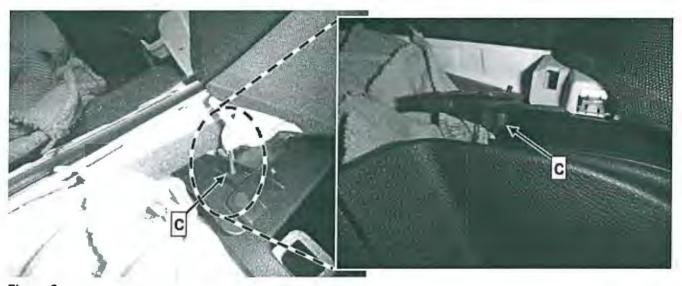
Figure 8

6. Insert protective padding (C, figure 8) from underneath upward into previously drilled hole.

Install protective padding (C) with lubricant if necessary.

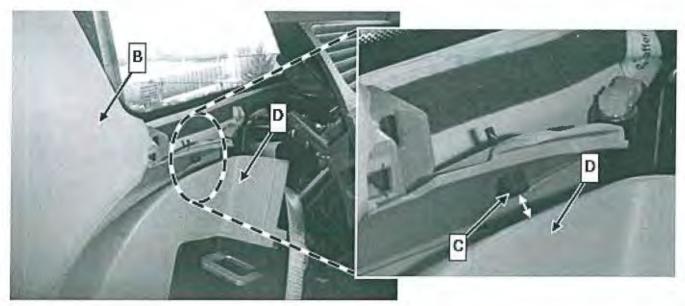
Figure 9

- 7. Check the distance (figure 9) between the protective padding (C) and side paneling (D).
- Use a feeler gauge like the one shown in (figure 10 and 11)
- i Protective padding (C) must be installed!
- The distance must not be greater than 9 mm.
- If the distance is 9mm or less as seen in (figure 10) reassemble in reverse order.
- If the distance is more than 9mm as seen in (figure 11) continue to step 8.

8. Remove the C-pillar (B, figure 9) trim, cut the centering pin off (E, Figure 12)

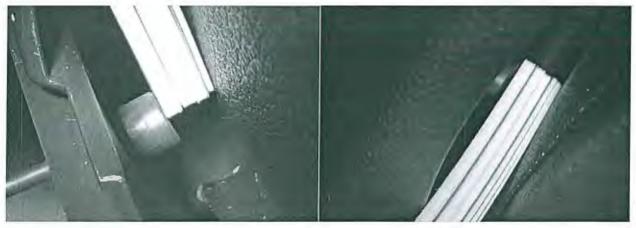
Figure 10 (OK)

figure 11 (Not OK)
