TO: Mercedes-Benz Dealer Principals, General Managers, Sales Managers, Service Managers, Parts Managers	FROM: Thomas Brunner, Department Manager, Vehicle Compliance and Analysis, Engineering Services
RE: Recall Campaign with Retail Hold 2017050023 Passenger 2017050024 Driver 2017050025 Driver & Passenger MY17 253 (GLC-Class) Front Seatbelt Pretensioner Igniter	DATE: June 9, 2017

SUBJECT: **Model 253, Model Year 2017**
Replace Right Front Seat Belt

SUBJECT: **Model 253, Model Year 2017**
Replace Left Front Seat Belt

SUBJECT: **Model 253, Model Year 2017**
Replace Left and Right Front Seat Belts

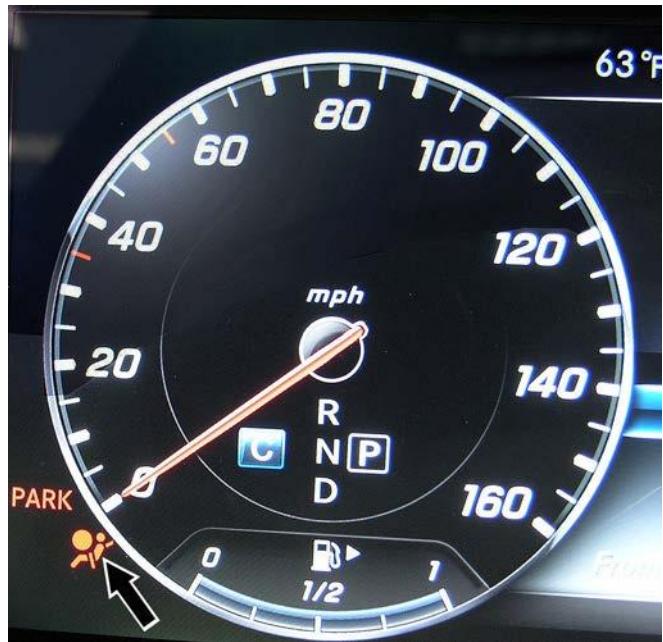
Figure 1 (shown on model 213)

1. Start engine and check whether Supplemental Restraint System (SRS) indicator lamp (arrow, Figure 1) goes out after a few seconds.

- Ensure seat belt is not twisted.
 - Ensure that all applicable steps in the referenced WIS instructions are completed.
5. **Speaker icon** After installation of new seat belt be sure to start engine and check whether SRS indicator lamp goes out after a few seconds (arrow, Figure 1).

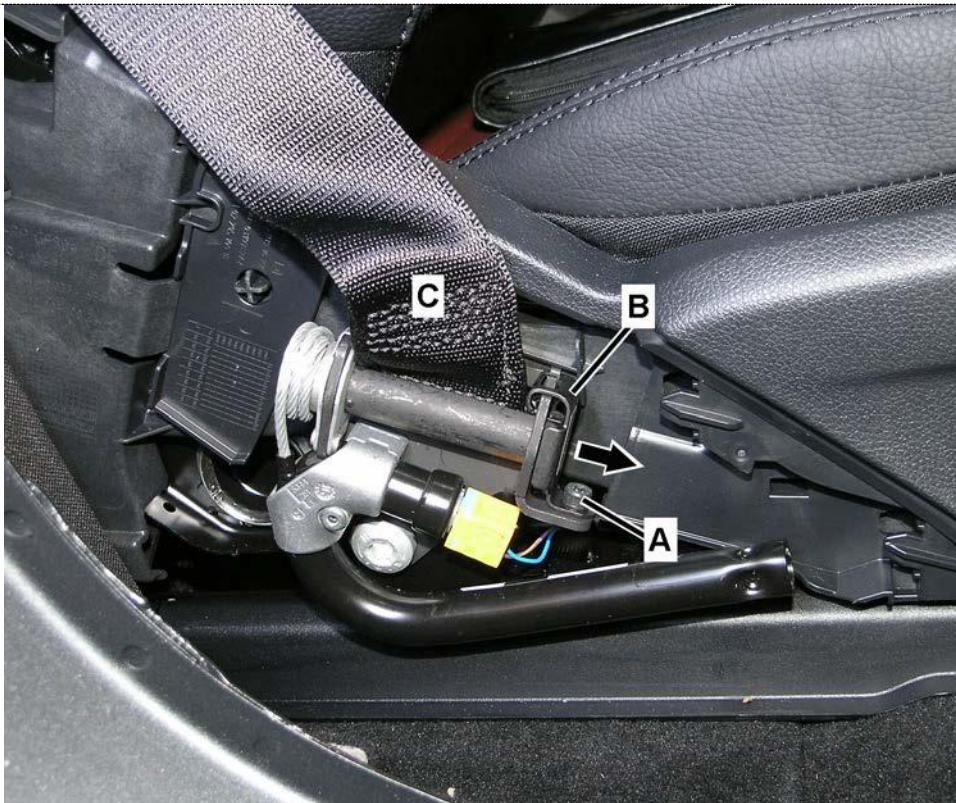
Figure 2

3. Supplemental information to above WIS instructions:
 - Remove screw (A, Figure 2).
Hm Upon installation, torque screw (A) to: 4 Nm.
 - Remove retaining clamp (B).
 - Pull seat belt (C) toward front (arrow) out of guide at front seat.

4. Install **new** seat belt in reverse order.

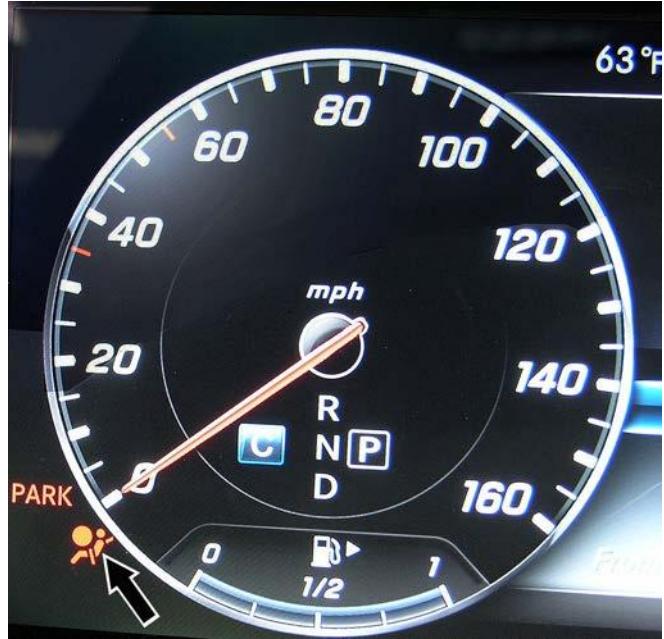
Figure 1 (shown on model 213)

1. Start engine and check whether Supplemental Restraint System (SRS) indicator lamp (arrow, Figure 1) goes out after a few seconds.
- i Note:** Prior to replacing seat belt, it must be ensured that:
- No errors are active in the SRS system (as described in this step).
 - No SRS error messages are active in the instrument cluster (as described in this step).
 - If an SRS error message is pending before start of work, it must be corrected. Fault corrections (repairs) are not claimable under this campaign.
2. Remove driver front seat belt, refer to WIS: AR91.40-P-1010LW.

- Ensure seat belt is not twisted.
 - Ensure that all applicable steps in the referenced WIS instructions are completed.
5. After installation of new seat belt be sure to start engine and check whether SRS indicator lamp goes out after a few seconds (arrow, Figure 1).

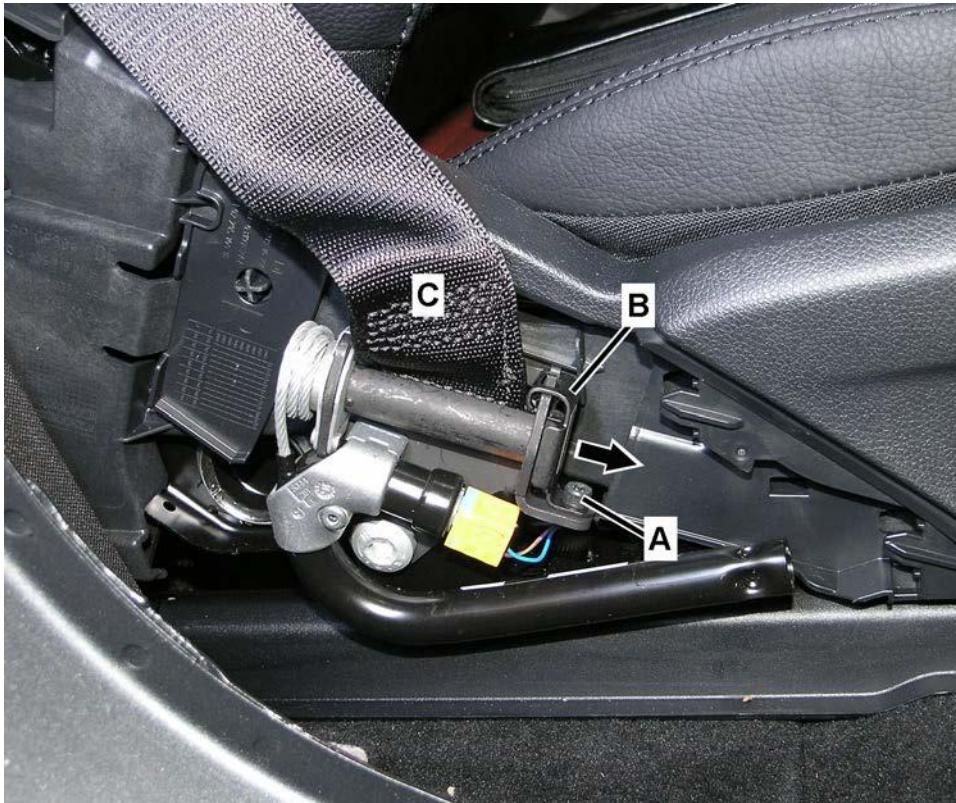
Figure 2 (shown on right front seat belt)

- Remove screw (A, Figure 2).
Nm Upon installation, torque screw (A) to: 4 Nm.
 - Remove retaining clamp (B).
 - Pull seat belt (C) toward front (arrow) out of guide at front seat.

4. Install new seat belt in reverse order.

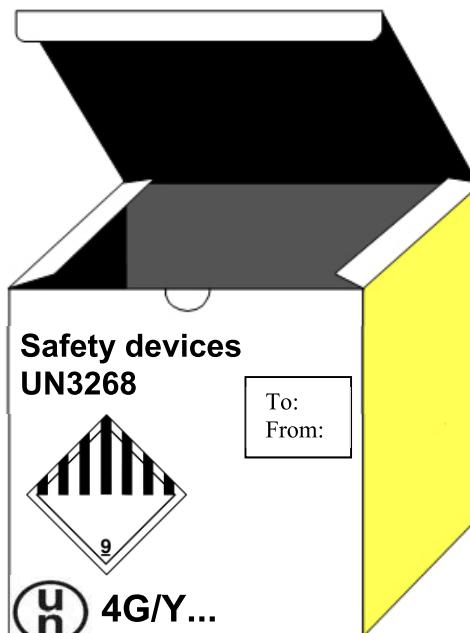
- The following words ("marking") must also be clearly visible on the same side of the box as the Class 9 label:
Safety devices
UN3268 (font size must be $\geq \frac{1}{2}$ inch)
- Affix **"To/From"** address label to same or adjacent packaging face as the hazardous markings/labels.
- The UN 4G code preprinted near the bottom edge of the box must also be clearly visible.

- Note:** The Packing Group and the EX# are no longer required to be printed on the HAZMAT bill of lading.
- Package example:**

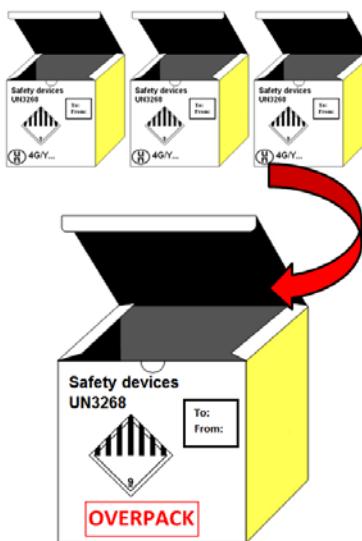
- Place each individual UN spec box (noted above) inside a larger non-UN spec box to keep shipment together.
- This larger box is an "**OVERPACK**".
- The Overpack box must have the identical **Class 9 label** and marked "**Safety devices**" and "**UN3268**" just as the boxes inside.
- Mark "**OVERPACK**" on the outside of the Overpack box on the same face as the hazmat markings and labels.
- Package example:**

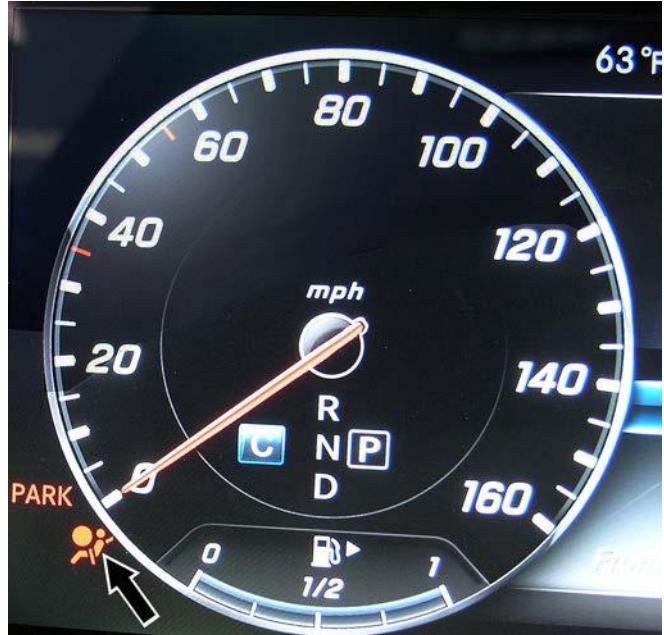
Figure 1 (shown on model 213)

1. Start engine and check whether Supplemental Restraint System (SRS) indicator lamp (arrow, Figure 1) goes out after a few seconds.

- Ensure seat belt is not twisted.
 - Ensure that all applicable steps in the referenced WIS instructions are completed.
5. After installation of new seat belt be sure to start engine and check whether SRS indicator lamp goes out after a few seconds (arrow, Figure 1).
 6. Repeat procedure on opposite side.

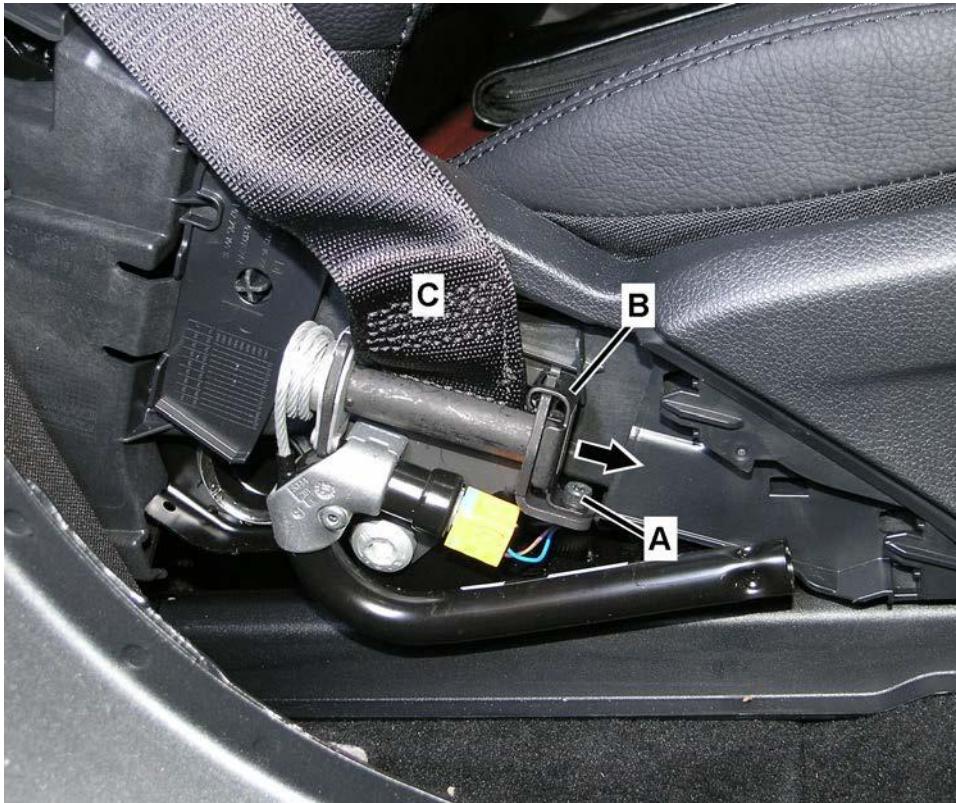
Figure 2

3. Supplemental information to above WIS instructions:
 - Remove screw (A, Figure 2).
Nm Upon installation, torque screw (A) to: 4 Nm.
 - Remove retaining clamp (B).
 - Pull seat belt (C) toward front (arrow) out of guide at front seat.
4. Install new seat belt in reverse order.

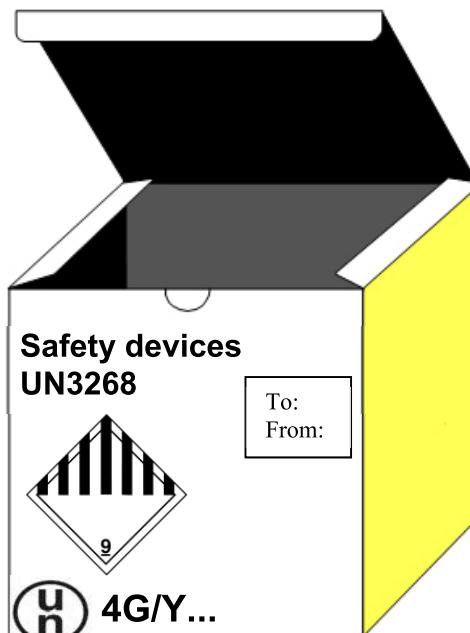
- The following words ("marking") must also be clearly visible on the same side of the box as the Class 9 label:
Safety devices
UN3268 (font size must be $\geq \frac{1}{2}$ inch)
- Affix **"To/From"** address label to same or adjacent packaging face as the hazardous markings/labels.
- The UN 4G code preprinted near the bottom edge of the box must also be clearly visible.

- Note:** The Packing Group and the EX# are no longer required to be printed on the HAZMAT bill of lading.
- Package example:**
