# Spark Plug Indexing for Direct Injection Engines

John Dahlquist  
June 19, 2014  
Version 3

Mercedes-Benz

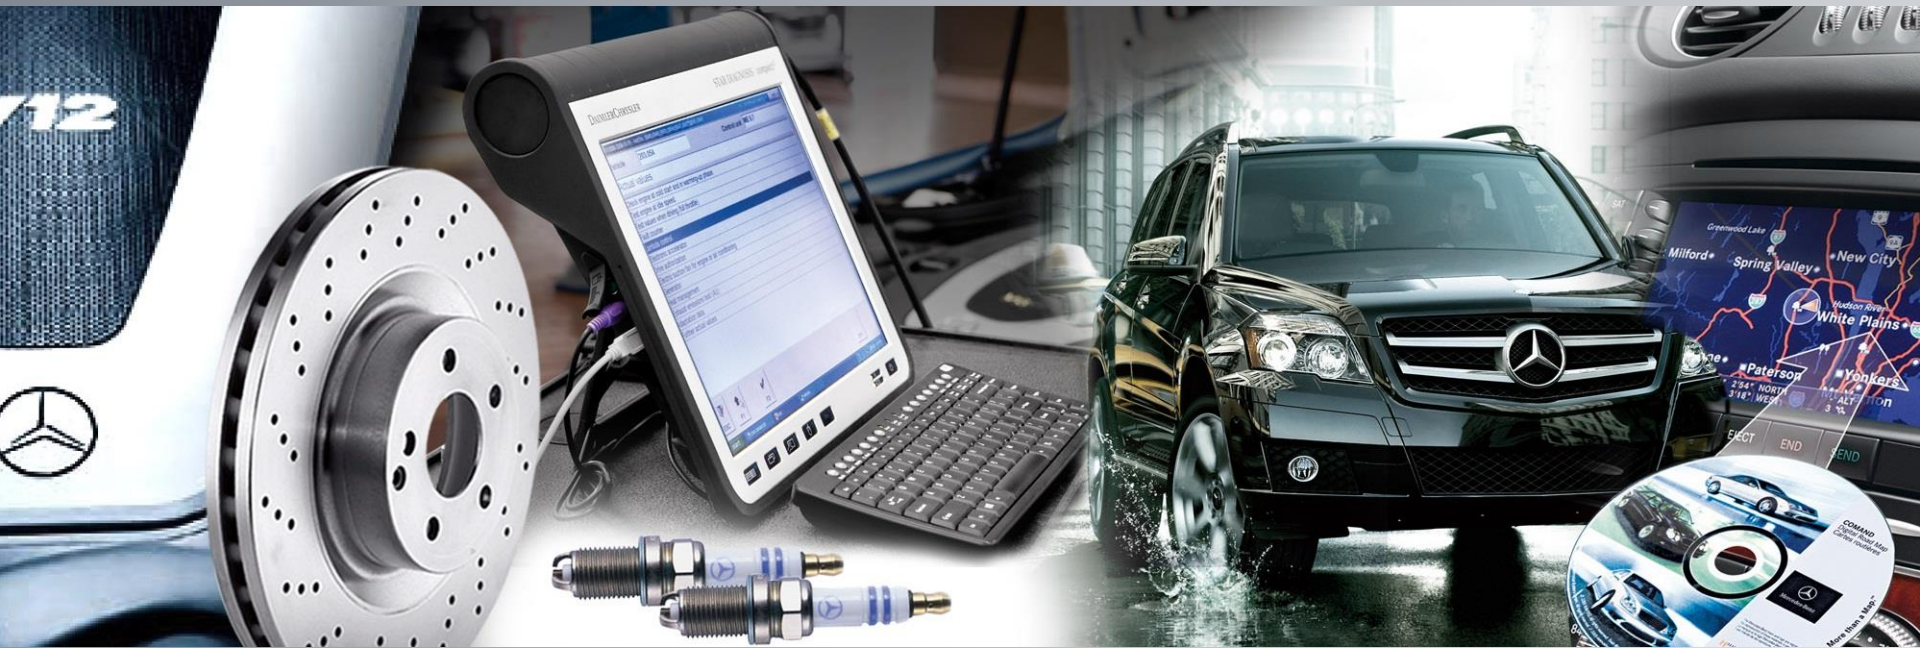
With direct injection system for engines 157, 276, 278 (for example) the spark plug indexing is very critical as indicated in the picture and the warning information in WIS when replacing spark plugs.

- Special spark plug
- Open side of electrode facing the injector
- Specific plug thread length
- Close-fitting requirement
- Specified torque must be observed

**Installation:** It is essential to adhere to the tightening torque as it influences the position of the spark plug electrodes in the cylinder.

An incorrect tightening torque causes misfires which can lead to damage to the engine and catalytic converter damage

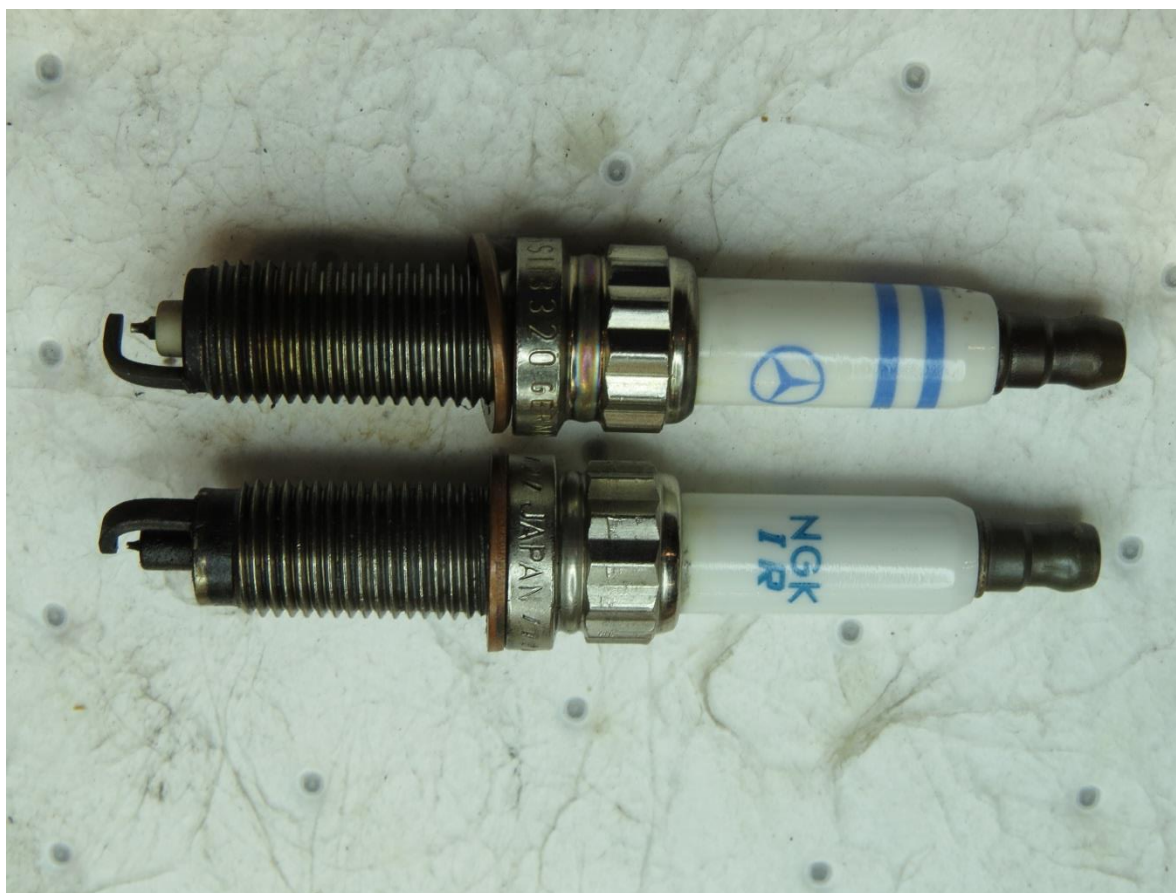
In the picture, an NGK unapproved spark plug is compared to a Mercedes approved spark plug. The NGK plug does not have the correct thread length for proper indexing and it isn't the correct heat range.

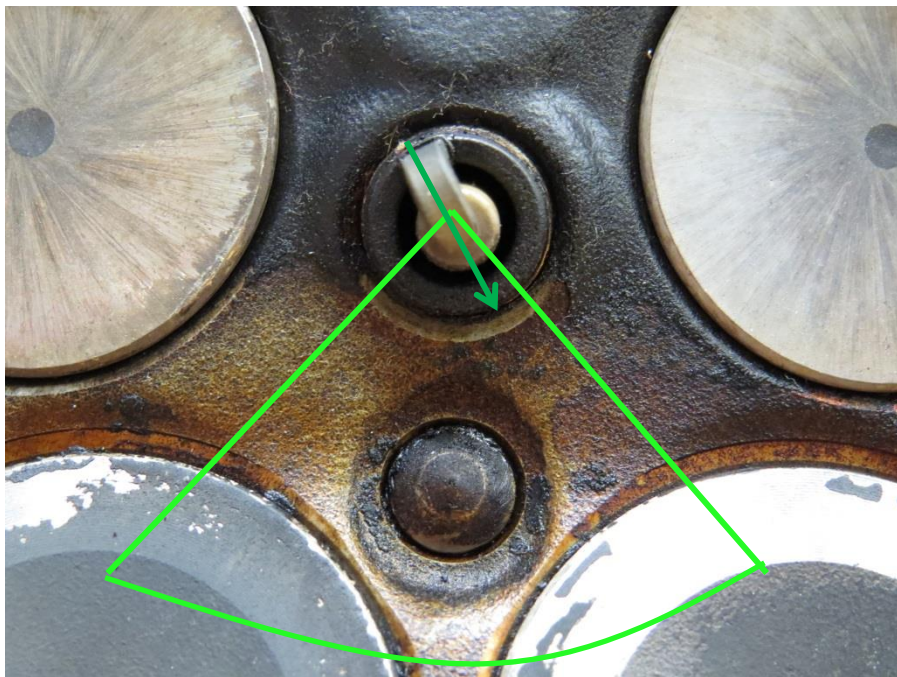
MB Plug

Below shows the indexing of the MB plug and the NGK plug when torqued at 23 Nm.

Note: For our direct injection engines, the indexing is up to 45 degrees of either side of the injector center.

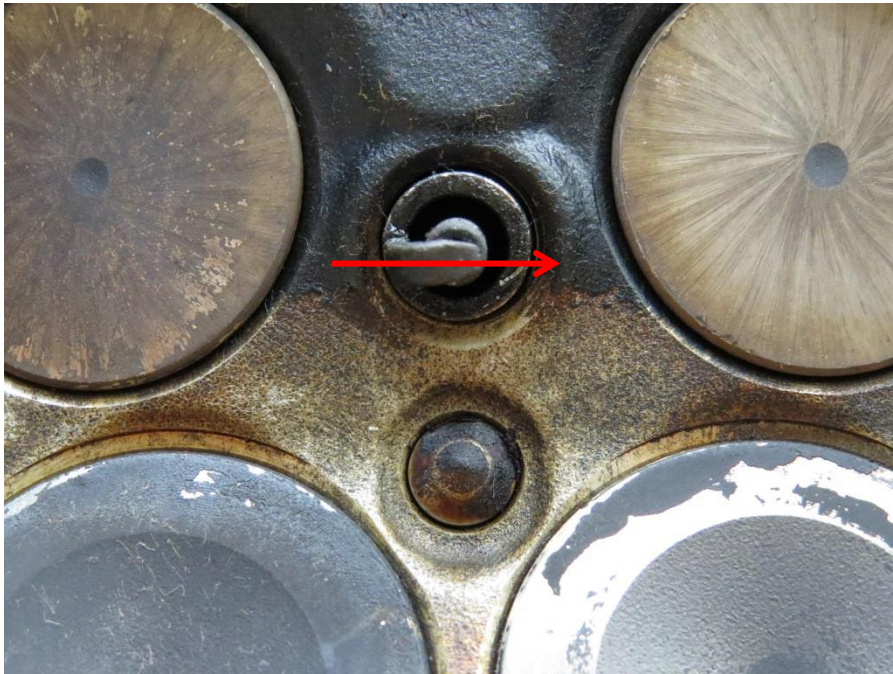
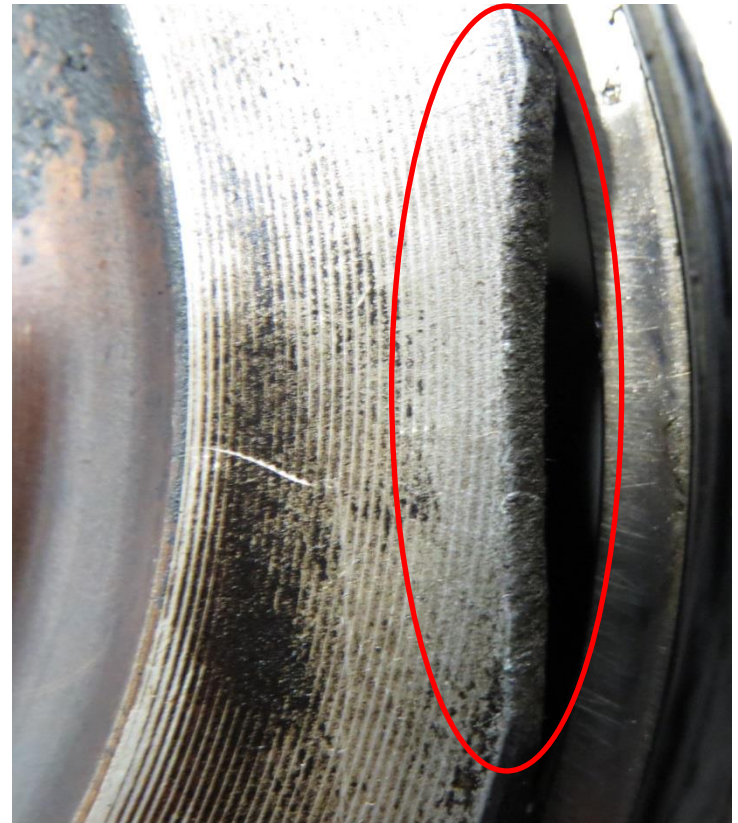
NGK Plug

In this case, the incorrect spark plug caused major engine damage (melted piston) that lead to a complete engine replacement. This is not a warrantable defect.
