Model 166.0, 292

Model 166.8

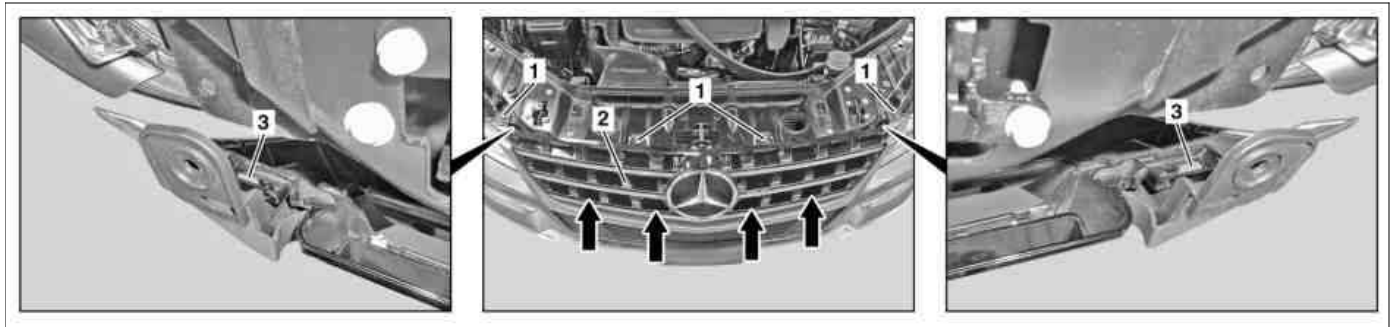
P88.40-2956-07

Shown on model 166.0 up to model year 2016 except code 501 (360° camera)

1 Expansion rivet

2 Radiator grille

3 Catch hook

ⓘ	Information on preventing damage to electronic components due to electrostatic discharge		AH54.00-P-0001-01A
⊞	Remove		
1	Switch on ignition and store transmitter key outside of transmission range (min. 2 m)		
2	Remove cover on radiator support	☑ Long wedge	*115589035900
3	Remove expansion rivets (1)	☑ Clip remover	*452589016300
4	Press catch hooks (3) (arrows) on inside of radiator trim (2) downward with suitable tool and disengage radiator trim (2)		
5	Expose electrical connector on 360° camera at front and disconnect	Model 166.0/8, 292 with code 501 (360° camera)	AR54.30-P-3001GQ
6	Press radiator grille (2) toward rear and remove		
⊞	Install		
7	Position radiator trim (2)		
8	Connect electrical connector to front 360° camera and fasten	Model 166.0/8, 292 with code 501 (360° camera)	AR54.30-P-3001GQ
9	Press radiator trim (2) toward front and remove	ⓘ The catch hooks (3) (arrows) should catch audibly in the radiator trim (2).

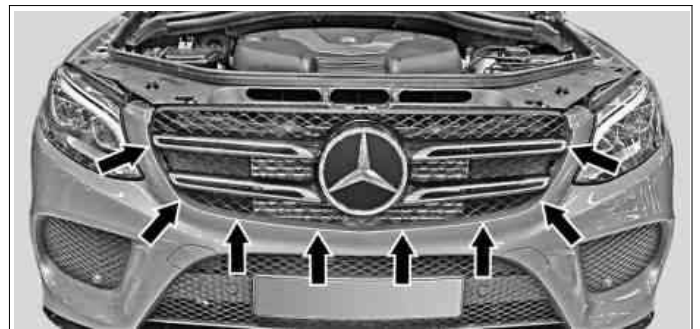
P88.40-3274-10

Shown on model 166.0 as of model year 2016 except code 501 (360° camera)

10	Install expansion rivets (1)
