2000 Mercedes Benz Truck ML 320 (163.154) V6-3.2L (112.942)

Campaign - Catalytic Converter Inspection/Replacement

Campaign No. 2005060014, September 2005
Revised November 2005

INSPECT CATALYST WELDS AND REPLACE [CATALYTIC CONVERTER](#) IF NECESSARY

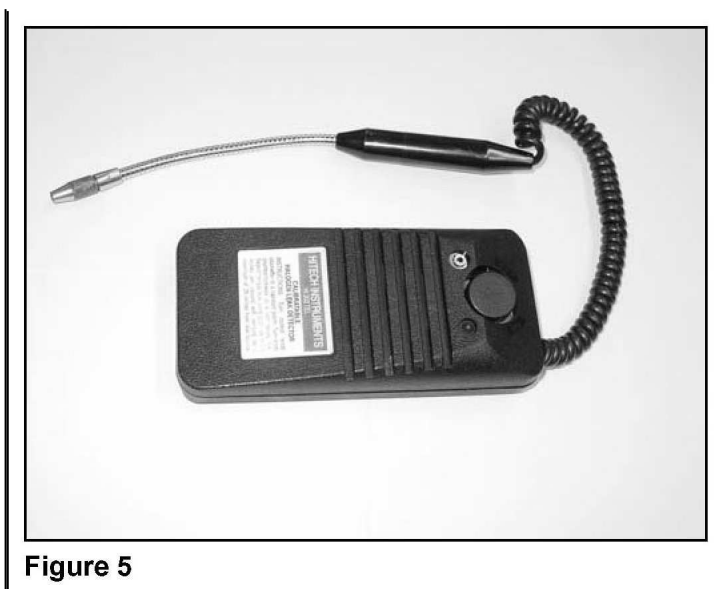
Figure 5

- HI TECH Instruments HI 300 TEL (Figure 5)
- Robinair 42-16600, TIF ZX-1
- Snap-On ACT755, CPS L5790B
- ^ Adjust leak detector (Figure 5) sensitivity to detect exhaust gas using a vehicle not involved with this campaign (this will help to prevent heating of [catalytic converters](#) on vehicle being campaigned).
- ^ Leak detector (Figure 5) will check for any change in ambient air quality. An exhaust gas leak will affect the quality of the ambient air around the [catalytic converter](#).

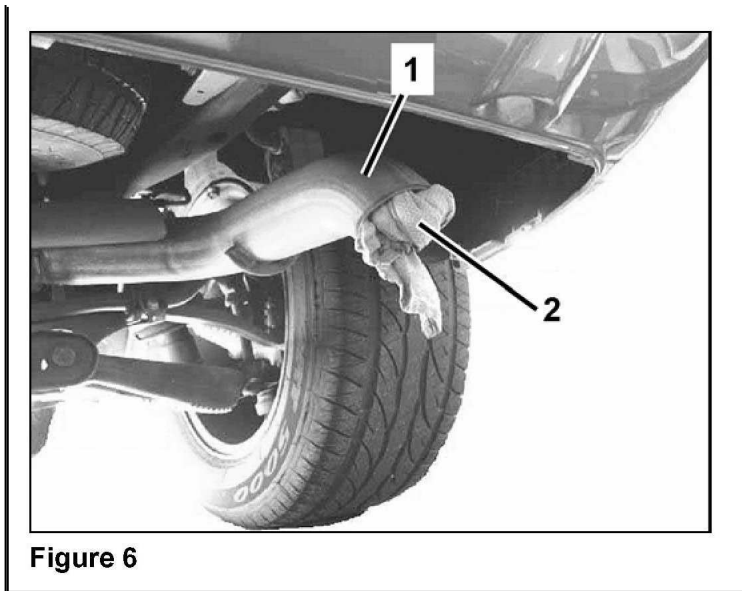
1. Plug tail pipe (1, Figure 6) of vehicle (e.g., wet rag [2]).
2. Start engine.

5. Remove exhaust plug (2, Figure 6).
6. If exhaust gas leak is detected proceed to subject C:
Replace [catalytic converter](#)/front exhaust system.
