MODELS 163.113 /128 /136 /154 /157 /172 /175 with CODE (810) Sound system

MODEL 163.174

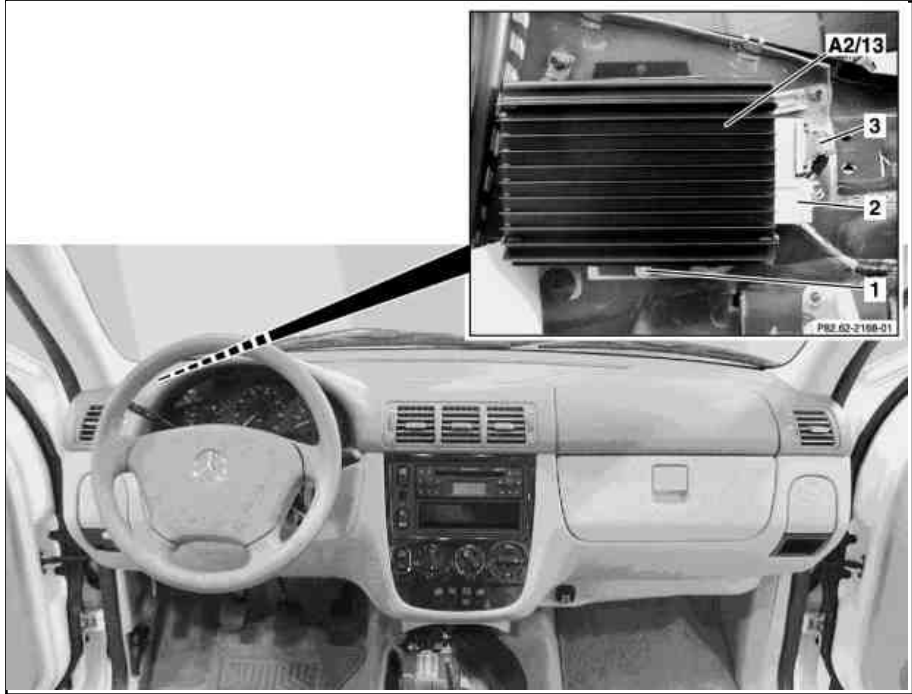
P82.62-2169-06

- 1 Bolt
- 2 Connector
- 3 Connector
- A2/13 Sound amplifier

Right-hand drive vehicle. 	<p>AR68.10-P-1500GH</p> <p>AR68.10-P-1520GI</p>
2	Unscrew screw (1) and detach Sound amplifier (A2/13) from bracket	<ul style="list-style-type: none">

Lay insulation down to side. 	
3	Disconnect connector (2, 3)	<ul style="list-style-type: none">

As of VIN A289565, X754620. 	AR82.95-P-0005-01A
5	Remove Sound amplifier (A2/13)	<ul style="list-style-type: none">
