MODEL 163.113 /128 /136 /154 /157 /172 /174 /175

P72.12-2061-09

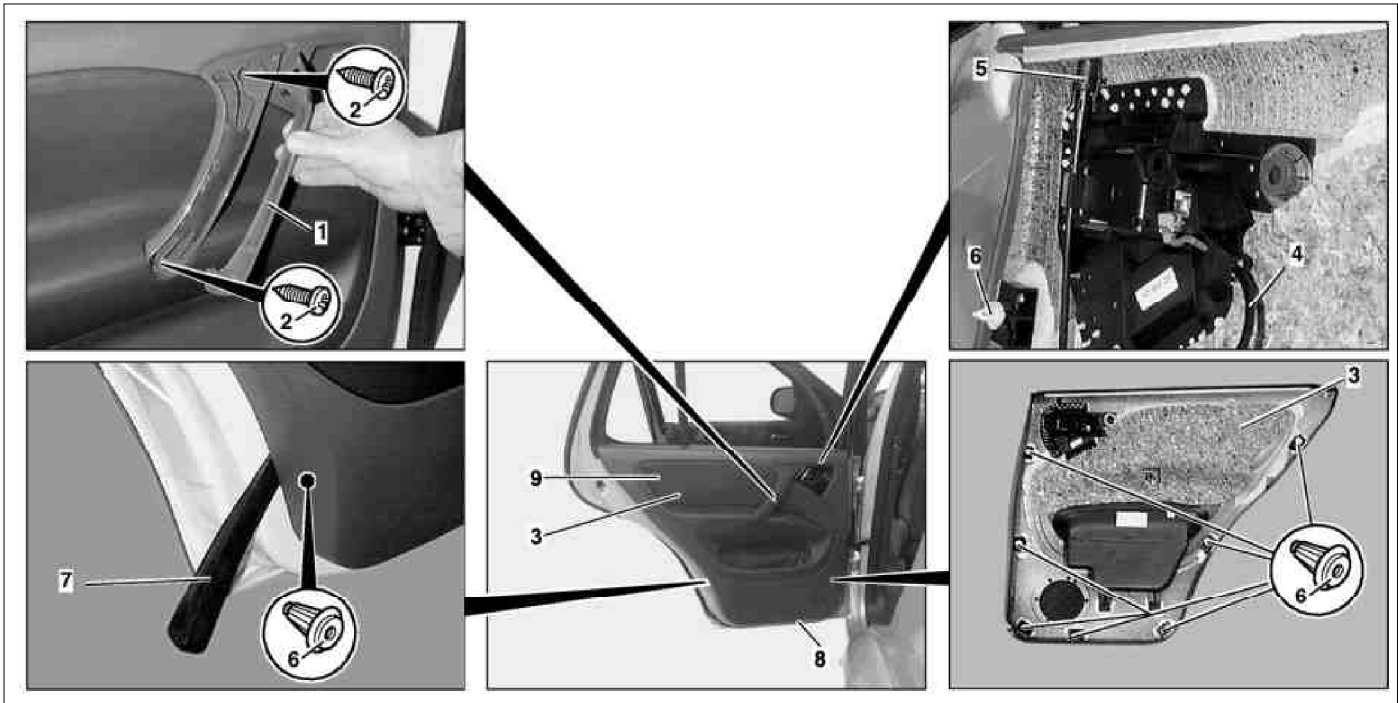
- 1 Door handle cover  
2 Bolt  
3 Door liner

- 4 Bowden cable  
5 Inner lock  
6 Clips

- 7 Assembly wedge  
8 Entrance lamp  
9 Bolt

Remove/install		
1	Open crank window		
2	Remove cover for door handle (1)		
3	Unscrew screw (2)		
4.1	Unclip SRS panel and unscrew screw (9)

As of vehicle identification number A145273, X708319.	
5	Press door liner (3) off of bottom, front and rear inner door panel with assembly wedge (7)

Position assembly wedge directly next to clips

Assembly wedge	*110589035900
6	Lift door liner (3) up and out		
7	Unhook control cable (4) on inner door actuating mechanism		
8	Unclip inner lock (5) on door liner (3)		
9.1	Remove entrance lamp (8)

As of vehicle identification number A145273, X708319.	
10	Lay down door liner		
11	Check foil and sheet metal clip nuts on inner door panel

Replace damaged foil. Replace all clips.	
12	Install in the reverse order
