MODEL 163.113 /128 /136 /154 /157 /172 /174 /175

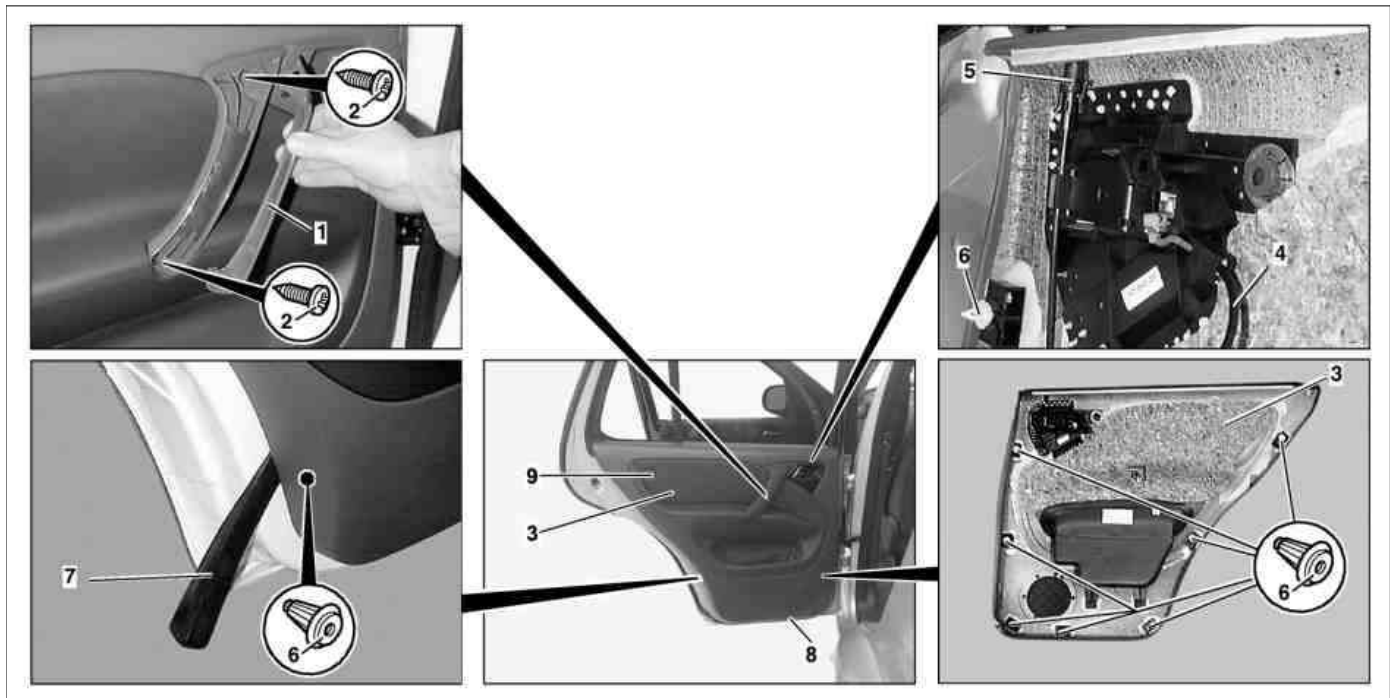
P72.12-2061-09

1 Door handle cover  
2 Bolt  
3 Door liner

4 Bowden cable  
5 Inner lock  
6 Clips

7 Assembly wedge  
8 Entrance lamp  
9 Bolt

Remove/install		
1	Open crank window		
2	Remove cover for door handle (1)		
3	Unscrew screw (2)		
4.1	Unclip SRS panel and unscrew screw (9)

As of vehicle identification number A145273, X708319.	
5	Press door liner (3) off of bottom, front and rear inner door panel with assembly wedge (7)

Position assembly wedge directly next to clips

Assembly wedge	*110589035900
6	Lift door liner (3) up and out		
7	Unhook control cable (4) on inner door actuating mechanism		
8	Unclip inner lock (5) on door liner (3)		
9.1	Remove entrance lamp (8)

As of vehicle identification number A145273, X708319.	
10	Lay down door liner		
11	Check foil and sheet metal clip nuts on inner door panel

Replace damaged foil. Replace all clips.	
12	Install in the reverse order
