## MODEL 251

N87/5 SDAR control unit

Remove/install

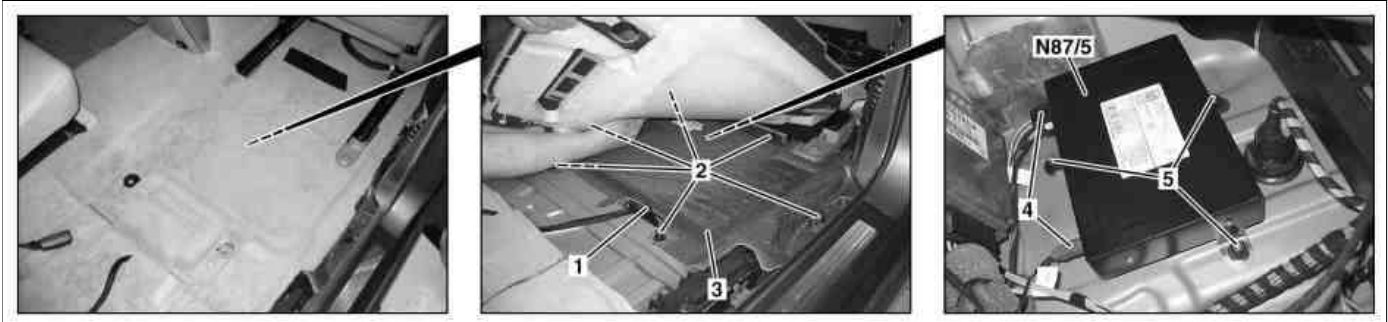
P82.60-5938-07

1 Bracket

2 Nuts

3 Intermediate bottom

4 Electrical connectors

5 Nuts

<b>Installation:</b> Ensure that guide lugs are installed correctly.	
8	Unclip rear seat rail covers from front seat		
9	Lift center floor cover		
10	Unclip brackets (1)		
11	Remove nuts (2)		
12	Remove intermediate bottom (3)		
13	Separate electrical connectors (4)

14	Remove nuts (5)		
15	Remove SDAR control unit (N87/5)		
16	Install in the reverse order
